Fracture of Skin/Stiffener Intersections in Composite Wind Turbine Structures

Douglas S. Cairns, Darrin J. Haugen

Abstract

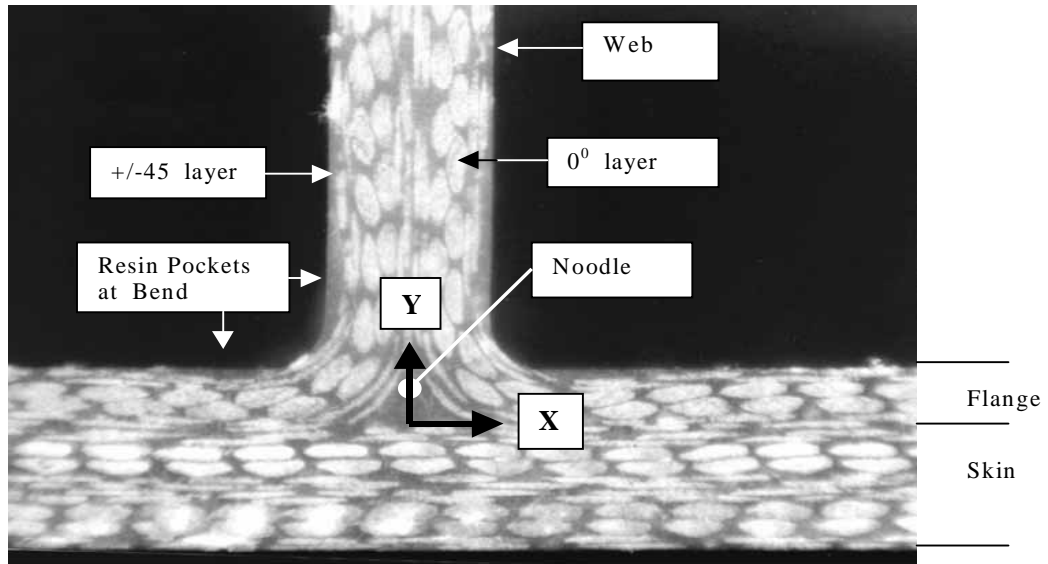
a.

A noticeable change in thickness across the width of the skin under the flanges was seen after the samples had cured. This was due to the mold compressing the fabric layers in the skin underneath the flanges. A matrix burn-off test was performed to calculate the fiber volume fraction at a known thickness for the skin material away from the flange area. The fiber volume fraction could then be calculated across the width since the lay-up is constant across the width. The fiber volume varies from 30% to nearly 36% across the width. This should be noted, since the strength varies with the fiber volume percentage, especially in fatigue.¹ It was also noted that the fabrics had a difficult time negotiating the small bend radius (1.8 mm) where they transition from the web to the flange. This caused small resin pockets to form on the surface of the samples in the bend area (Fig. 3a).

The first series of tests involved comparison of the one-piece specimens to the samples bonded with adhesive. The same failure modes and sequences were seen in all of the samples. The first damage to appear was between the +/-45 plies at the bend surface, where the web transitions into the flange. This damage is labeled crack 1 in both the photograph of Figure 3b and the load vs. displacement curve (Fig. 4). The two load drops for crack 1 correspond to identical damage on the right and left sides of the sample. The next damage to appear is labeled as crack 2, and was a crack at the interface of the matrix rich "noodle" region and the inner -45 layer at the bend. Several more cracks formed in the noodle region, including cracks at the centerline of the web and the small resin pockets at the bend surface. This array of cracks eventually joined and moved downward to the flange/skin interface. The delaminations then began at this interface as well as the web centerline. The delamination lengths at the flange and web were nearly the same length in the x and y directions (Fig. 3a), respectively, throughout the test.

Figure 3. Photo of specimen with (a) key features labeled, and (b) initial damage zone.

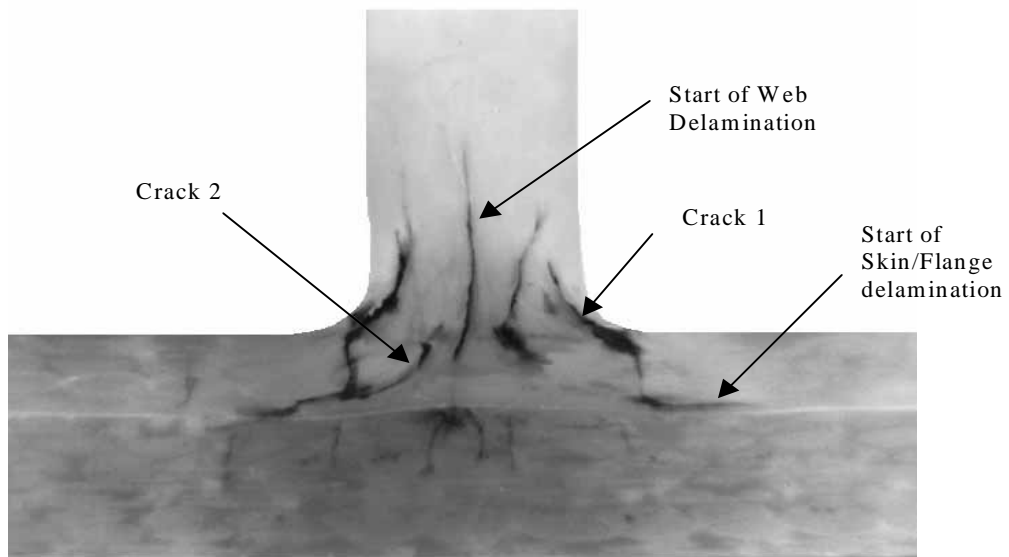
b.

In the one-piece samples, the delamination formed either within the matrix layer at the skin/flange interface, or just below, within the skin's +45 top ply. This was also observed in the bonded samples. In addition, the delamination did not grow within the tougher adhesive layer. It formed below it at the interface, or within the topmost skin ply as seen in the one-piece samples. This is consistent with other findings in similar pull-off tests² and the fact that interlaminar strength tends to be dominated by matrix toughness.³ Thus, the crack can more easily propagate within the brittle polyester matrix than in the tougher Hysol layer. The delamination continued to progress outward toward the flange tip in a stable manner until final pull-off when the crack was very near the flange tip.

The noodle/bend region of the stiffeners appears to be a critical design detail. This area usually displayed the first damage in the samples. The bend is an obvious stress concentration in this type of structure. Furthermore, the fiberglass fabric used in manufacturing had a hard time conforming exactly to the bend radius. This caused resin pockets on the sample surface, as well as possible local fiber bunching and increased fiber volume percentage at the bend.^{1,6,7} Bend radii of mold surfaces should be increased to lower the stress concentration and allow the fabric to conform to the bend surface more easily. Fiberglass tows should also be placed in the noodle area to raise the strength of this pure matrix region.

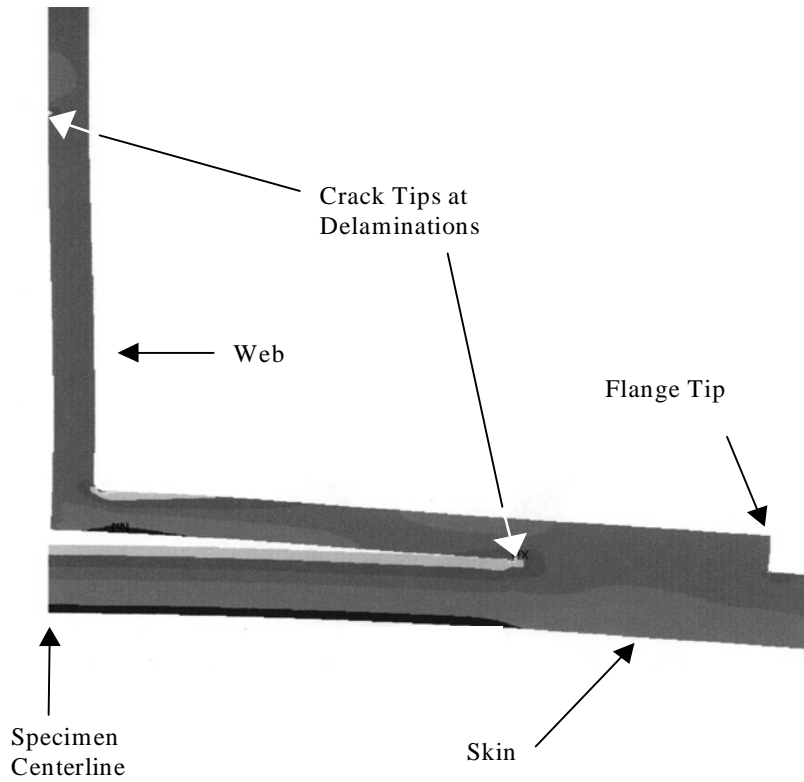
A plot of the deflected shape for a sample containing a delamination is shown in Figure 7. The results of the SERR calculations are presented in Figures 8 and 9 for mode I and II contributions, as well as total SERR (G). Two distinct delaminations were investigated. The first crack was at the interface of the flange and skin. The second was located at the mid-plane of the web, growing vertically between the two inner -45° plies. The results are for delamination lengths greater than 1.2 cm, as measured from a point at the specimen centerline on the flange skin interface (Fig. 3a). The SERR results are calculated for the one-piece samples without the adhesive layer. Figure 8 shows that the total SERR is dominantly mode I as the delamination approaches the flange tip for the flange/skin crack. The maximum value for G_{Ic} is approximately 700 (J/m²) per unit width. It also appears that the mode II contribution is greatest at small crack lengths near the noodle region. The vertical web crack is purely mode I due to the symmetry of the test. It has a relatively constant value of about 600 (J/m²) per unit width (Fig. 9).

Figure 7. Plot of deformed skin/stiffener intersection region with delamination present (from ANSYS).
