Montana State University
**Johnstone Center Exterior Painting
Construction Drawings**

PPA #19-0025
February 2021

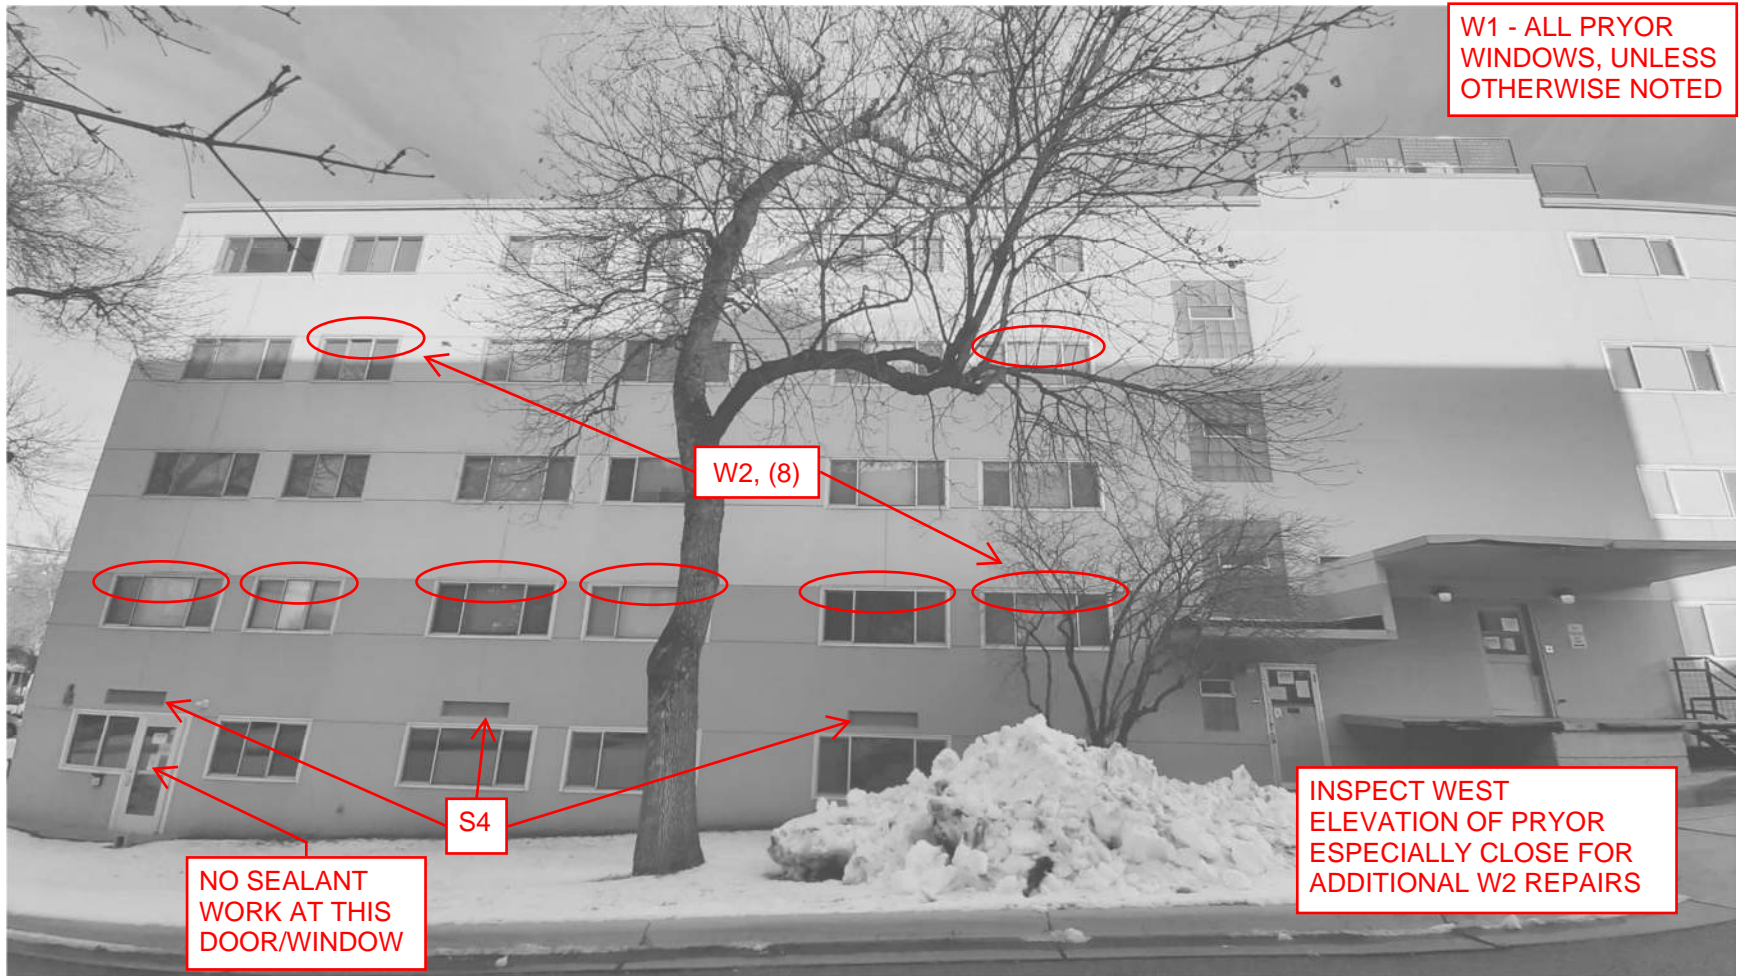
PRYOR - NORTH

W1 - ALL PRYOR
WINDOWS, UNLESS
OTHERWISE NOTED

W2, (8)

NO SEALANT
WORK AT THIS
DOOR/WINDOW

S4

INSPECT WEST
ELEVATION OF PRYOR
ESPECIALLY CLOSE FOR
ADDITIONAL W2 REPAIRS

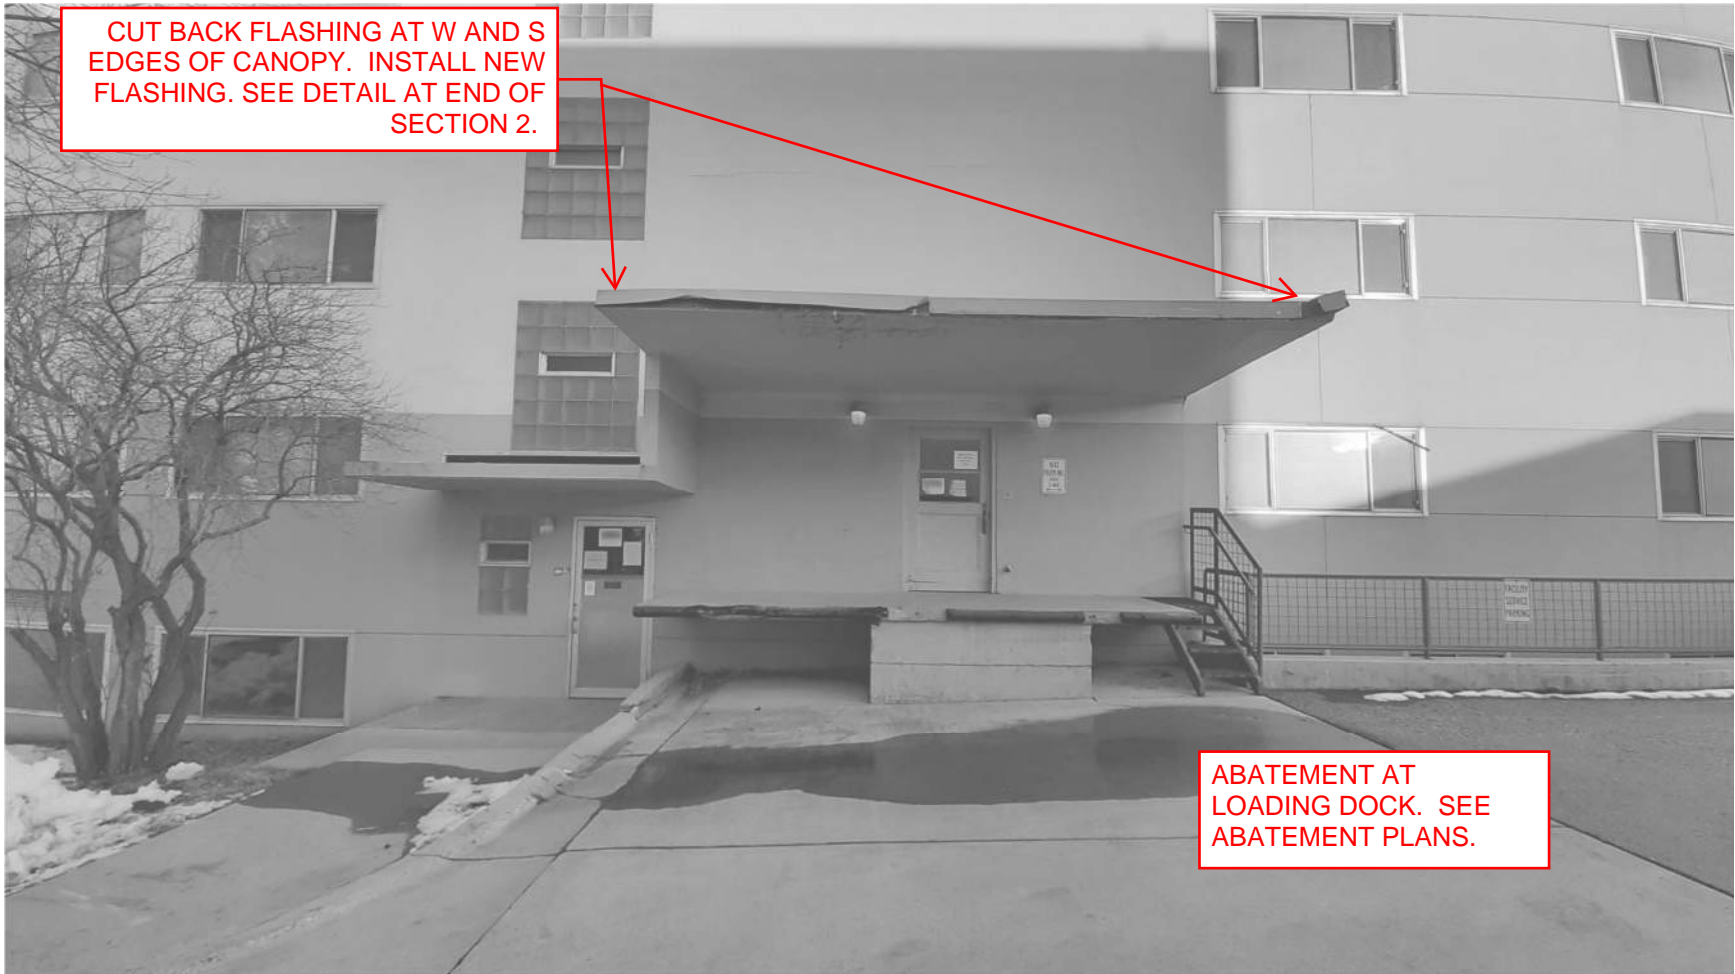
PRYOR - WEST

CUT BACK FLASHING AT W AND S EDGES OF CANOPY. INSTALL NEW FLASHING. SEE DETAIL AT END OF SECTION 2.

ABATEMENT AT LOADING DOCK. SEE ABATEMENT PLANS.

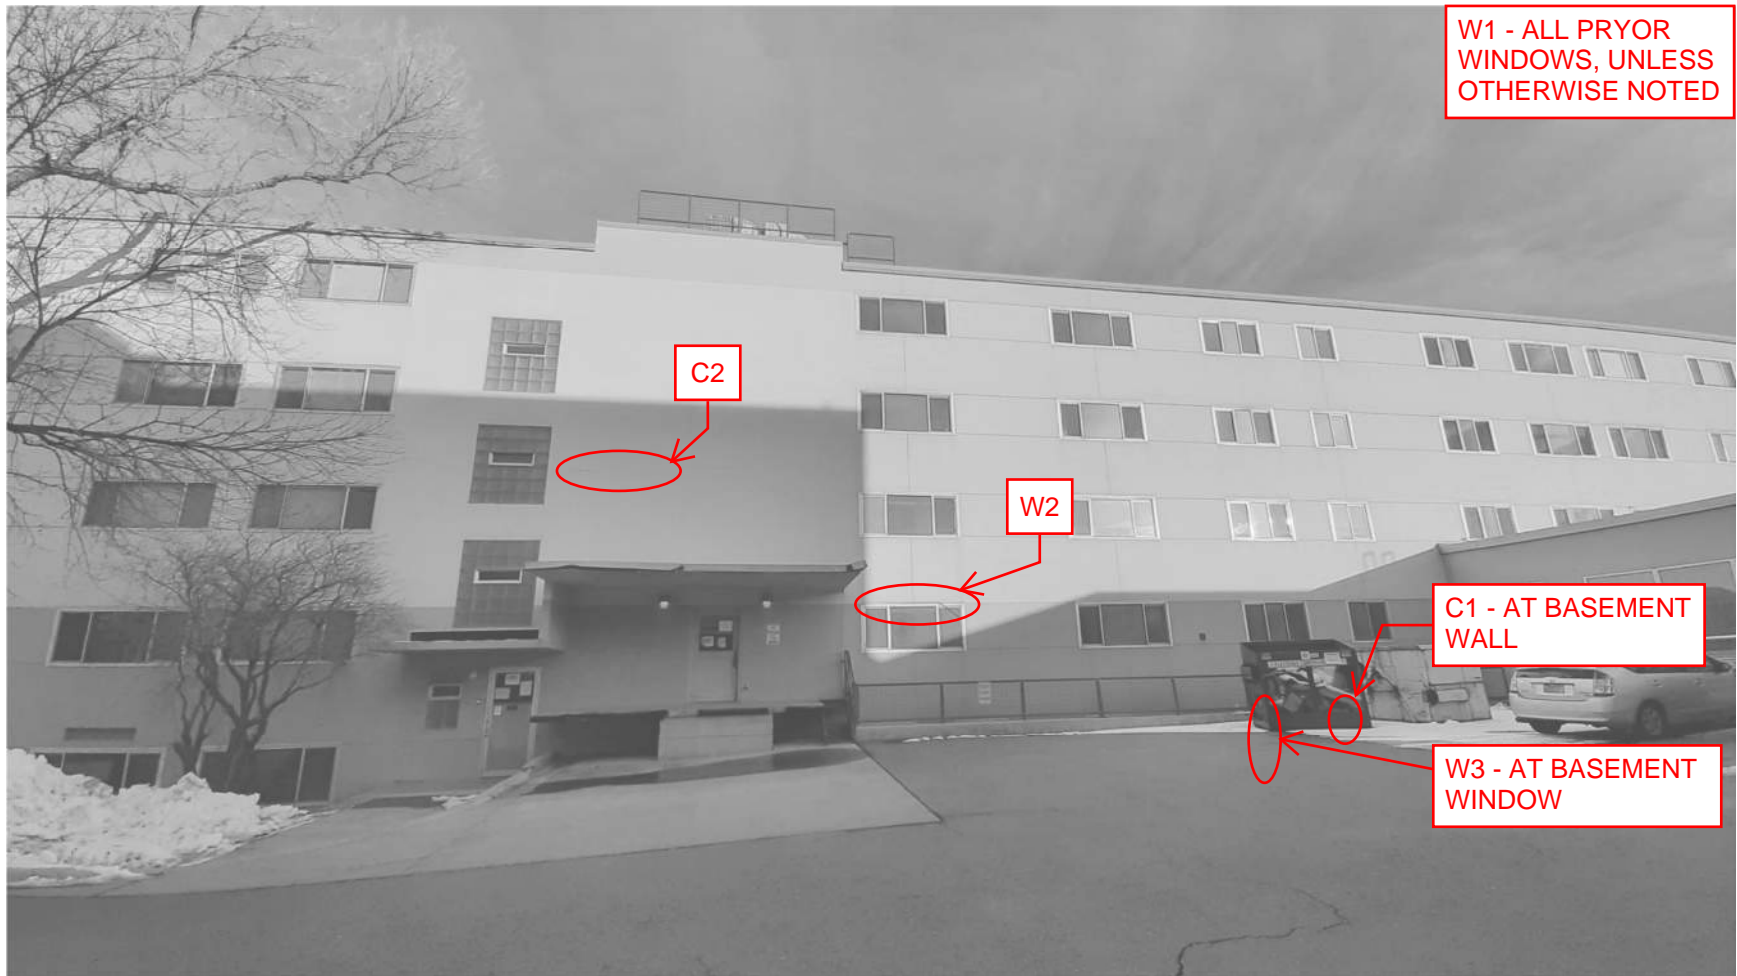
PRYOR - WEST

W1 - ALL PRYOR
WINDOWS, UNLESS
OTHERWISE NOTED

C2

W2

C1 - AT BASEMENT
WALL

W3 - AT BASEMENT
WINDOW

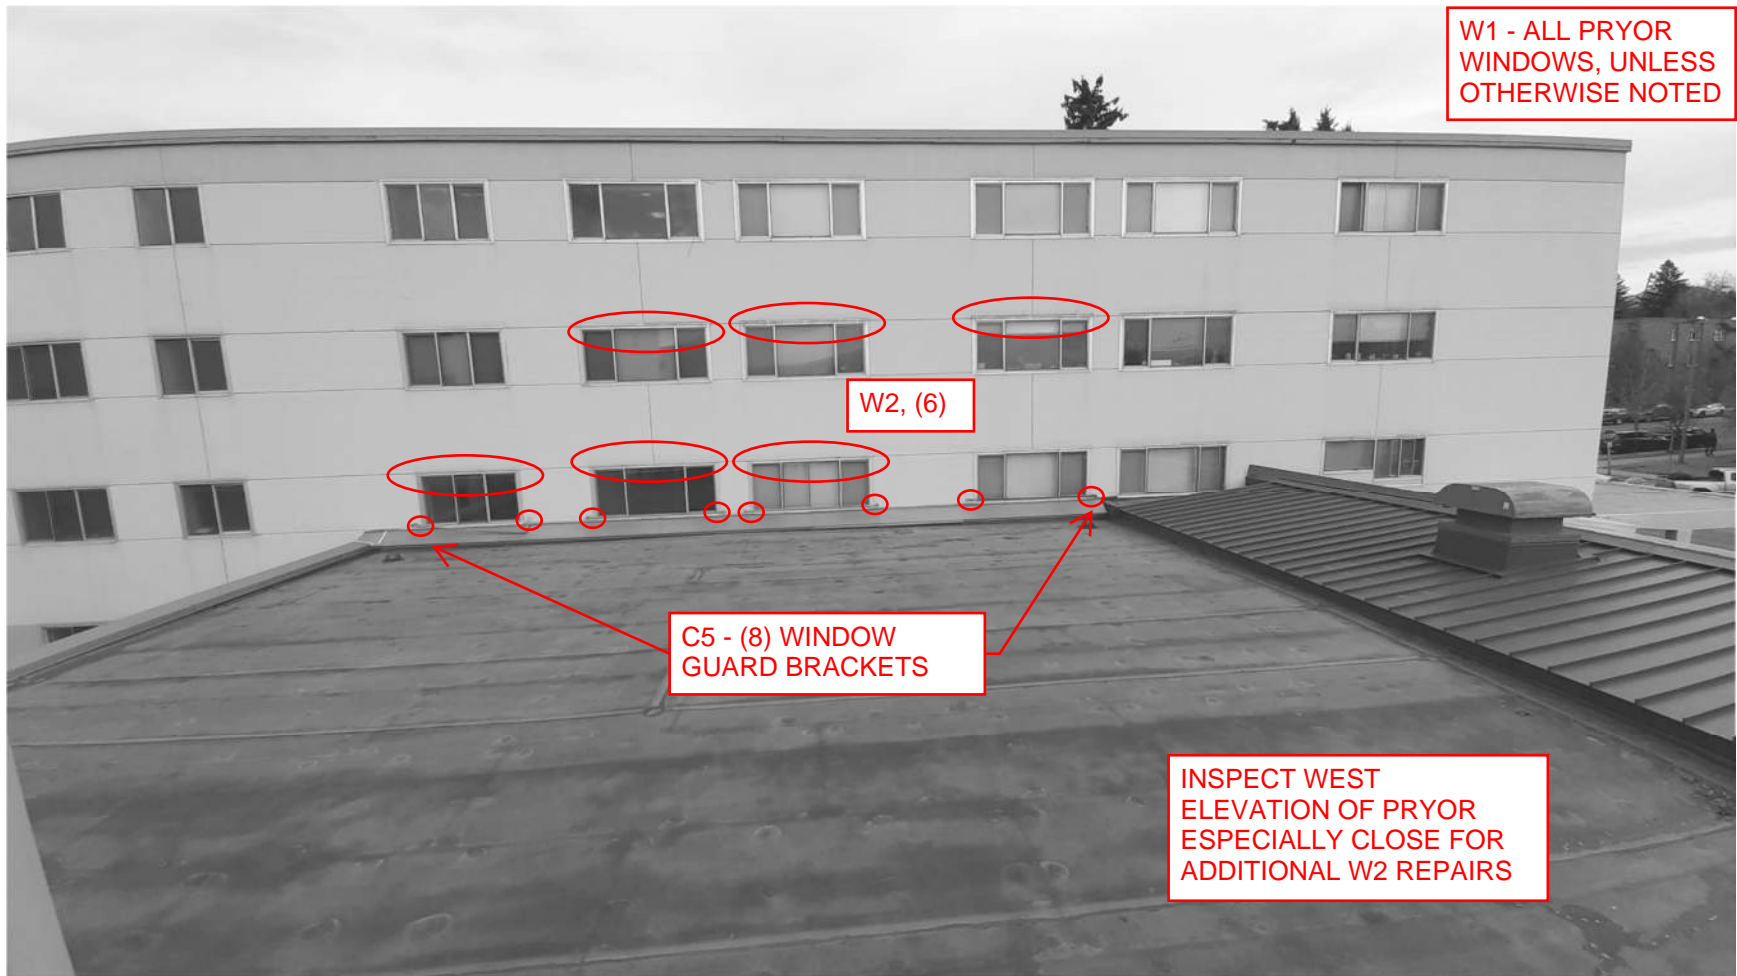
PRYOR - WEST

W1 - ALL PRYOR
WINDOWS, UNLESS
OTHERWISE NOTED

W2, (6)

C5 - (8) WINDOW
GUARD BRACKETS

INSPECT WEST
ELEVATION OF PRYOR
ESPECIALLY CLOSE FOR
ADDITIONAL W2 REPAIRS

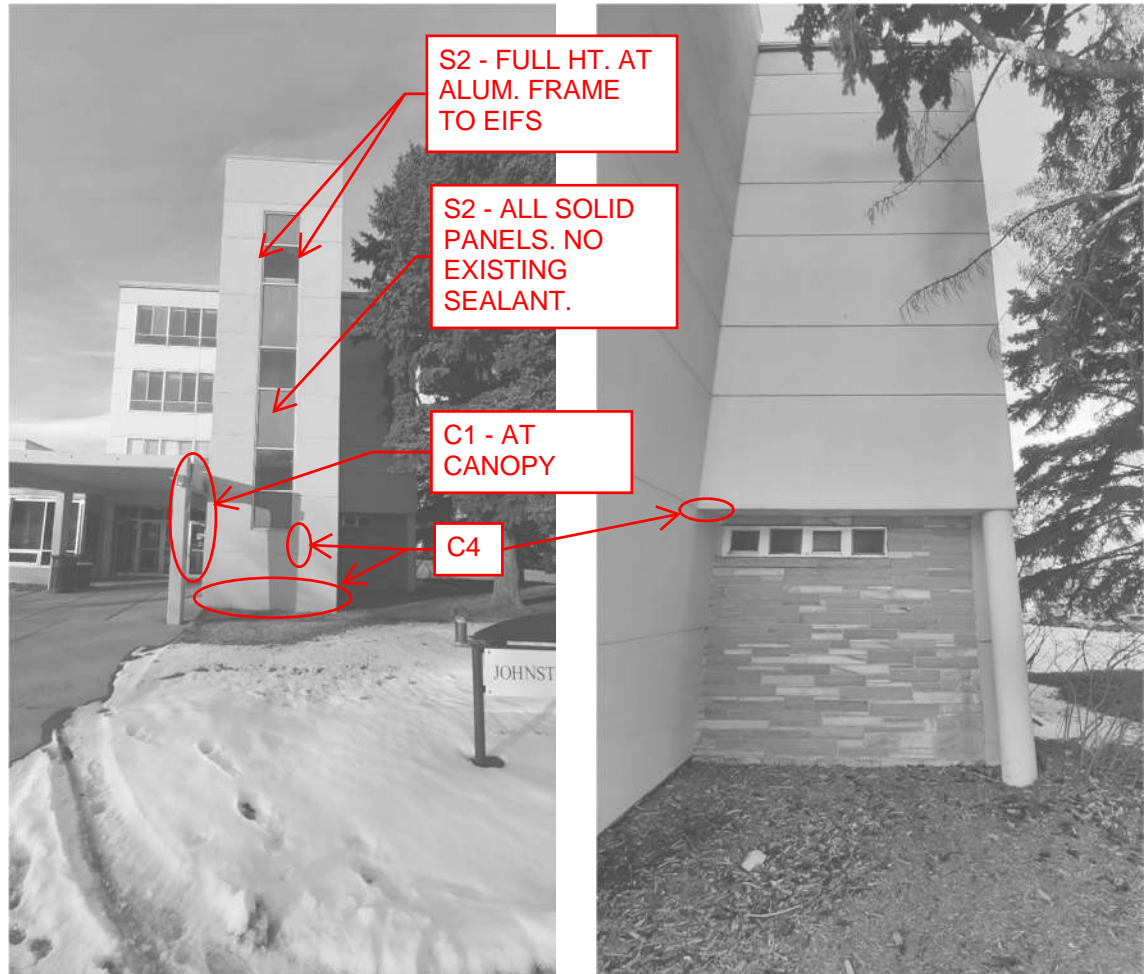
C1 - AT
CANOPY

C4

S2 - FULL HT. AT
ALUM. FRAME
TO EIFS

S2 - ALL SOLID
PANELS. NO
EXISTING
SEALANT.

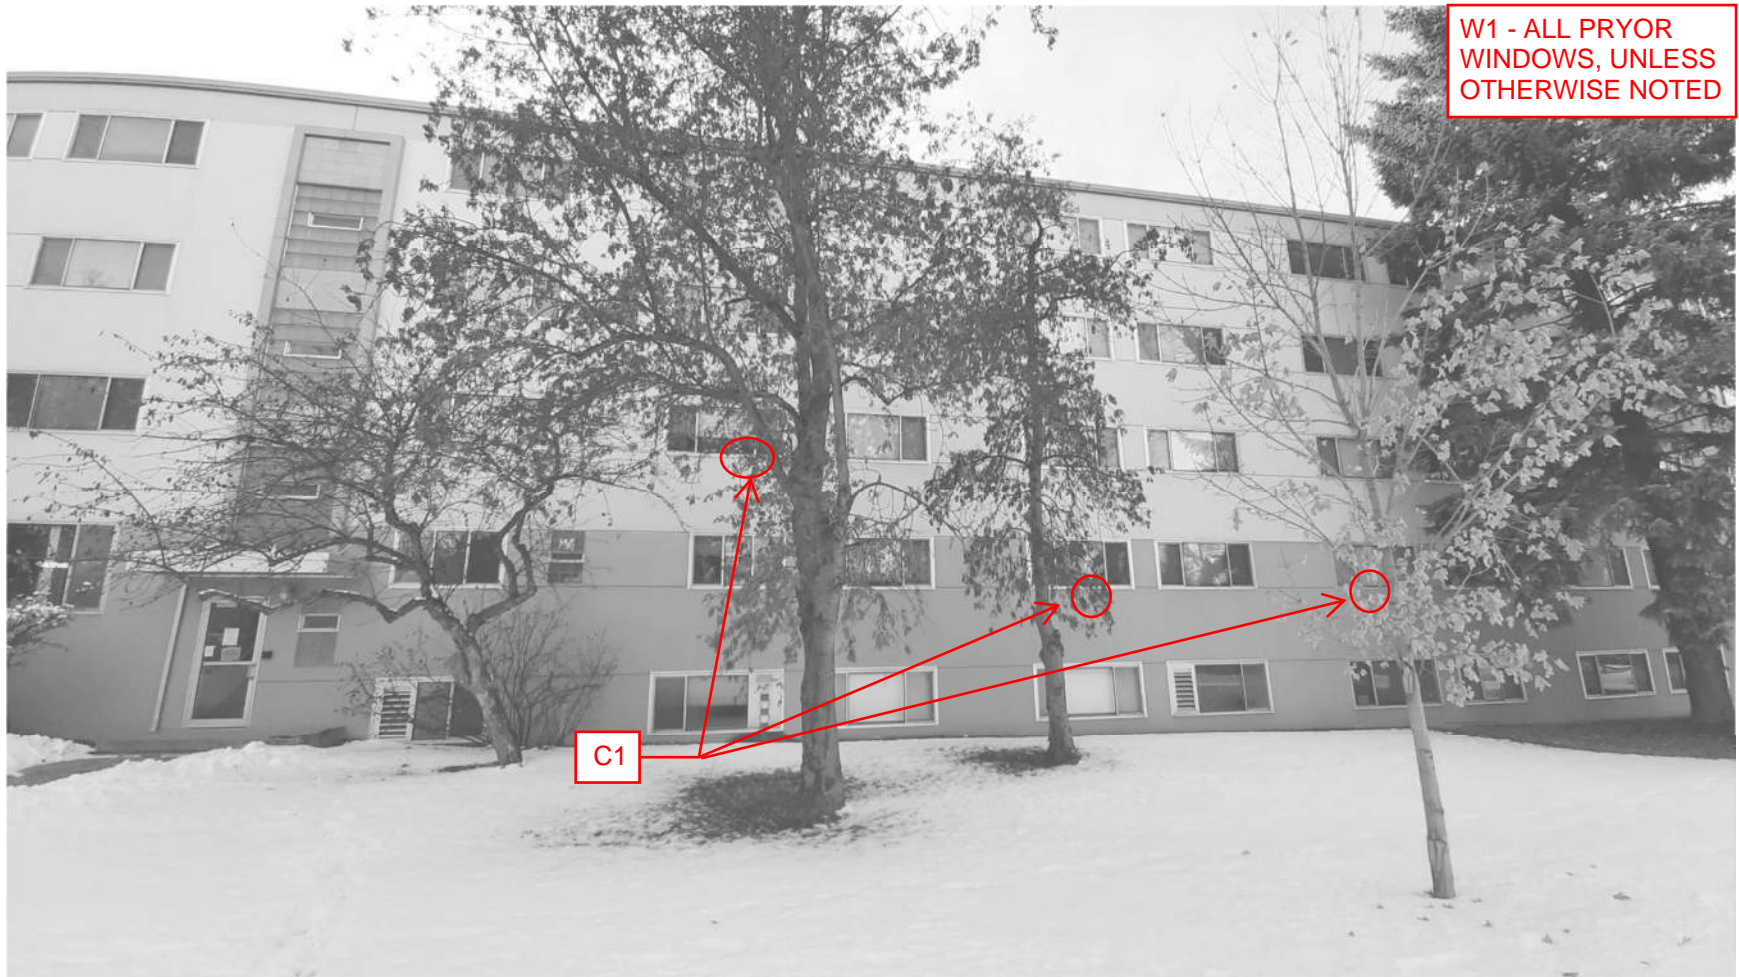
PRYOR - EAST

W1 - ALL PRYOR
WINDOWS, UNLESS
OTHERWISE NOTED

C1

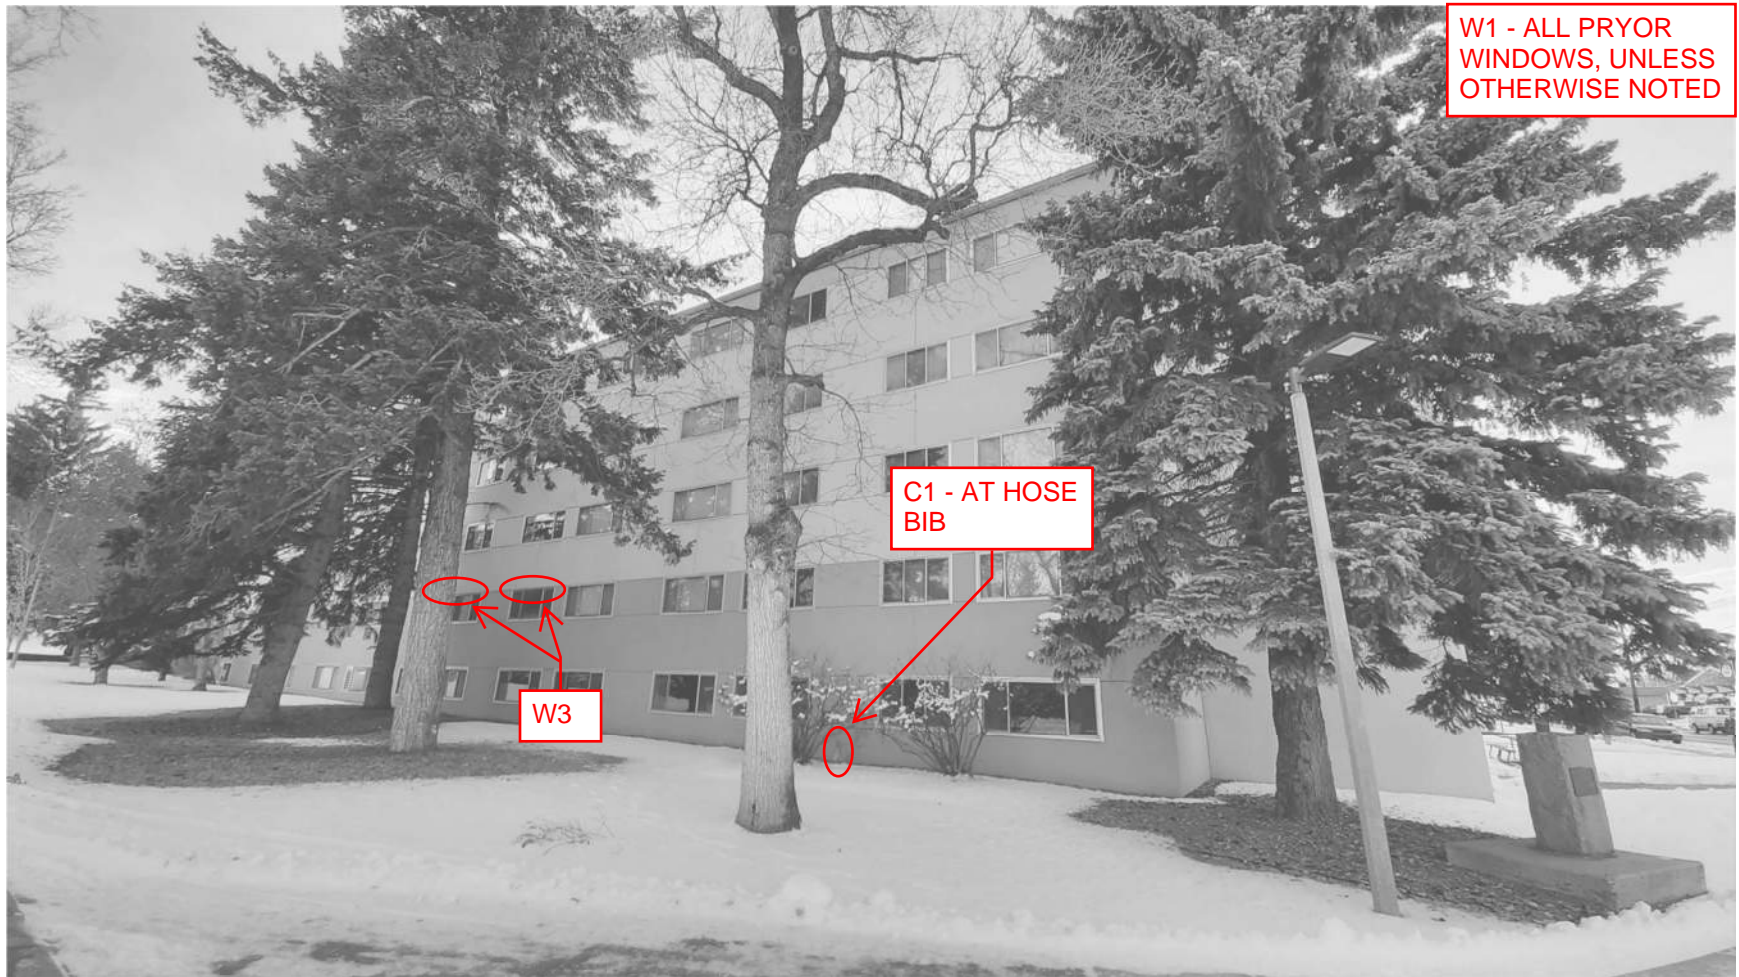
PRYOR - EAST

W1 - ALL PRYOR
WINDOWS, UNLESS
OTHERWISE NOTED

C1 - AT HOSE
BIB

W3

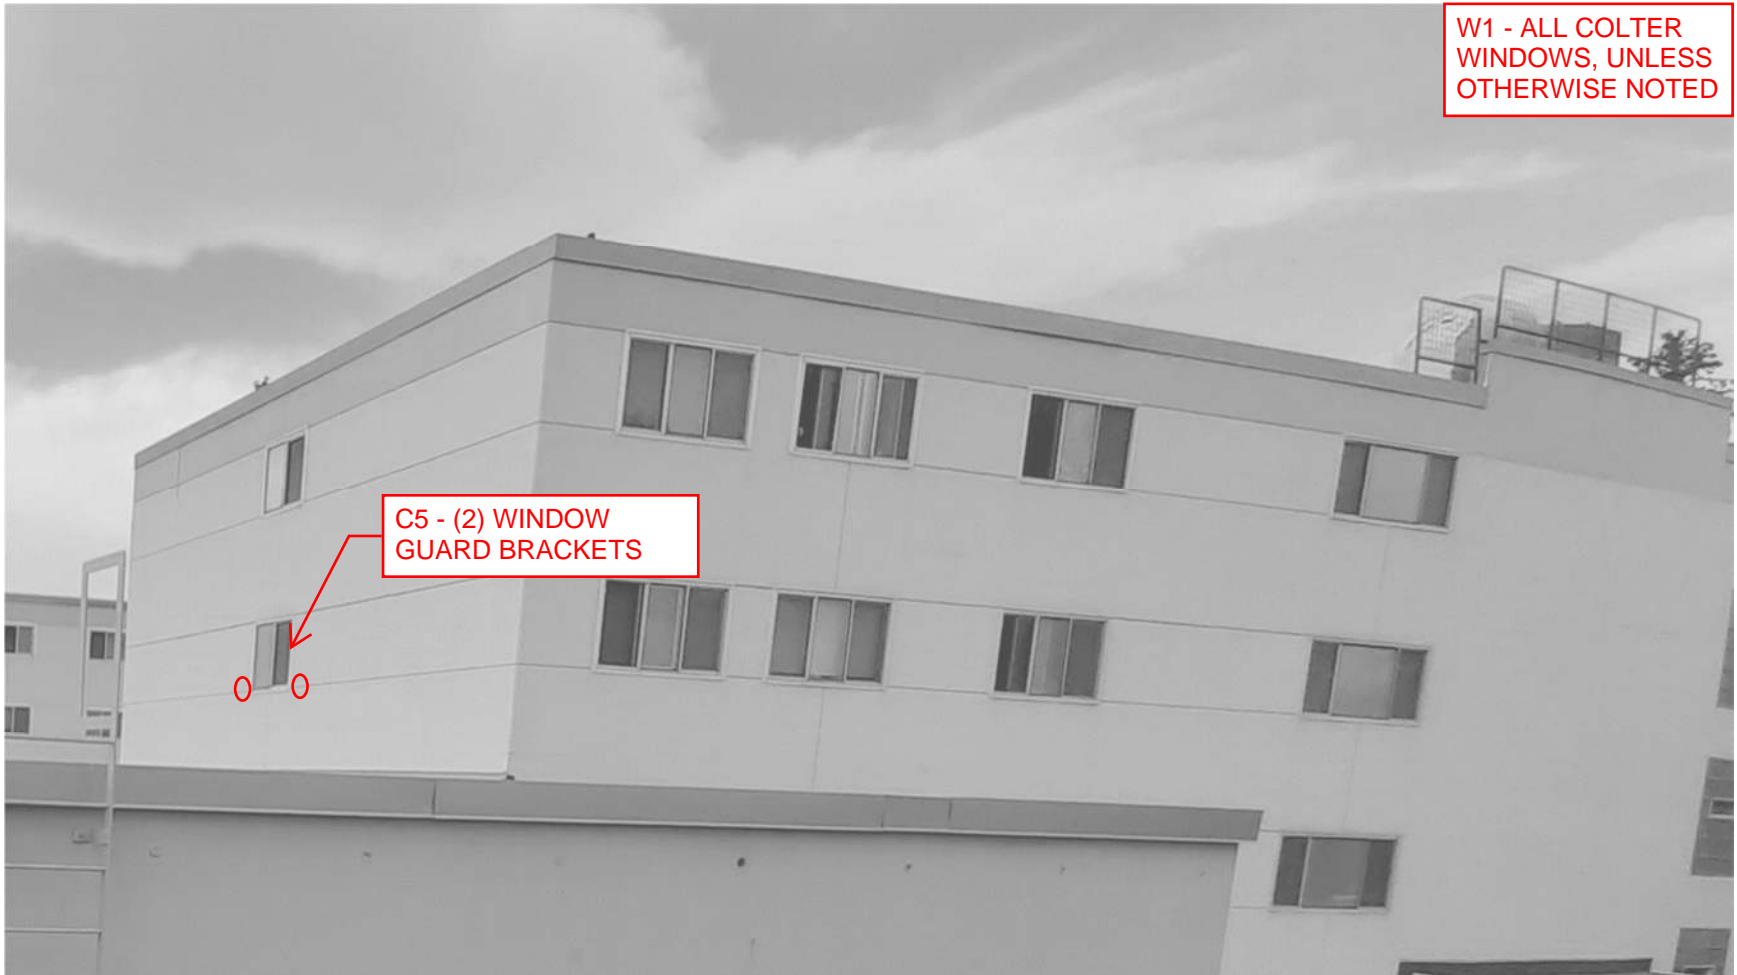
COLTER - WEST

W1 - ALL COLTER
WINDOWS, UNLESS
OTHERWISE NOTED

C5 - (2) WINDOW
GUARD BRACKETS

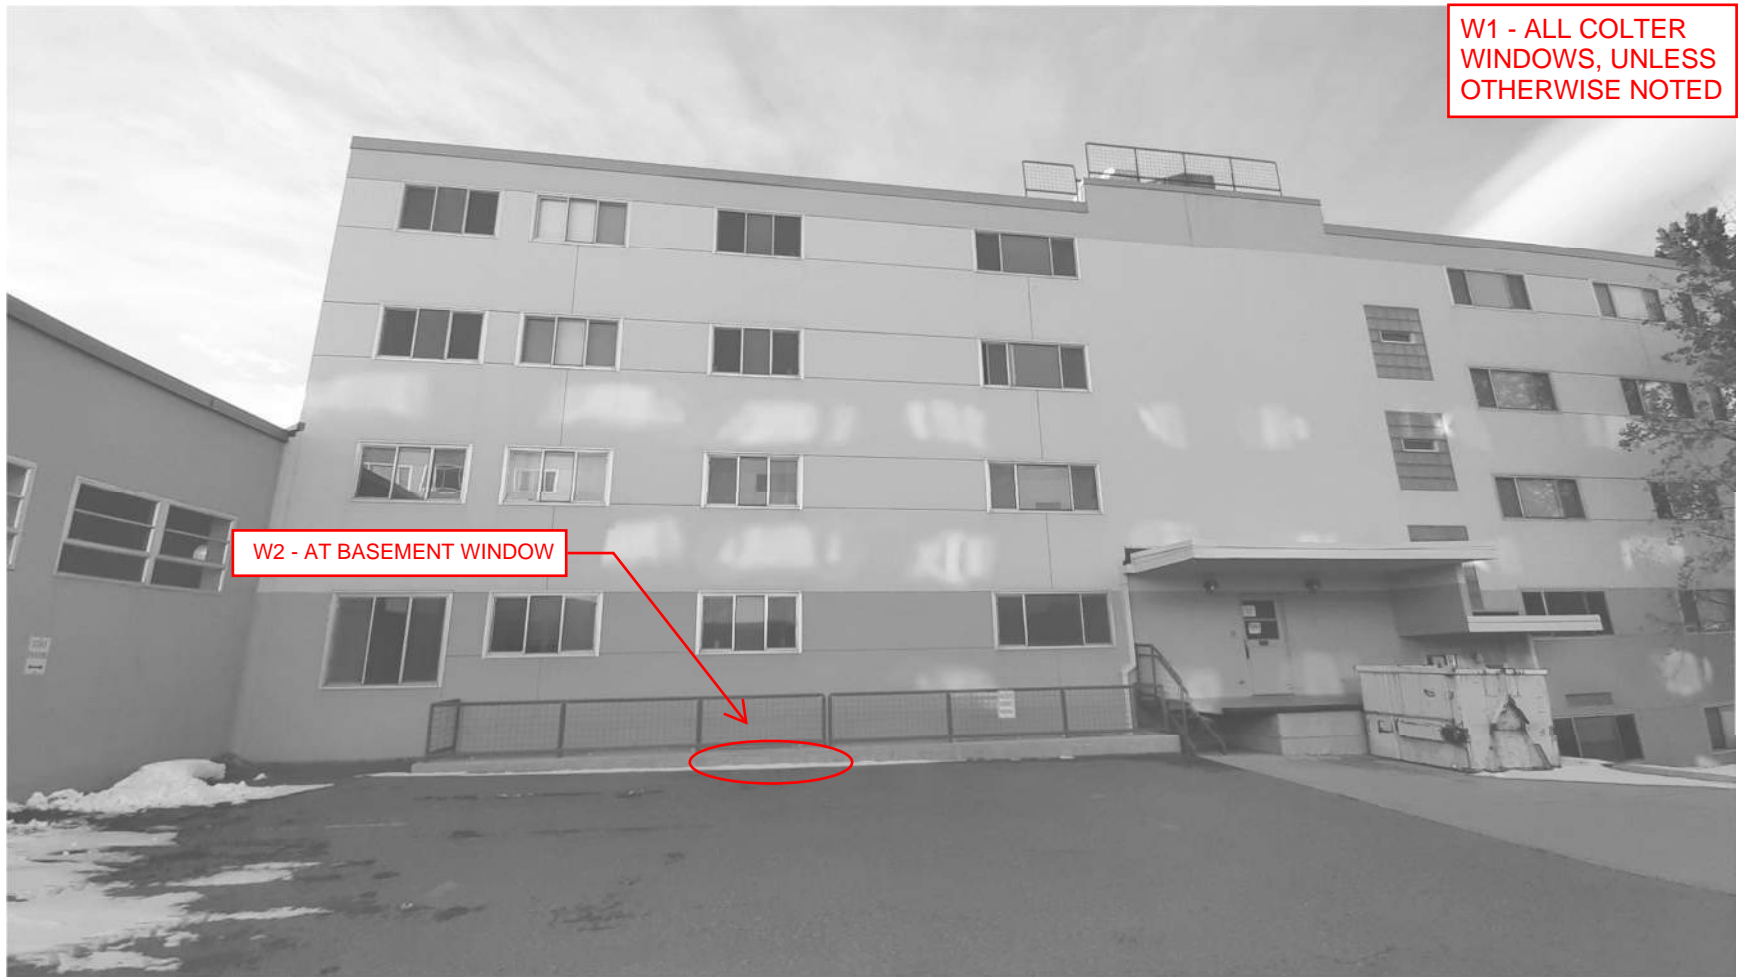
COLTER - SOUTHEAST

W1 - ALL COLTER
WINDOWS, UNLESS
OTHERWISE NOTED

W2 - AT BASEMENT WINDOW

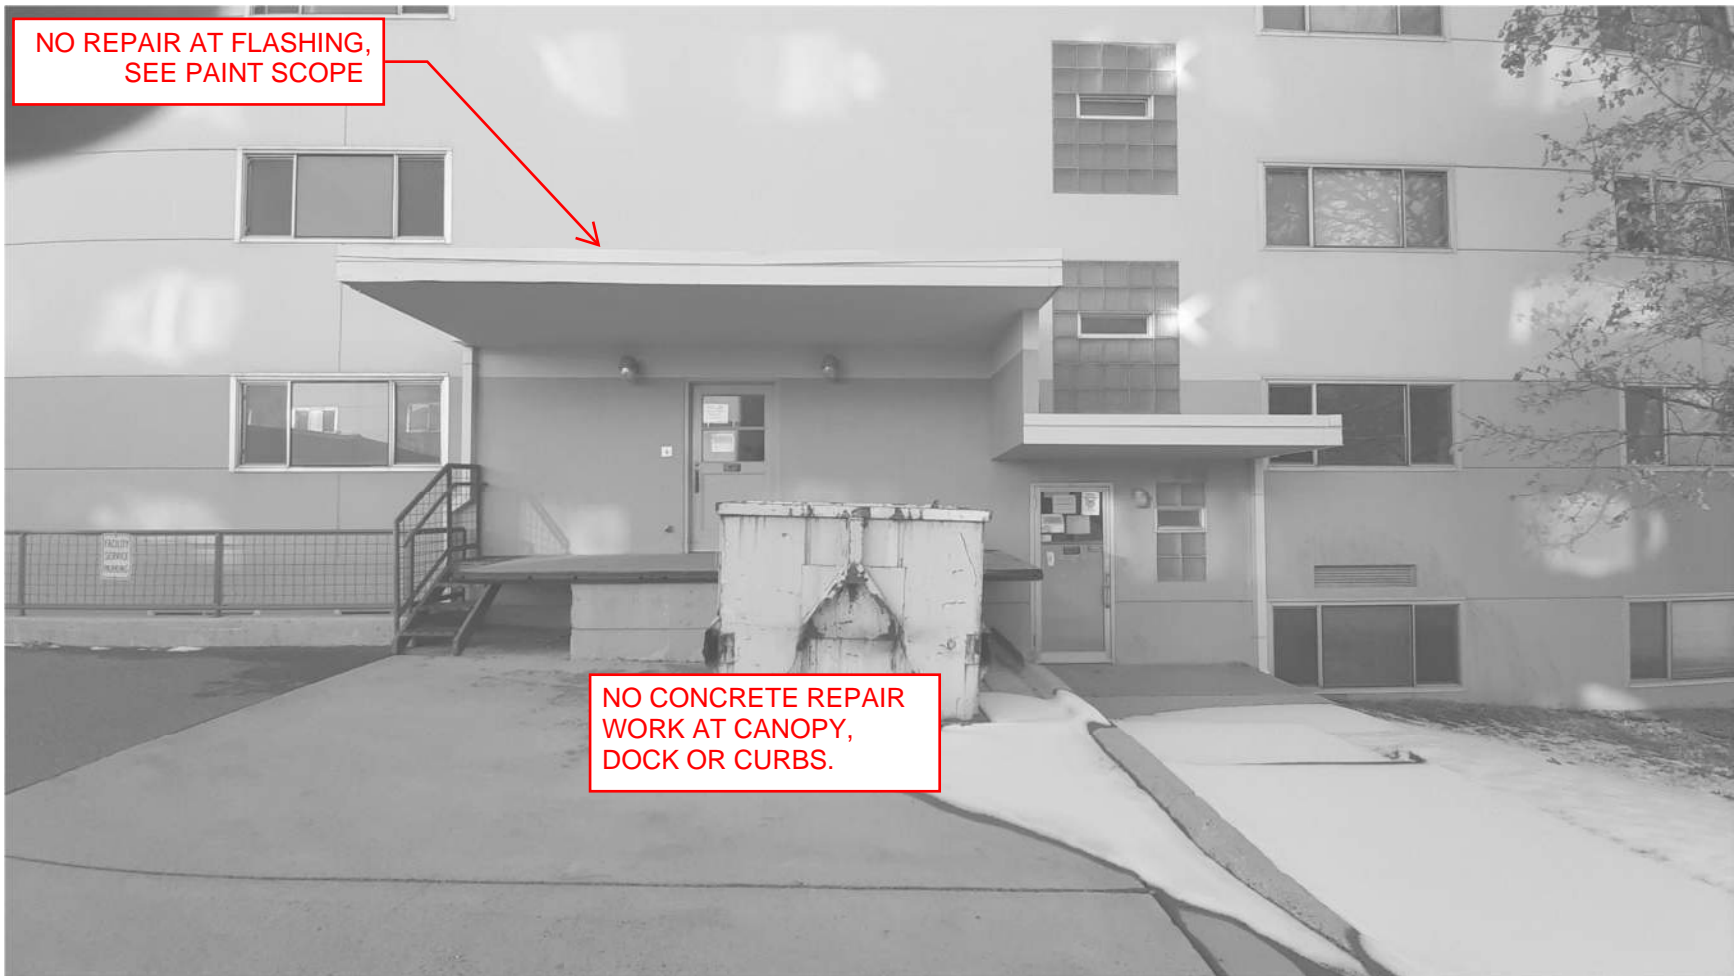
COLTER - EAST

NO REPAIR AT FLASHING,
SEE PAINT SCOPE

NO CONCRETE REPAIR
WORK AT CANOPY,
DOCK OR CURBS.

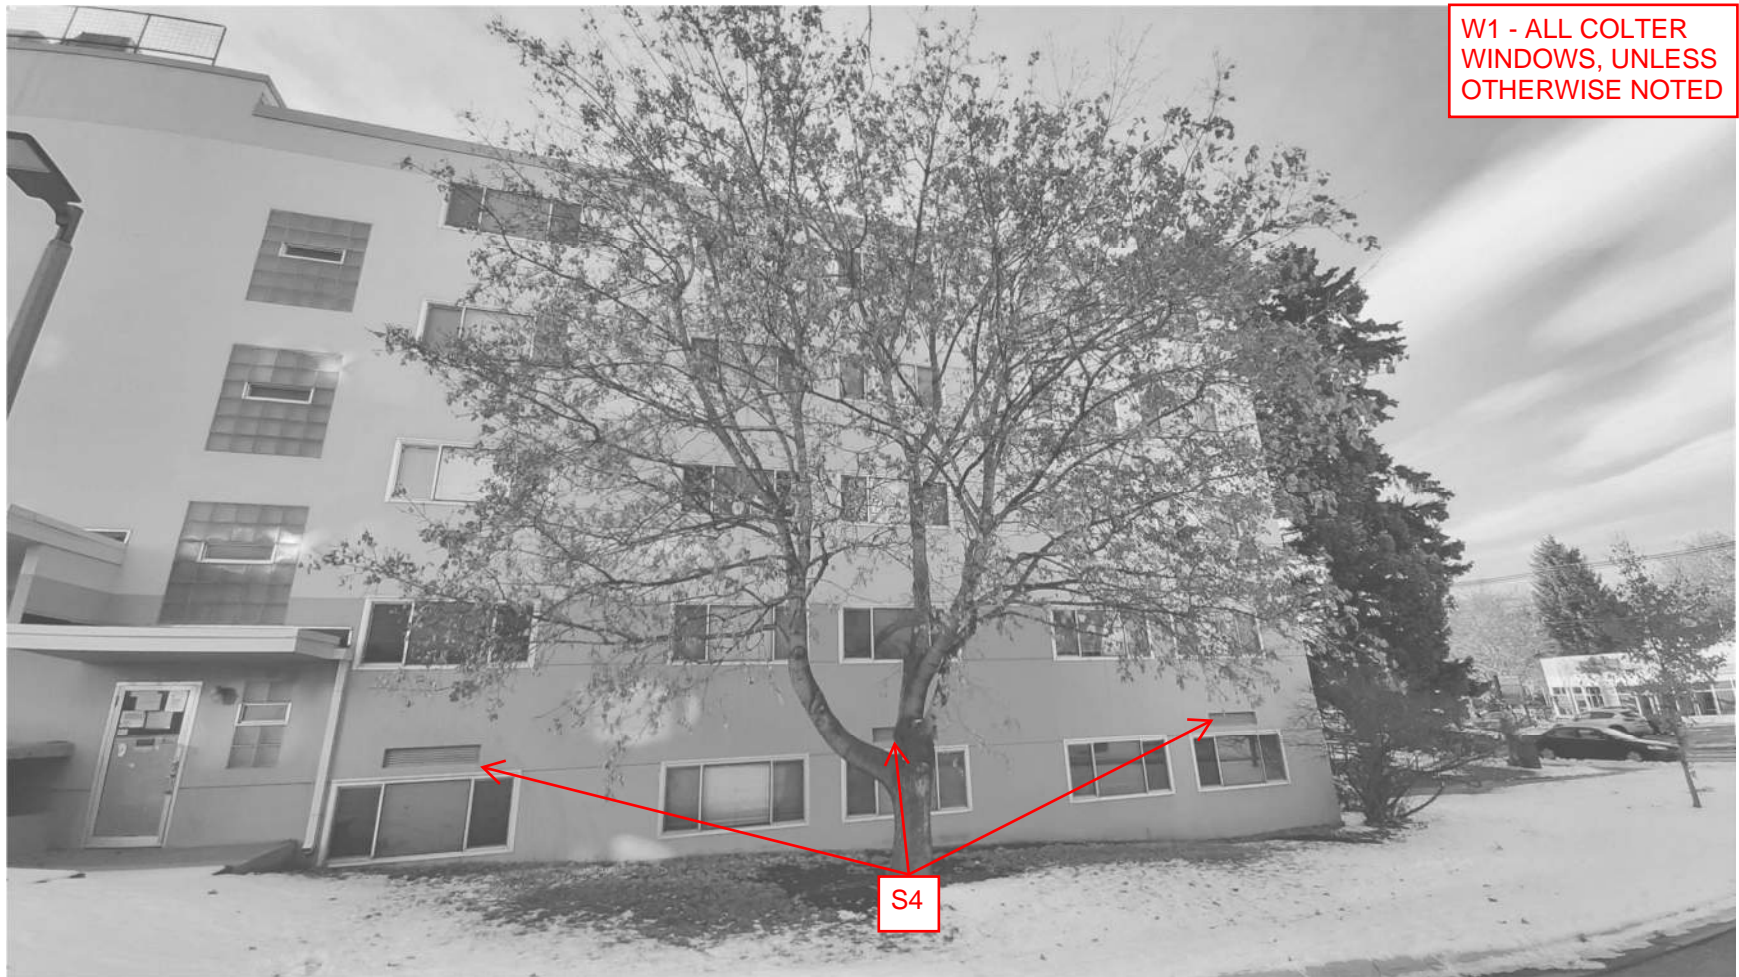
COLTER – EAST

W1 - ALL COLTER
WINDOWS, UNLESS
OTHERWISE NOTED

S4

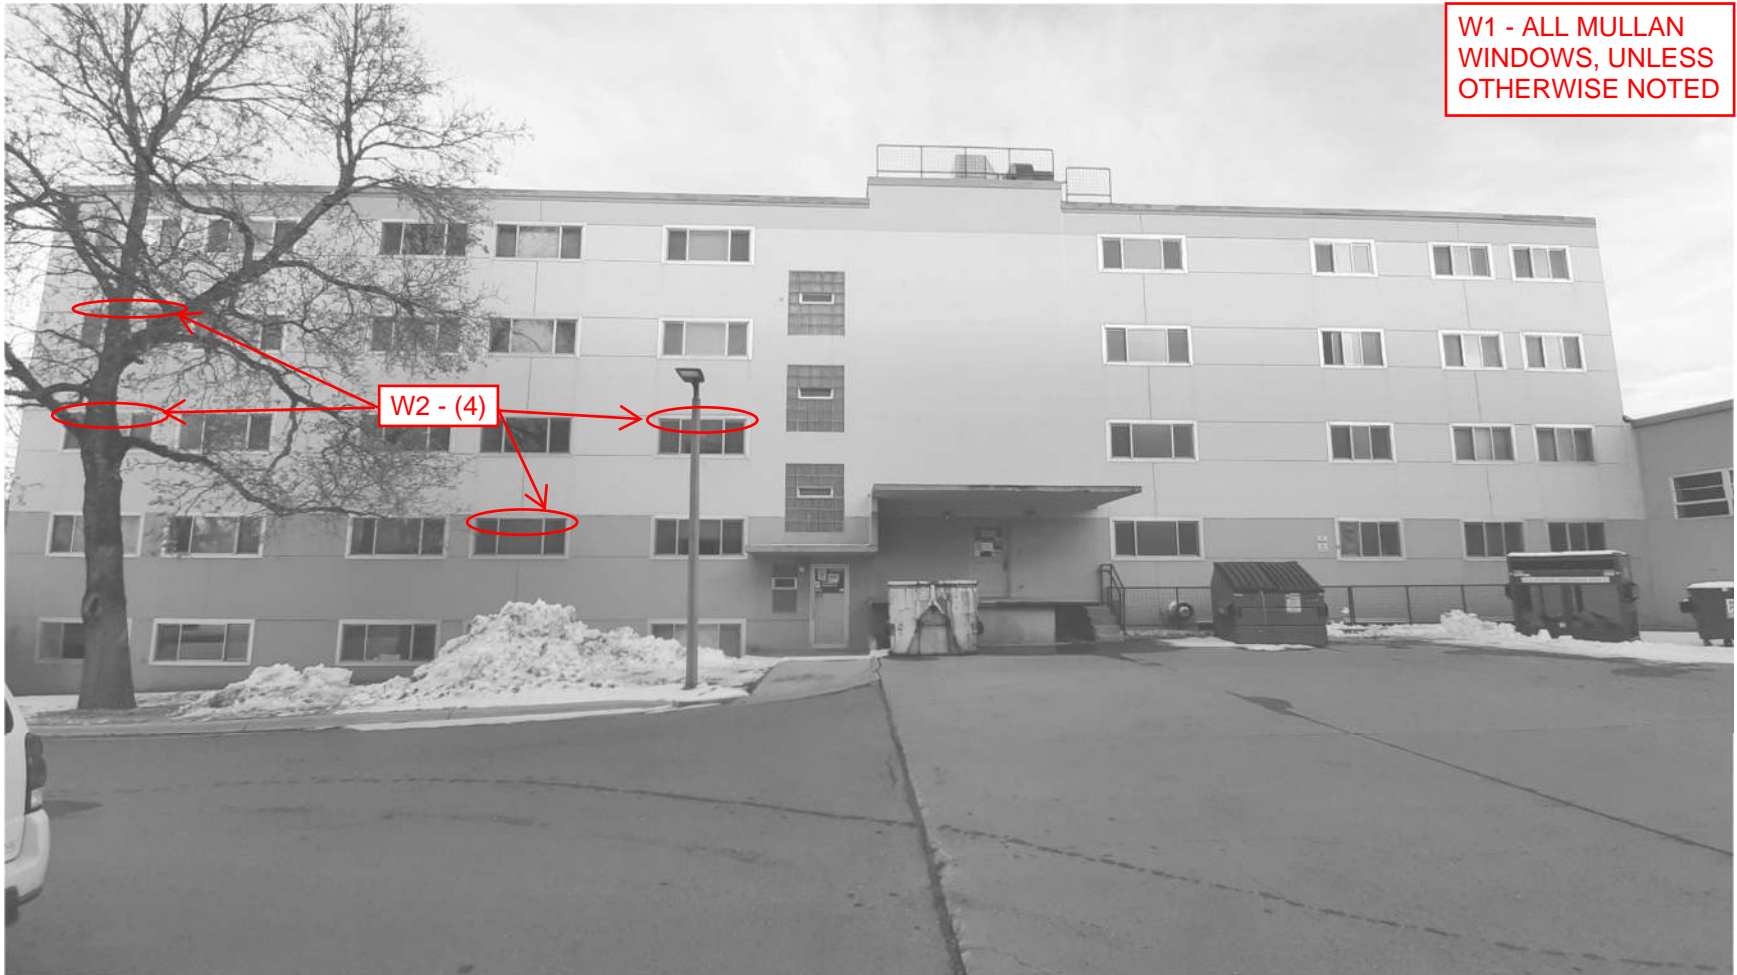
MULLAN - NORTH

W1 - ALL MULLAN
WINDOWS, UNLESS
OTHERWISE NOTED

W2 - (4)

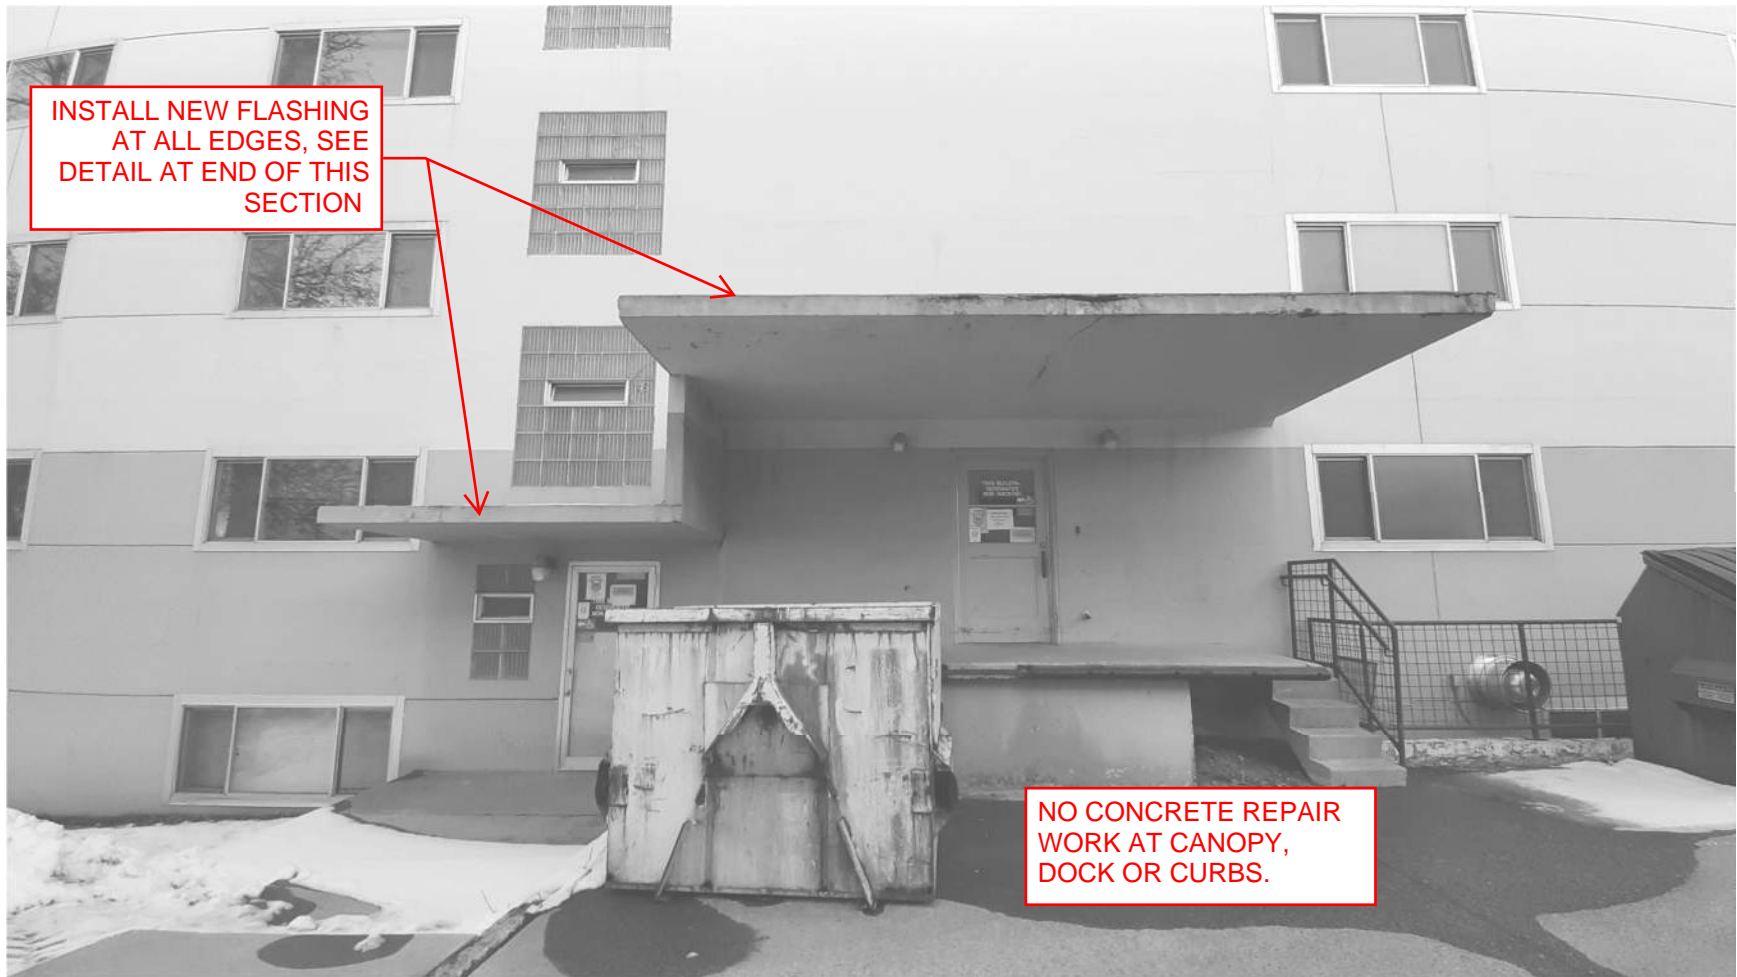
MULLAN - WEST

INSTALL NEW FLASHING
AT ALL EDGES, SEE
DETAIL AT END OF THIS
SECTION

NO CONCRETE REPAIR
WORK AT CANOPY,
DOCK OR CURBS.
