Montana State University
**Johnstone Center Exterior Painting
Construction Drawings**

PPA #19-0025
February 2021

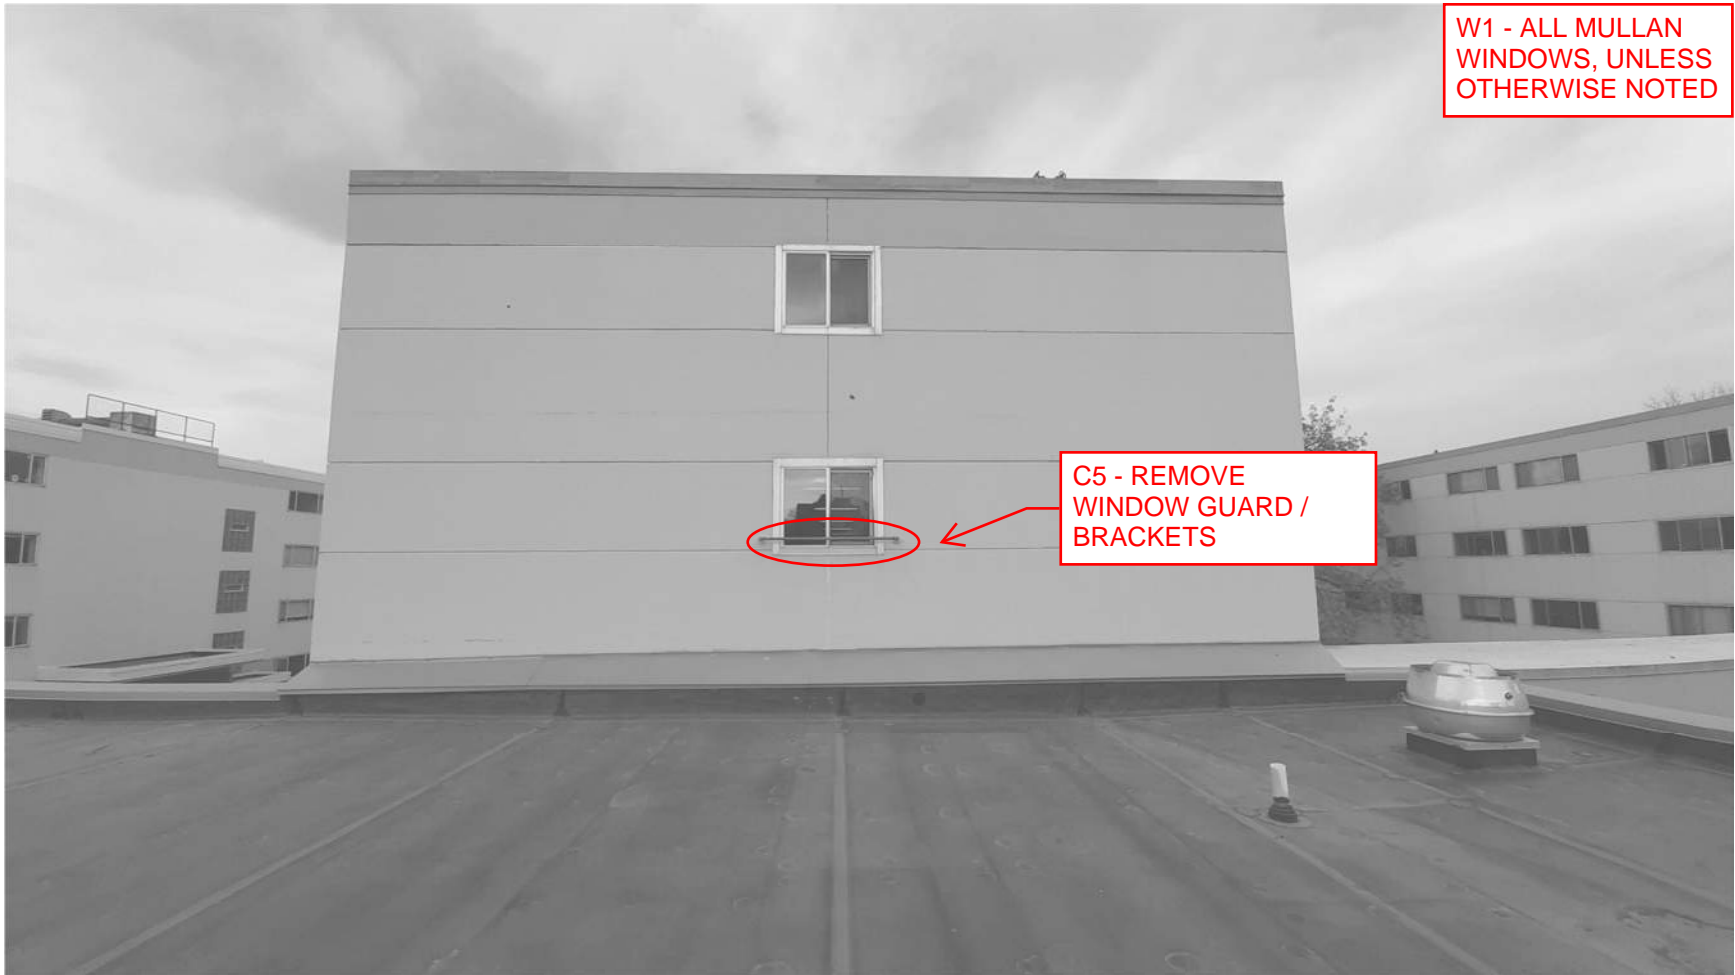
MULLAN - WEST

W1 - ALL MULLAN
WINDOWS, UNLESS
OTHERWISE NOTED

C5 - REMOVE
WINDOW GUARD /
BRACKETS

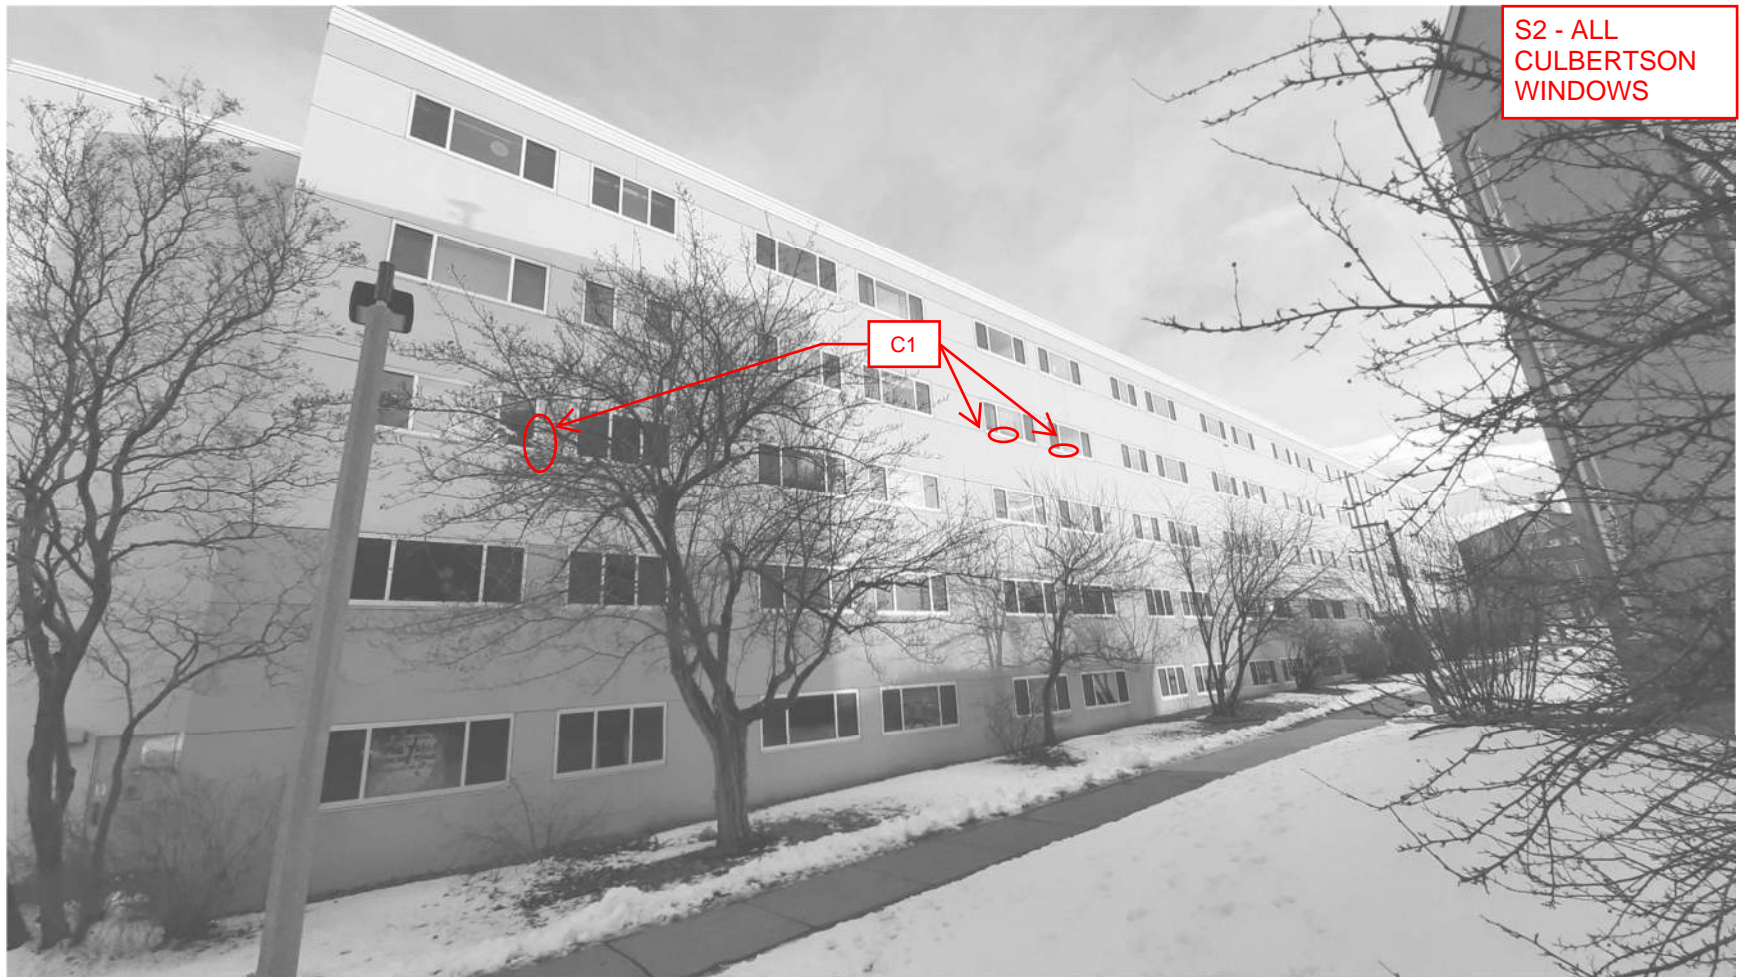
CULBERTSON - NORTH

S2 - ALL
CULBERTSON
WINDOWS

C1

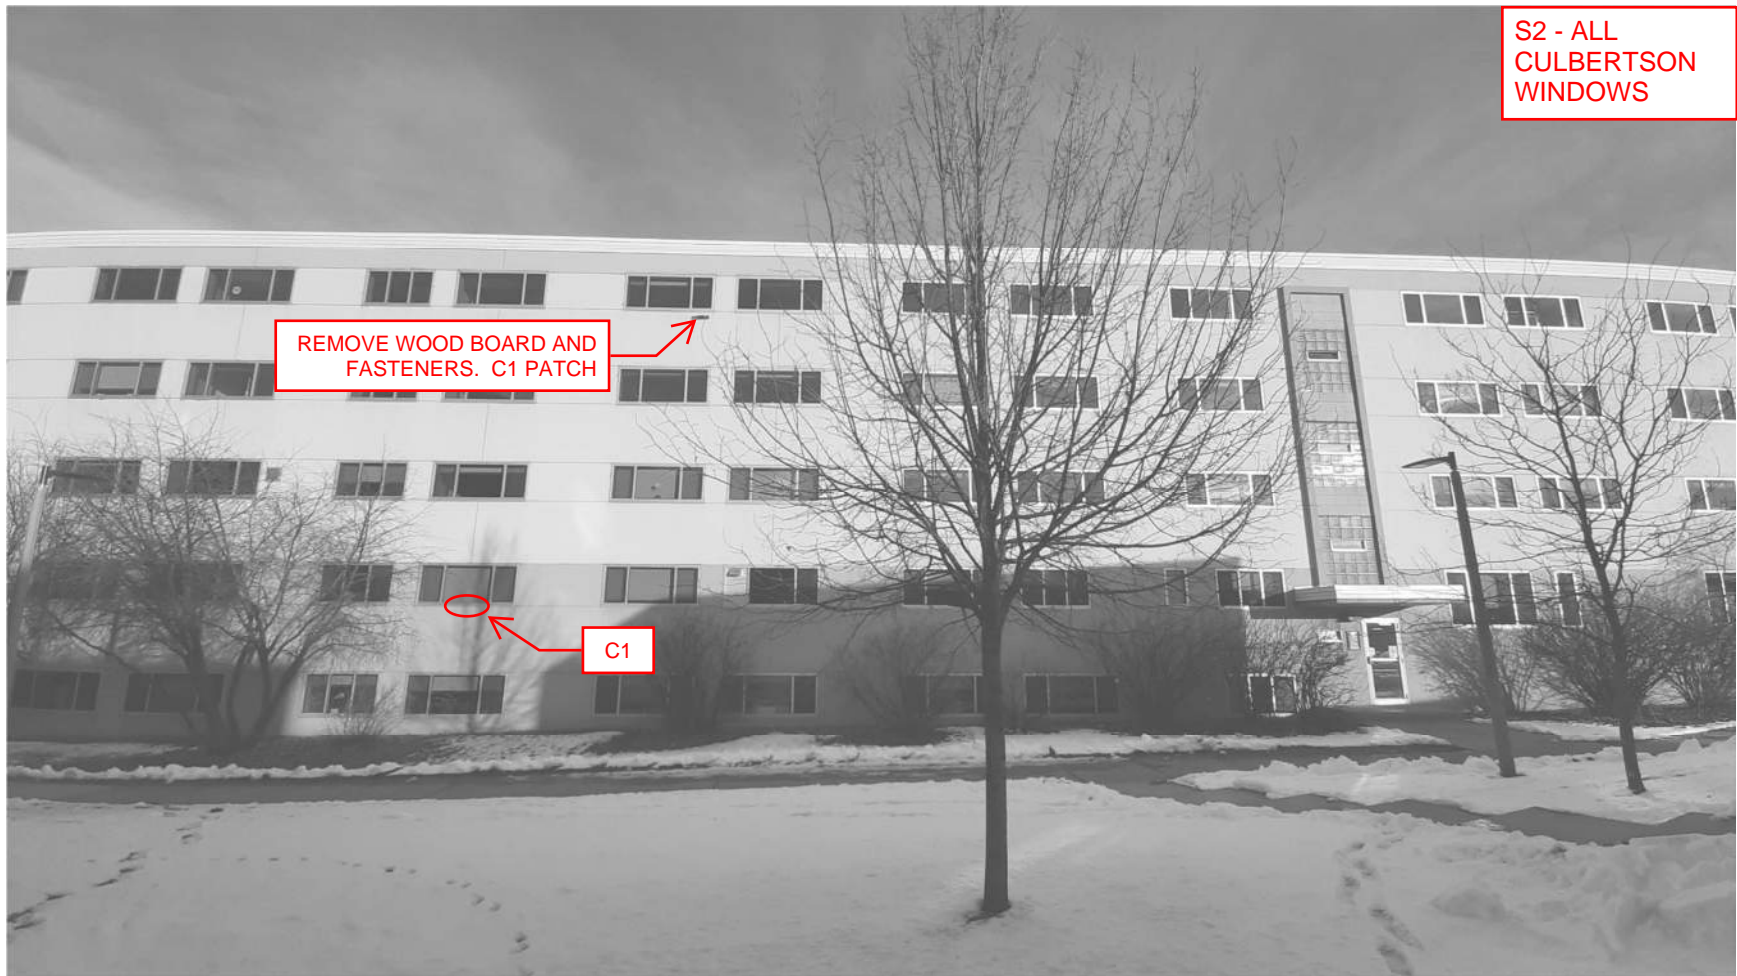
CULBERTSON - WEST

S2 - ALL
CULBERTSON
WINDOWS

REMOVE WOOD BOARD AND
FASTENERS. C1 PATCH

C1

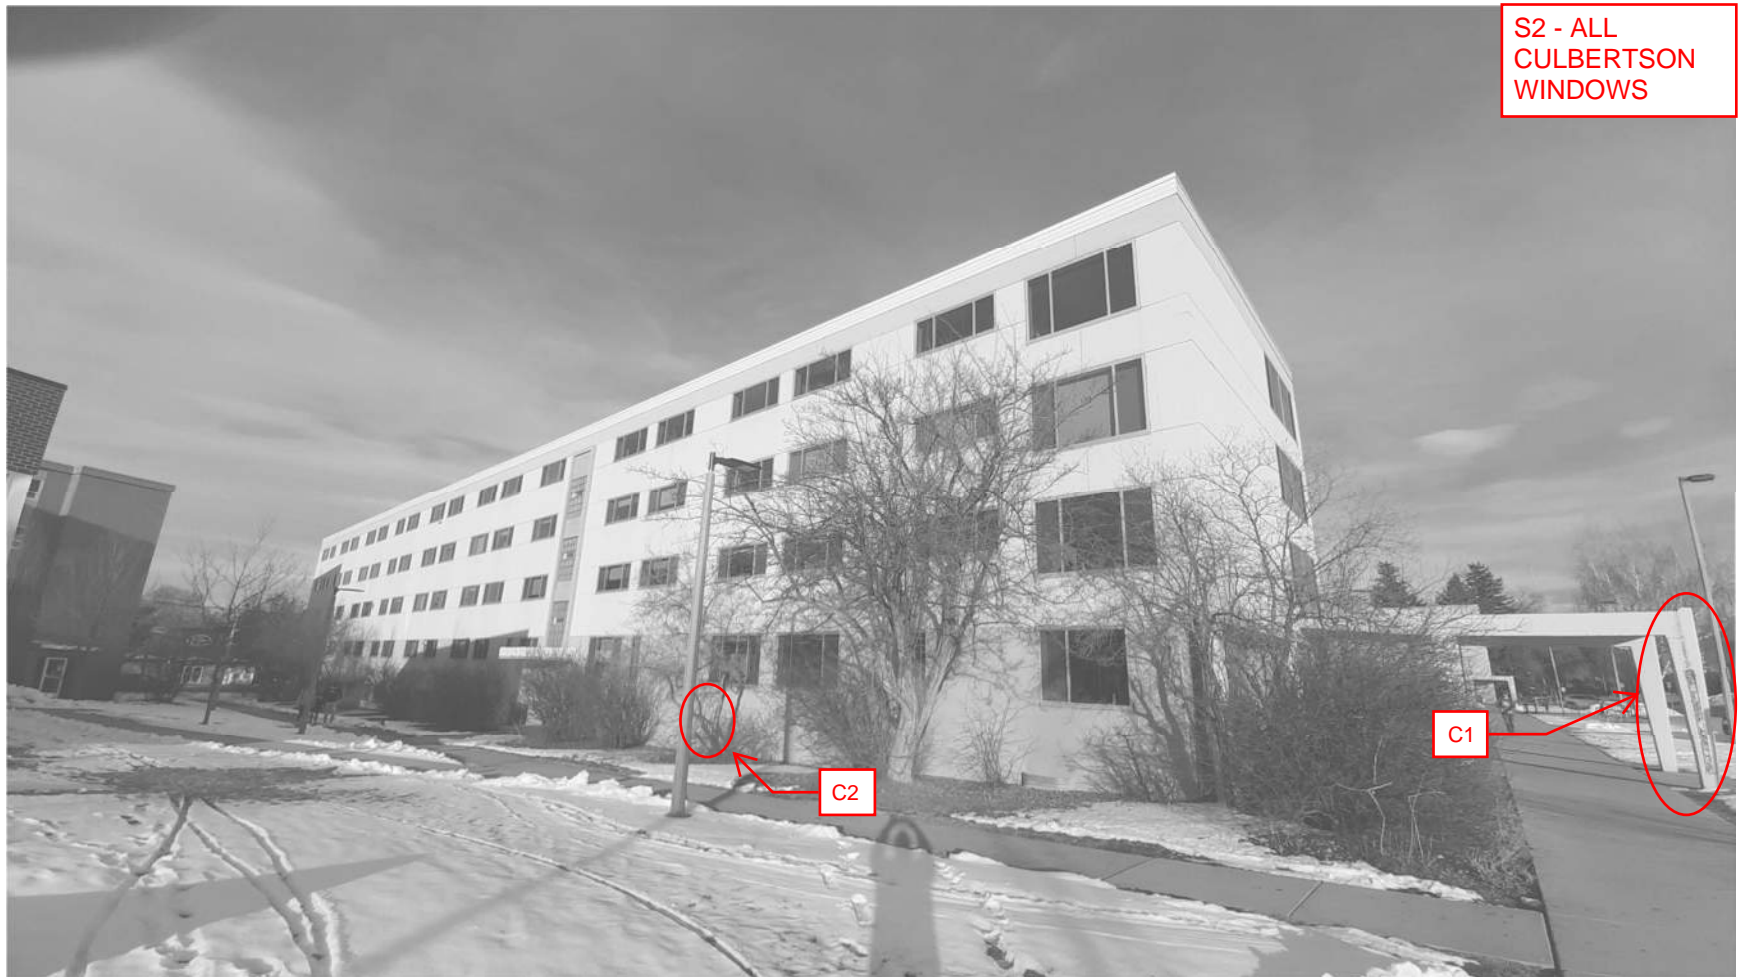
CULBERTSON - WEST

S2 - ALL
CULBERTSON
WINDOWS

C2

C1

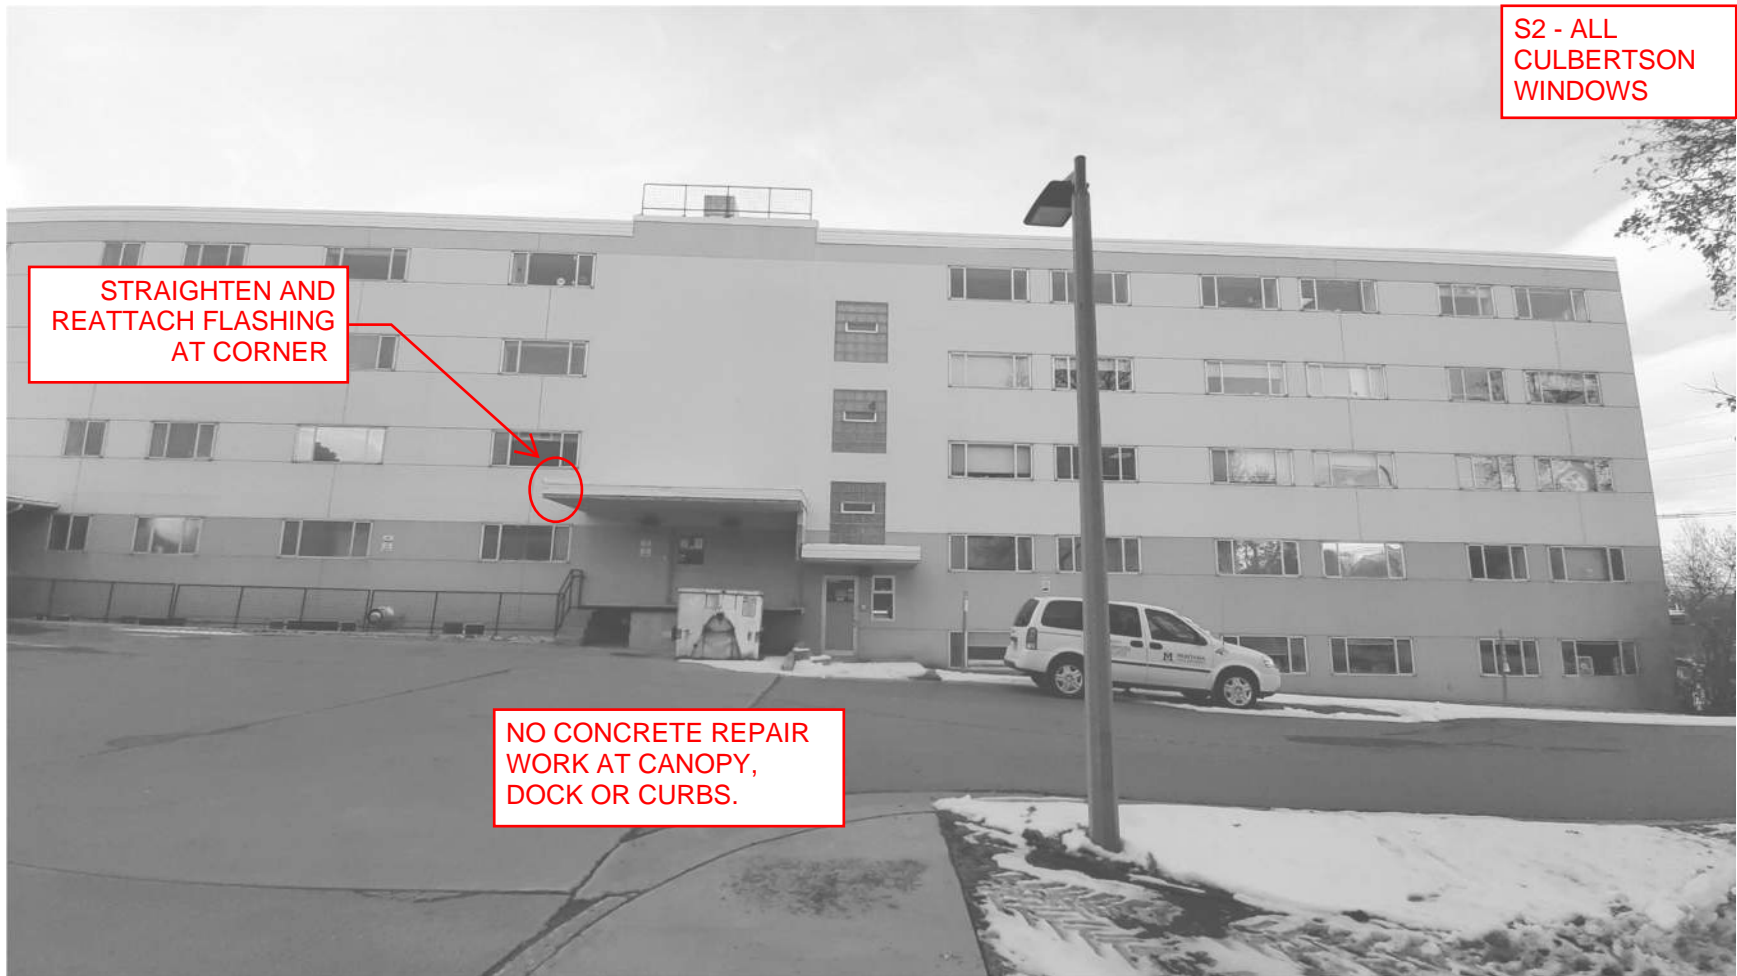
CULBERTSON - EAST

S2 - ALL
CULBERTSON
WINDOWS

STRAIGHTEN AND
REATTACH FLASHING
AT CORNER

NO CONCRETE REPAIR
WORK AT CANOPY,
DOCK OR CURBS.

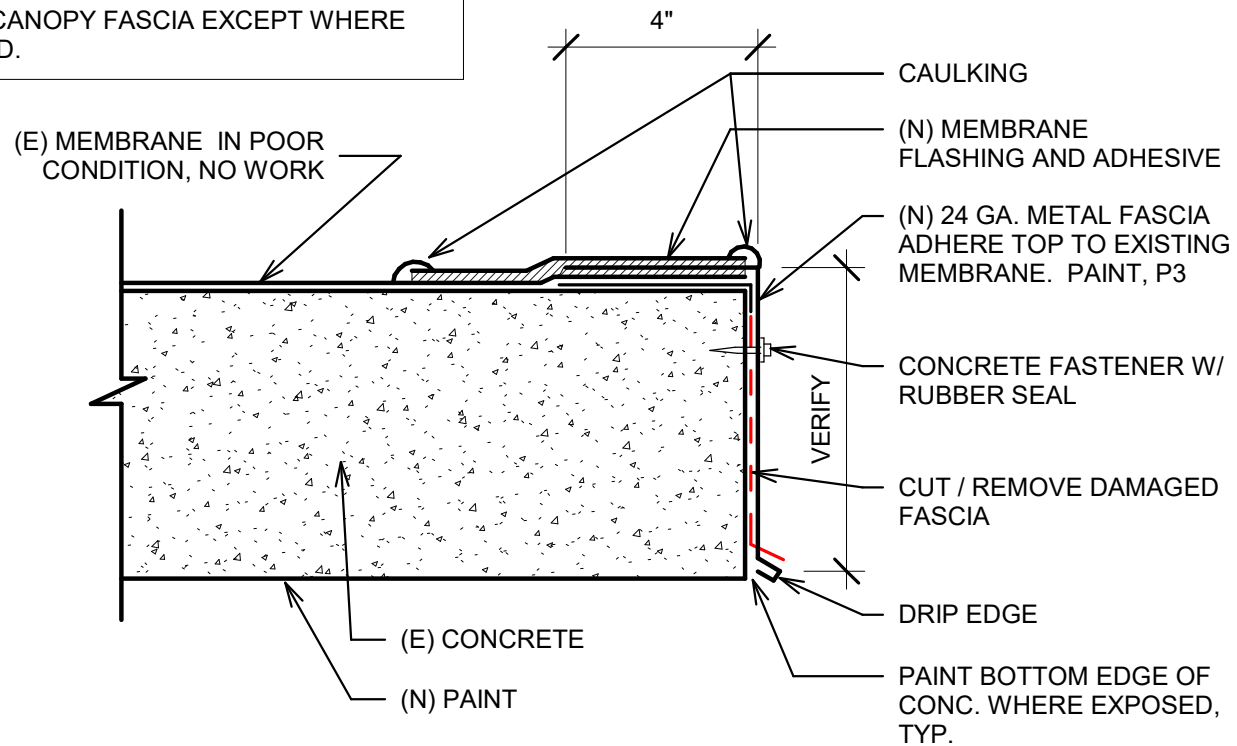
CANOPY FLASHING DETAIL
6" = 1'-0"

- NO REPAIR TO CANOPY CONCRETE.
- PAINT CANOPY AS INDICATED ON PHOTO PLANS.
- REPAIR/REPLACE METAL FASCIA WHERE INDICATED ON PHOTO PLANS
- PAINT ALL METAL CANOPY FASCIA EXCEPT WHERE OTHERWISE NOTED.
