# ADDENDUM 1 – OUTLINE AND SUMMARY INFORMATION

Project Name: Miller Pavilion Roof Recover, Bid Package #3

**SUBJECT: Pre-Renovation Asbestos Inspection Report  
Door Replacements Project  
End Walls  
Bob Miller Pavilion  
Bozeman, Montana  
Tetra Tech Project No. 117-8598054**

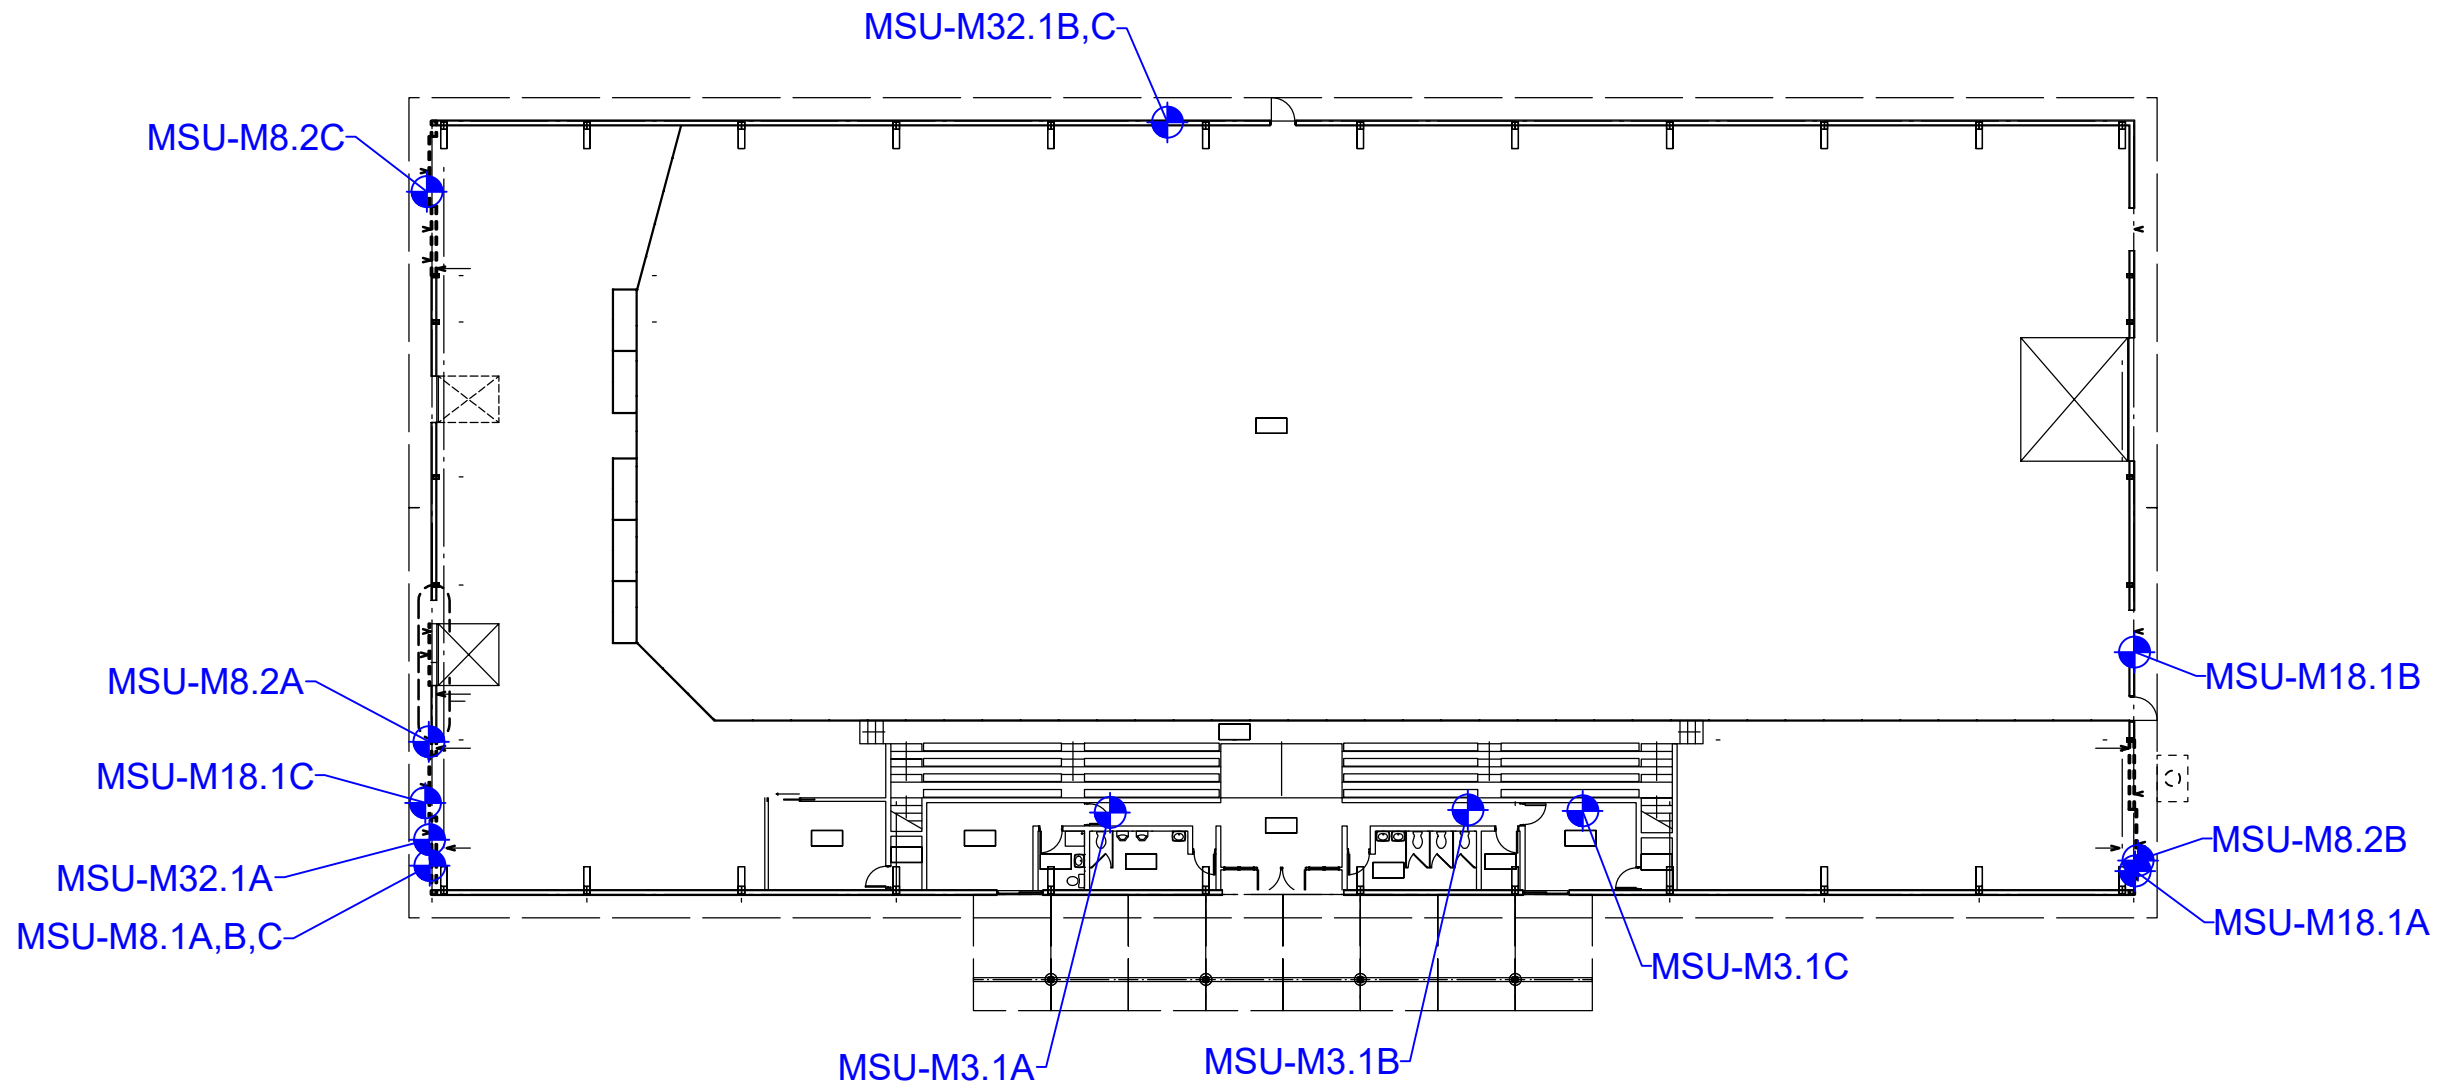
| | <b>FIGURE</b><br><b>1</b> | |

A summary of the ACMs identified to contain greater than 1% asbestos are provided in Table 1. Approximate sample collection locations are presented on Figure 1 and approximate ACM locations are presented on Figure 2.

Asbestos sample location

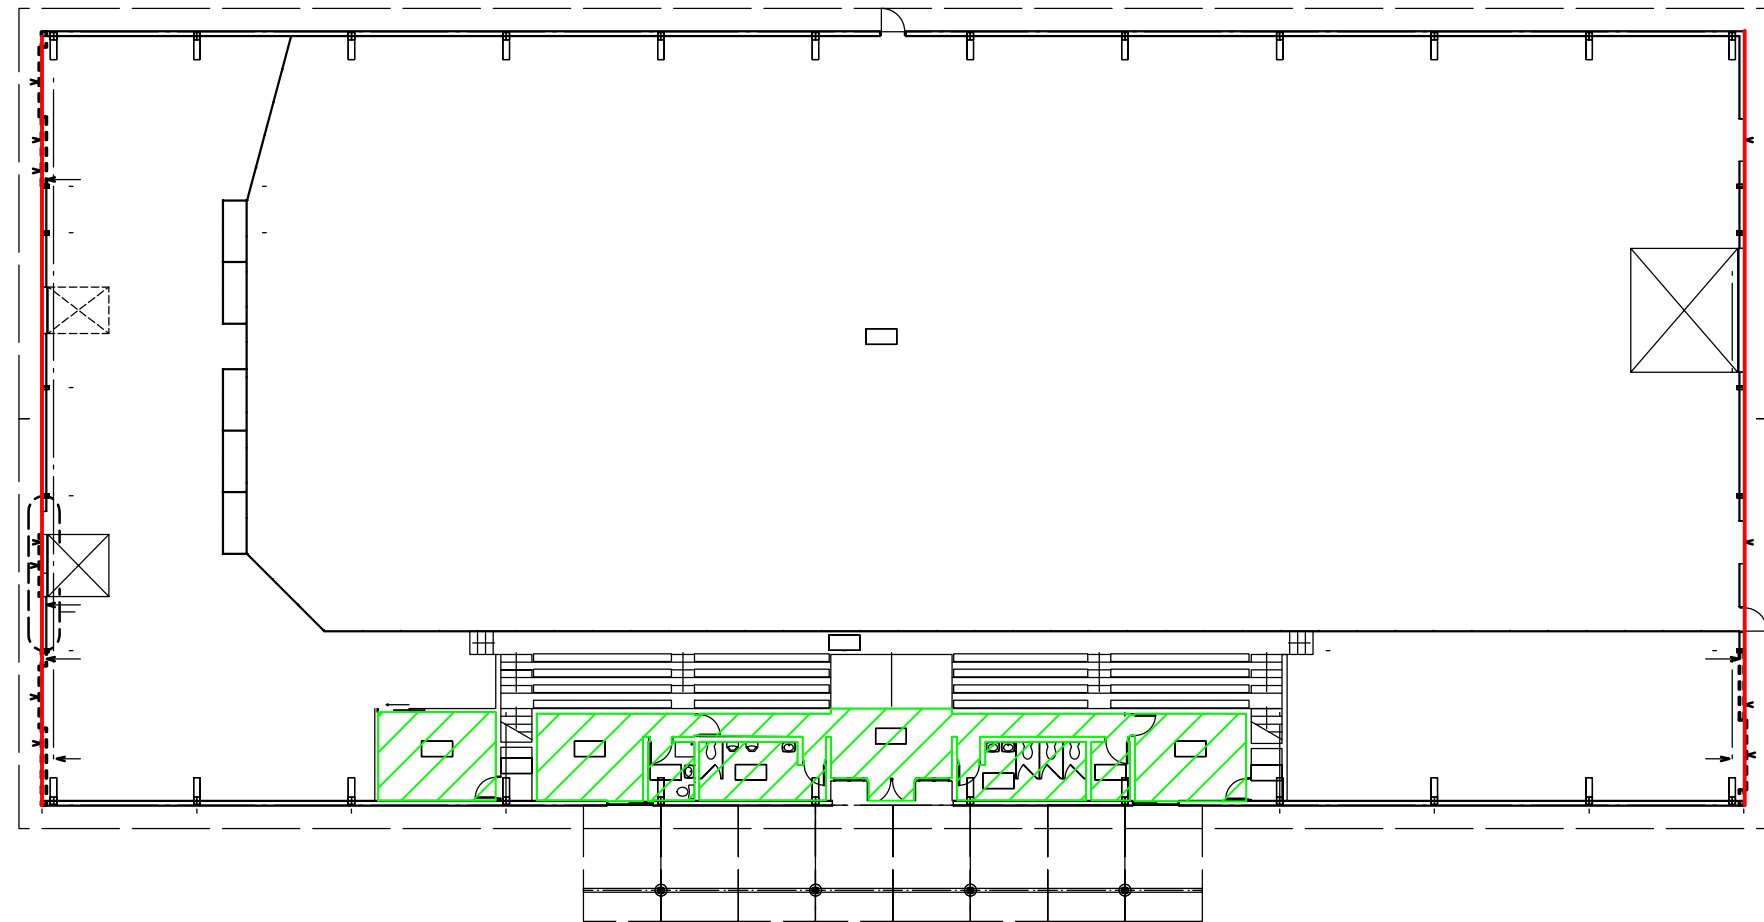
FIGURE  
2

| Table 1<br>Summary of ACM | | | | |
|--|---|--|---|---|
| MSU-M3.1 | Joint compounds associated with smooth wallboard system | Wallboard: ND<br>Joint Compound<br>Layers: 2% Chrysotile | Miscellaneous | Category II<br>Non-Friable |
| MSU-M8.1 | Off white caulking on upper, vertical, beams | 2% Chrysotile | Miscellaneous | Category II<br>Non-Friable |

— M8.1 - Off-white caulk

▨ M3.1 - Wallboard and taping system

In accordance with state and federal regulations pertaining to asbestos, the ACMs identified in Table 1 are required to be abated prior to disturbance. The ACMs are required to be removed by a licensed asbestos abatement contractor using appropriate asbestos abatement methods and procedures in accordance with applicable state and federal regulations. Following the completion of asbestos abatement, a visual inspection and asbestos air clearance need to be conducted as required by ARM 17.74.357. Any contractor preparing to bid or perform work on the site should be informed of the potential presence of ACMs. Contractors should also be informed of compliance requirements under current state and federal regulations.
