USE OF PULTRUDED CARBON FIBER / EPOXY INSERTS AS  
REINFORCEMENT IN COMPOSITE STRUCTURES

A thesis submitted in partial fulfillment  
of the requirements for the degree

Mechanical Engineering

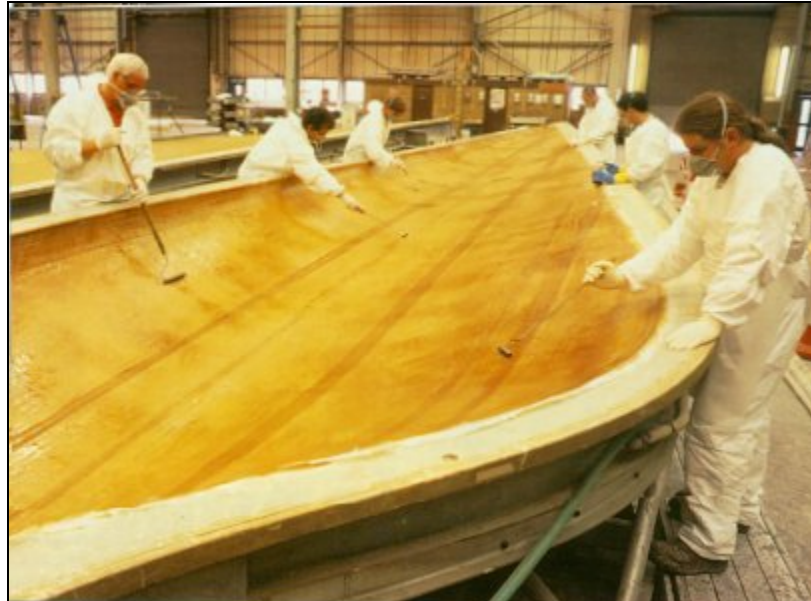
A photograph showing laborers physically laying up a wind turbine blade skin is shown in Figure 3 [5]. The fabric schedule is placed layer by layer until the desired thickness is reached; between layers polymer resin is poured over the new fabric. Wind turbine blade manufacturers primarily use thermosetting resins for their low viscosities in infusing into fabrics and relative mechanical property stability in higher temperatures and low cost [6]. The hand rollers used are to compact the fibers down, push any trapped air to the surface, and push away excess resin.

Figure 3: Physically laying up half a blade skin [5]

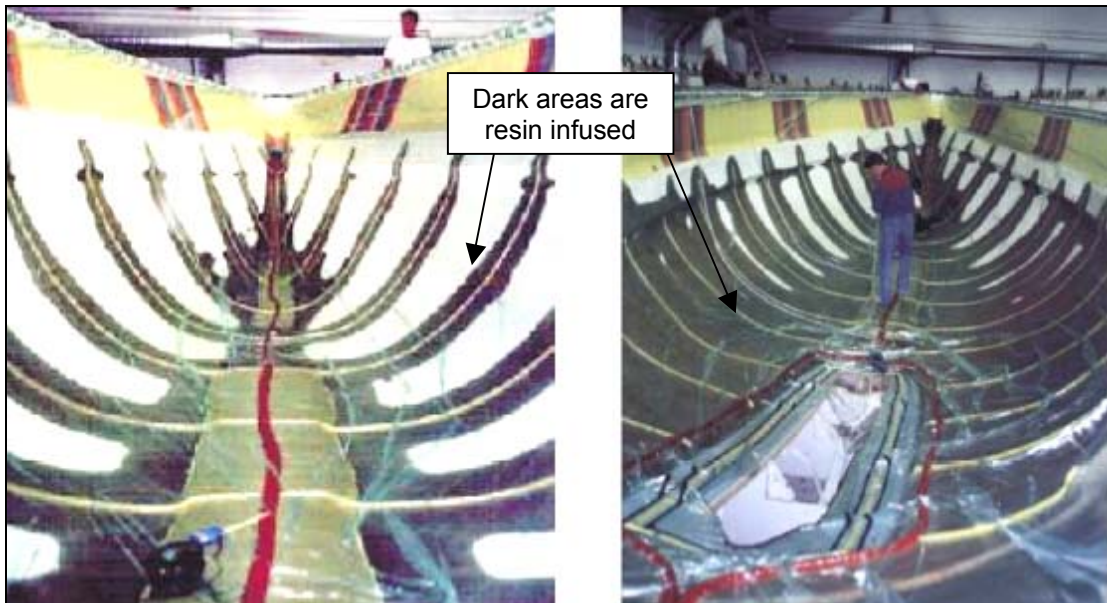
Figures 4 and 5 [8] show large structural skin members being infused with resin by use of vacuum pressure (vacuum assisted RTM) to pull resin through the fabric rather than push the resin. Figure 4 shows a 20 meter long rotor blade. Figures 5a and 5b show a 16.4 m long by 4.5 m wide by 2.5 m high fiberglass

boat hull being vacuum infused. The thicknesses of these parts were not given in the reference. Due to increasing understanding and successes of resin infusion processes in thicker laminates, manufacturing methods for wind turbine blades are turning away from hand lay-up methods and towards the various forms of resin infusion because of the advantages in production time, labor, and materials [1, 7, 9].

Figures 5a and 5b: 54 ft long fiberglass boat hull under vacuum resin injection [8]

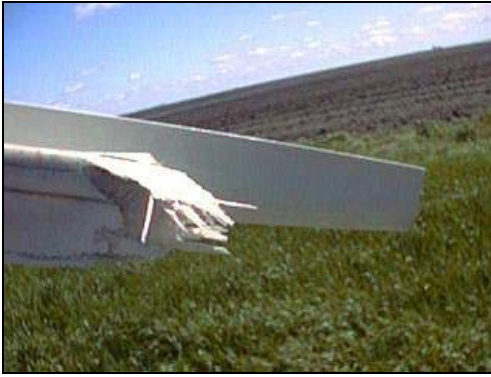
The resulting damage opens up the structure to environmental factors that could further compromise the performance of the local material or structure. An example of the damage sustained by a 7.5 ft long wind turbine blade after a tower strike is shown in Figures 7, 8, and 9 [12]. It appears from the preceding figures that damage from the strike to the blade weakened the local structure. The loads on the compromised blade tip caused delaminations around the damaged area. The damaged material then cracked too much and finally snapped off.

Figure 7: Damaged blade after tower strike compared to undamaged blade [12]

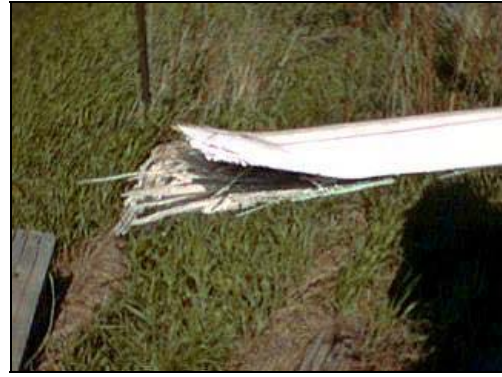
Figure 8: Same damage, view from trailing edge [12]

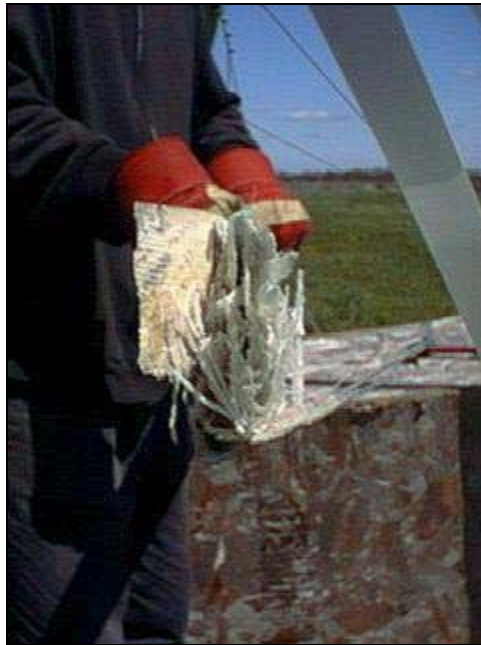
Figure 9: Straight on view of damaged blade [12]

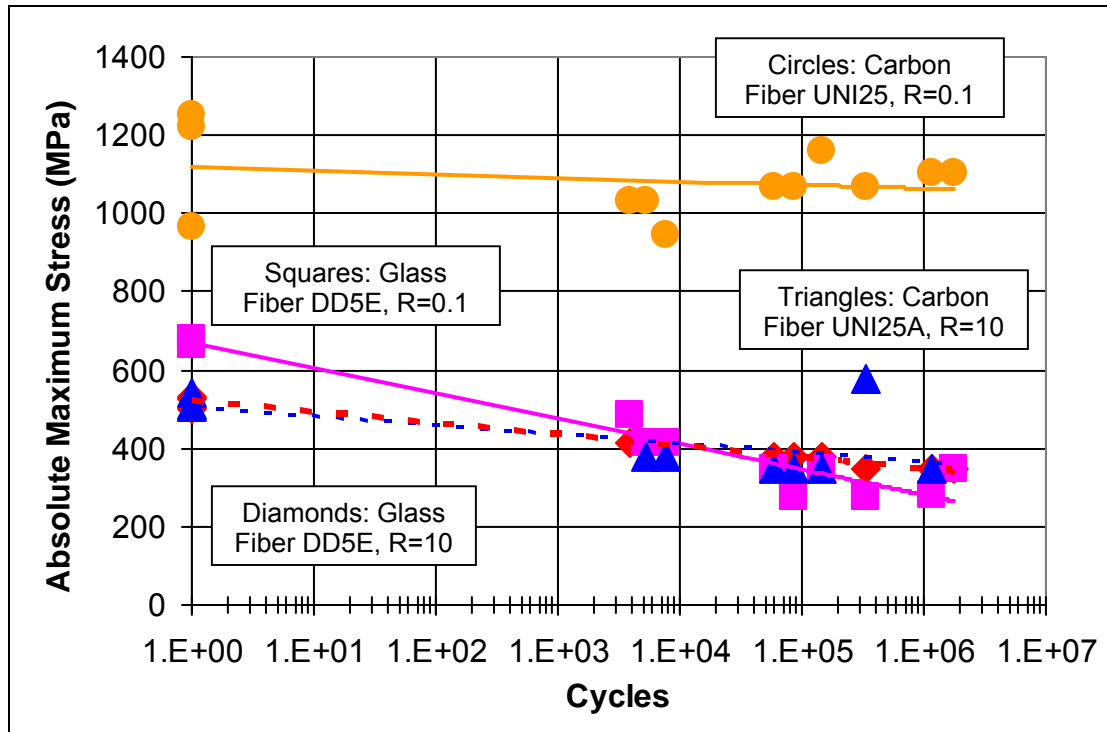
Figure 10: S-N Curves for fiber laminates in tension and compression fatigue [16]

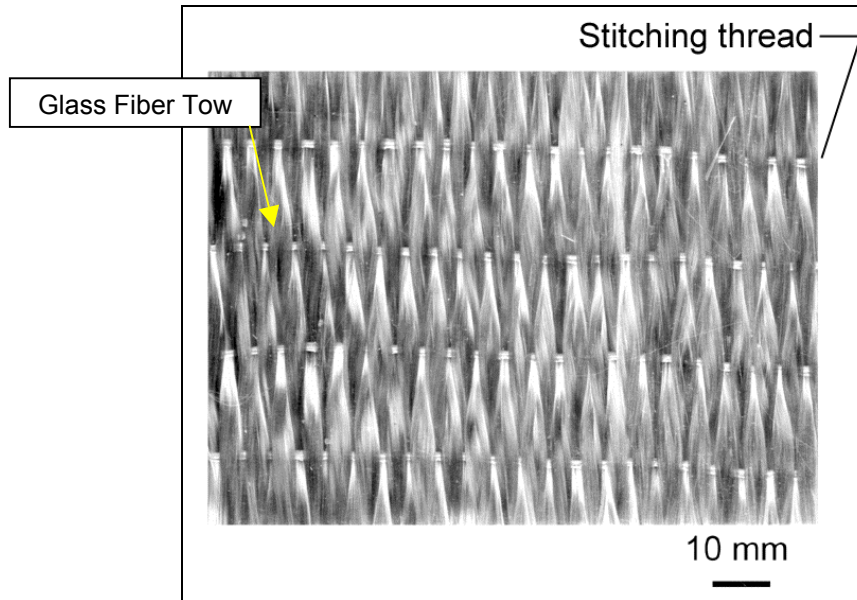
An example of fiber waviness in dry fabric architecture is shown below in Figure 11. This low cost glass fabric called A130, commonly used in wind turbine blades [19], has inherent out-of-plane and in-plane waviness. The unidirectional tows go under and over the stitching thread creating the out-of-plane waviness. The fiber tow profile expands over one stitching thread and contracts under the next one creating in-plane waviness.

Figure 11: A130 fabric showing fiber strand distortion in the thickness direction [20]

severities is such as those that occur in A130 fabric in Figure 11, significantly reduce the compressive strength by predisposing the fibers to the buckling geometry that grew the delaminations.

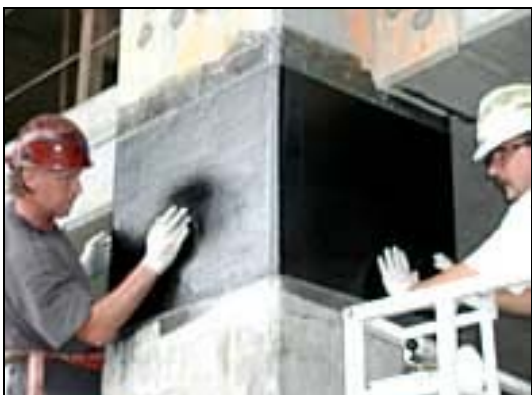
Exterior Strengthening - Pultruded strips, sheets, and shells can be applied externally to deteriorating bridge substructures such as the undersides of bridge decks or support columns. These composites can have their lifetimes extended by strengthening in flexure and shear at a fraction of the associated costs of classical rehabilitation concrete structures. The light weight of carbon PMC composites translates into easier handling, fewer laborers and lifting devices and fast executions needed as seen in Figures 20 and 21 [30, 31, 32]. Most joining is accomplished by high performance epoxy adhesives. The best bonding environment is accomplished by increasing the surface area of both adherends. Sandblasting the concrete and abraiding the surface of the composite is typically done. Mechanical fastening methods are also occasionally employed [32]. The high strength of the composite allows less material to be used compared to traditional steel plate rehabilitation and pultrusions do not corrode like steel.

Figure 20: Column Strengthening [33]

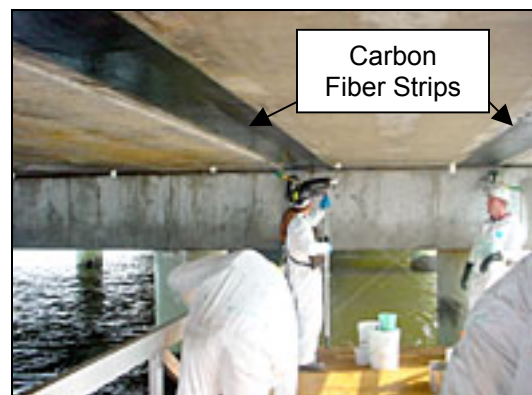
Figure 21: Bridge Strengthening [33]

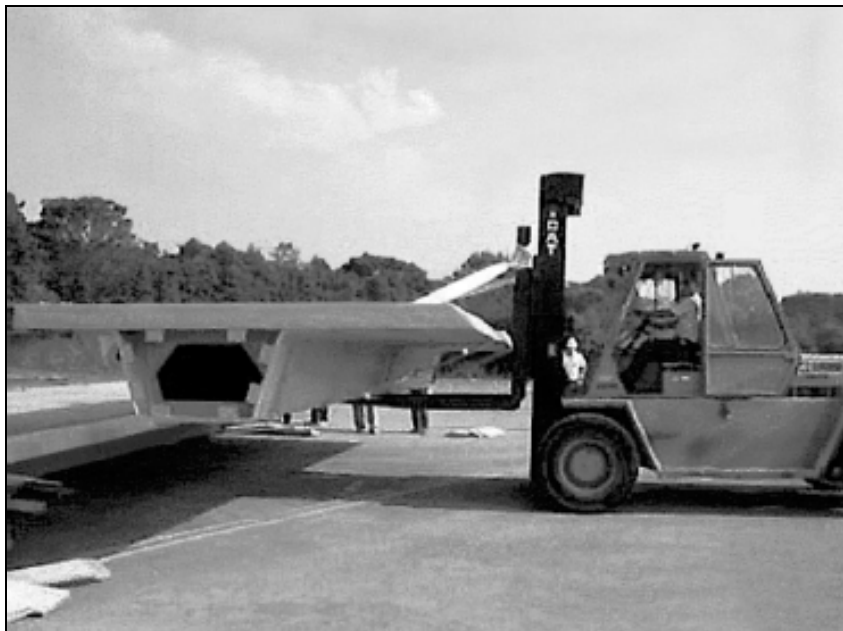
Figure 25: Element of composite bridge deck transported into position [38]

Pultruded bridge deck components have received the greatest attention in recent years due to their inherent advantages in strength and stiffness per unit weight compared to traditional steel reinforced concrete [32]. The light weight of these composites allows rapid replacement of unrepairable bridges and a reduction in the dead load compared to a concrete bridge. Many pultrusion producers supply custom profiles based on customer designs or market directly to engineers with previously used shapes in bridge decking. Some of these profiles are shown below in Figure 24 [38]. The individual cells of these pultruded composites can either be joined by application of adhesives or mechanical fastening. The lightweight of the pultruded PMC components allows easy transportation to the construction site as seen in Figure 25. Joining the composite components together can also easily be done on site.

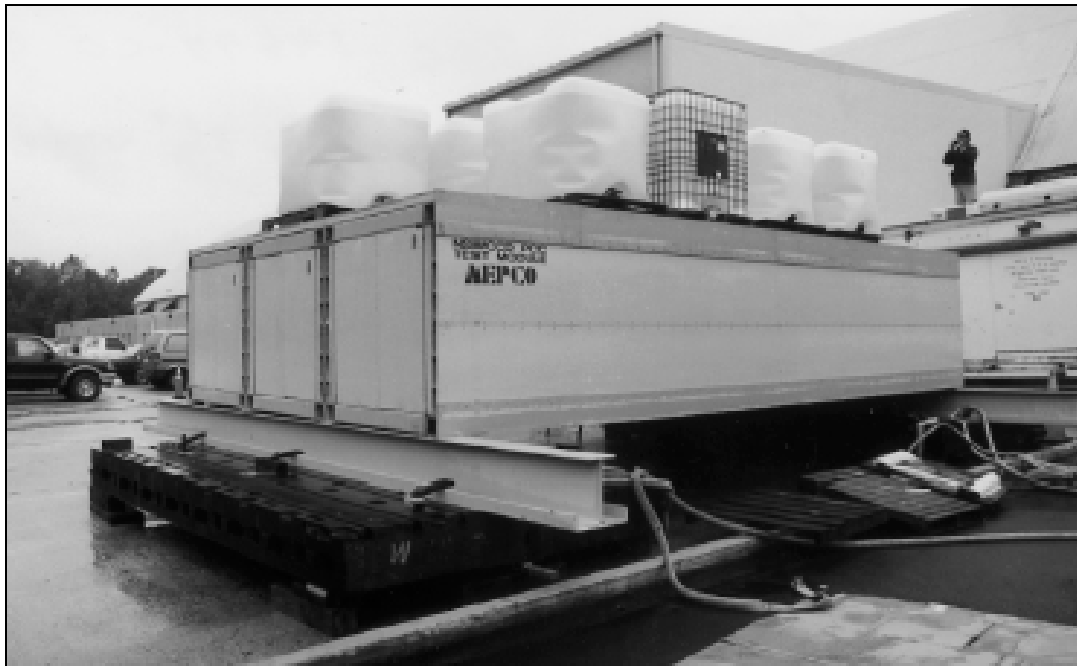
Figure 26: Completed causeway structure element under load [39]

An example of pultrusions assembled in a box girder for a marine environment causeway structure details how easy it is to assemble a pultrusion based structure. The composite structure shown below in Figure 26 was

assembled from several multi cell pultrusions as shown in Figure 27. The assembly was done by a couple of laborers and a light crane. Each square beam in Figure 27 was mechanically fastened at its corners to a girder along the top and a T-beam connection at the bottom. The completed structure in Figure 26 was loaded by 14 1-m<sup>3</sup> containers filled with water for a total of 132.7 kN for 7 days. The structure deflected 6 mm at the center and recovered half of that after unloading [37, 39].

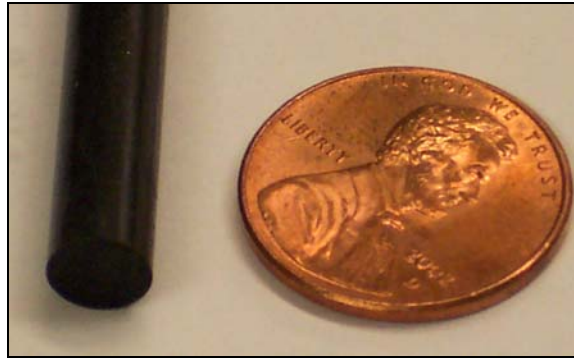
Figure 32: Scale of pultruded rods used in this study

The pultruded sections used in this study were primarily 5.91 mm diameter by 1.83 meter rods that employed Zoltek brand Panex® 35 intermediate modulus carbon fiber [54]. The matrix was Epon 826 Bisphenol-A based epoxy manufactured by Shell Chemical Corp. The curing agent used was LS-81K, made by Lindau Chemicals. This epoxy system is specially formulated for pultrusions [55]. The tip of one such rod is shown in Figure 32.

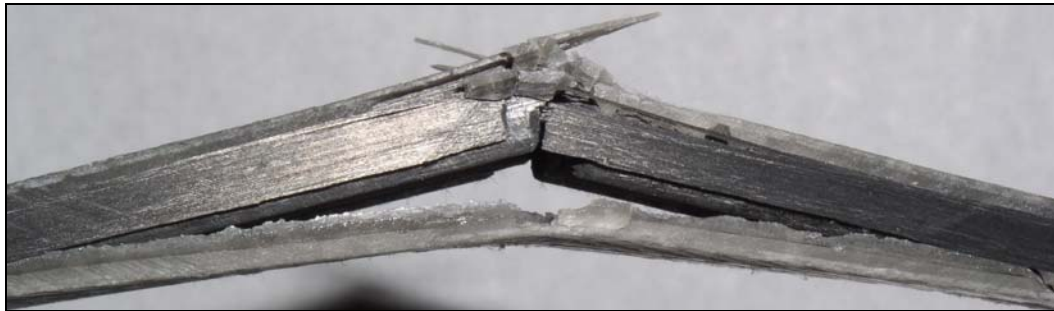
Figure 36: Three-point bending test result showing that the secondary resin had peeled off the pultrusion

The pultruded rods used in this series of experiments have a very smooth surface to the touch when received from the manufacturer. This might lead to an inadequate bond between pultrusion and embedding matrix that would easily fail under load. Initial three-point bending tests on a rod based beam structure shown previously in Figure 17 showed that the vinyl ester secondary resin around the

pultrusions peeled away under load. Observations of the rod surfaces and resin in Figures 36 and 37 saw that the resin had an imprint of the lightly abraded rod surface. It would be an area of concern if this phenomenon was common. Thus various mechanical and chemical surface treatments were performed on the rods in this study to observe the pultrusion-secondary matrix (Epon 862 epoxy) bond strength change compared to an untreated rod.

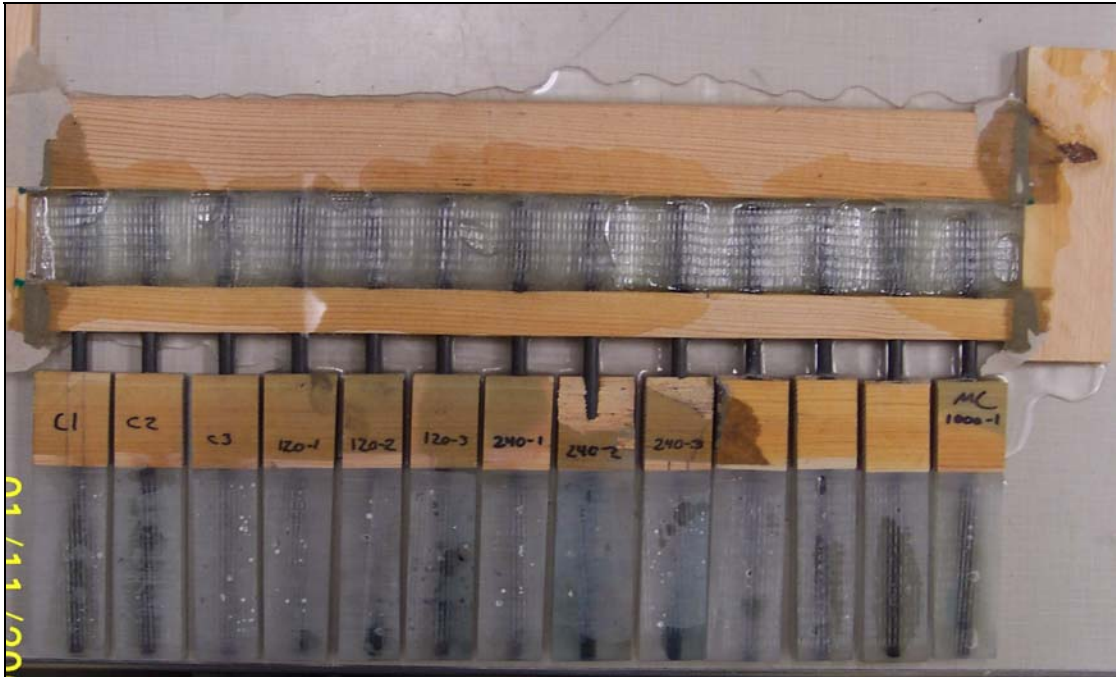
Figure 41: Top down view of the short end mold

Two rectangular molds were made to encase both ends of the rod in epoxy with the middle of the rod exposed. The length of epoxy on the longer end was 76.2 mm long with a depth of 9.525 mm and width of approximately 25.4 mm after cutting the coupons. The shorter end would be 38.1 long x 25.4 x 9.525 mm. Prior pullout tests with just one rod end in resin resulted in premature failure in the free end. Tempered glass was placed over the mold after applying the secondary resin. These molds are seen in Figures 41 and 42.

end mold was made separately to encase this end after the crushing problem could not be overcome by other means. The mold was made of 2x4 boards cut lengthwise with the thickness dimension vertical so the thickness of the wood was 9.525 mm. The overall length of the mold was as long as needed to create as many coupons as possible. The mold was held together with gray adhesive tape. This tape did not react with the resin and could be peeled away after infusion. The rod holes were drilled most of the way through with a 6.35 mm drill bit; the last 3.175 mm distance was drilled with a 5.9436 mm bit. This part of the hole fit snugly against the rod and would resist resin leaking through the hole. The wood parts of the mold were bonded to the secondary epoxy instead of the pultruded rod.

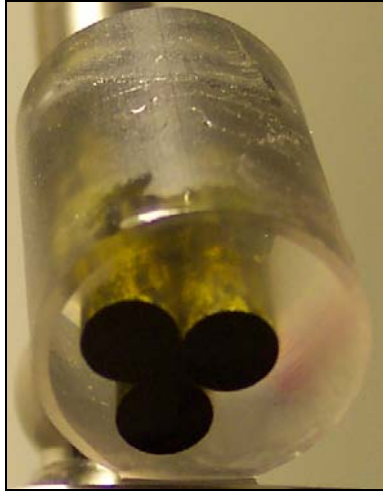
Figure 60: Washed 60 min  $\text{HNO}_3$  trial

Again, trials with short rod sections were tried to observe the effectiveness of each proposed solution. The distilled water soak took about five days to reach pH neutrality for the 15, 30, and 60 min HNO<sub>3</sub> only treatments and five days to dry in atmospheric air conditions. When embedded in secondary resin, the porosity was almost eliminated but the yellow discolor remained and the color intensity increased as acid treatment time increased. The resin rich areas between the rods were also clear in all trials. The appearance of the 60 min HNO<sub>3</sub> trial is seen in Figures 60 and 61. The 15 and 30 min trials were all similar in appearance to the Figures below. This distilled water approach, while probably not fit for production environments, was considered a success at neutralizing the leftover nitric acid.

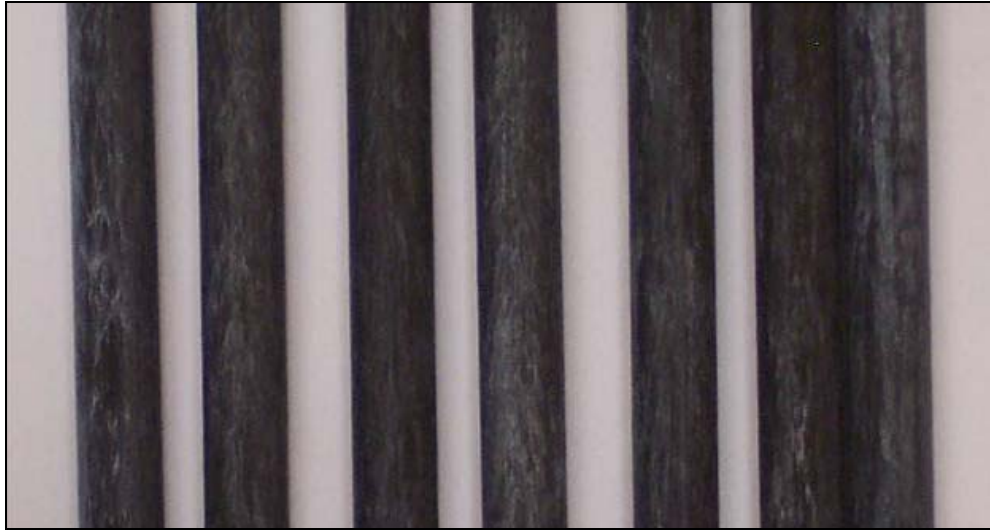
Figure 68: 15 min HNO<sub>3</sub> treated rod surfaces before secondary epoxy infusion

The 15, 30, and 60 minute nitric acid only treatment series were soaked in heated nitric acid as previously described for the designated time. All treated rods of these series were then submersed in different beakers of distilled water in an attempt to dissolve out as much nitric acid as possible from the rods before resin infusion. The pH of each beaker of water was monitored and replaced frequently until the water pH reached neutral for several monitoring periods. This procedure lasted 4 to 5 days with shorter nitric acid exposure times needing less time for the pH rising to neutral. The rods were then removed from the water and dried in standing atmosphere for 15 days before bundling into a rod pack for infusion and testing. The appearances of the nitric acid only treated rods after drying are shown in Figures 68 through 70.

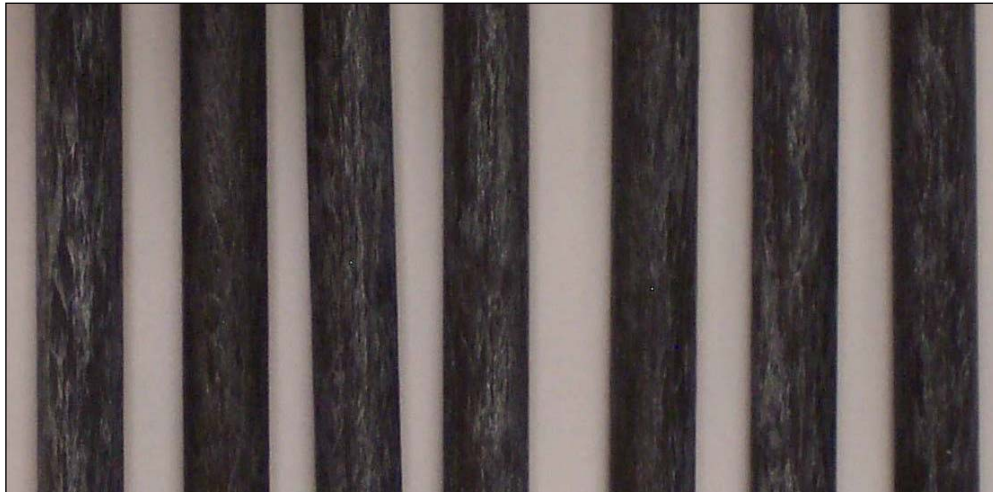
Figure 69: 30 min HNO<sub>3</sub> treated rod surfaces before secondary epoxy infusion

As the nitric acid exposure time increases, the amount of white discoloration on the surfaces of the rods also increases. Free carbon fibers are now visible on the surfaces of the 60 min HNO<sub>3</sub> treated rods and are easily moved out of alignment by handling.

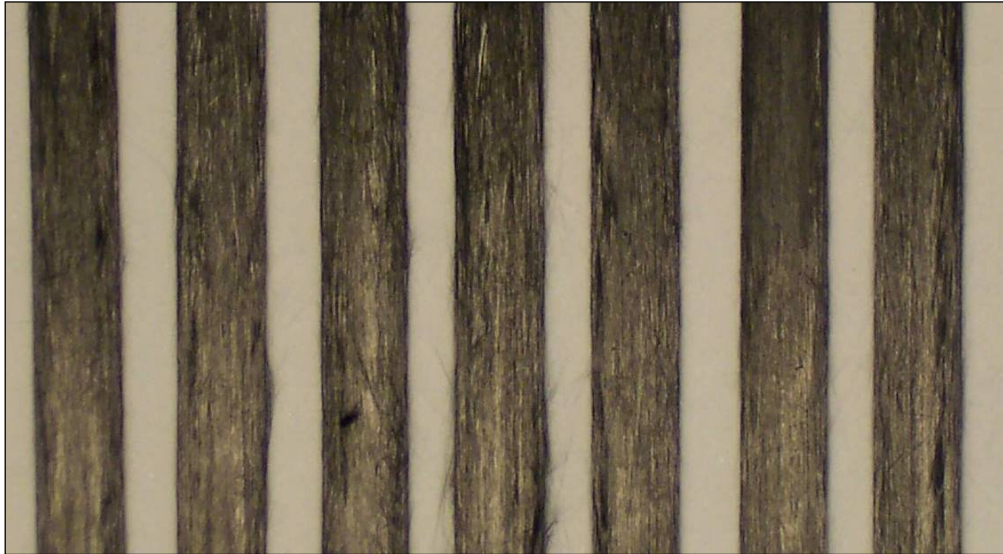
Figure 71: 60 min  $\text{HNO}_3$  / 20 sec 1M NaOH treated rod surfaces before secondary epoxy infusion

For the test coupon series of HNO<sub>3</sub> plus NaOH exposed rods, the NaOH treatment time was limited to 15-20 seconds in each respective molar concentration. The NaOH exposure was performed in a 1000 mL graduated cylinder over a magnetic mixing plate. The magnetic stirring rod mixed the solution at a medium-high speed. This mixing was performed to allow the NaOH solution to interact with the entire surface of the rod quickly, rather than having an uneven exposure profile when the rod is dipped in. This mixing speed caused the loose fibers to leave the unidirectional orientation and entangle around the surface and freed the smaller loose fibers. This entanglement is seen in Figures 71 through 73 and was exacerbated by the handling of the rods throughout the procedure.

removed and dried in standing atmosphere for 15 days before bundling and infusion. The appearances of the treated rods after drying are shown in Figures 71 through 73.

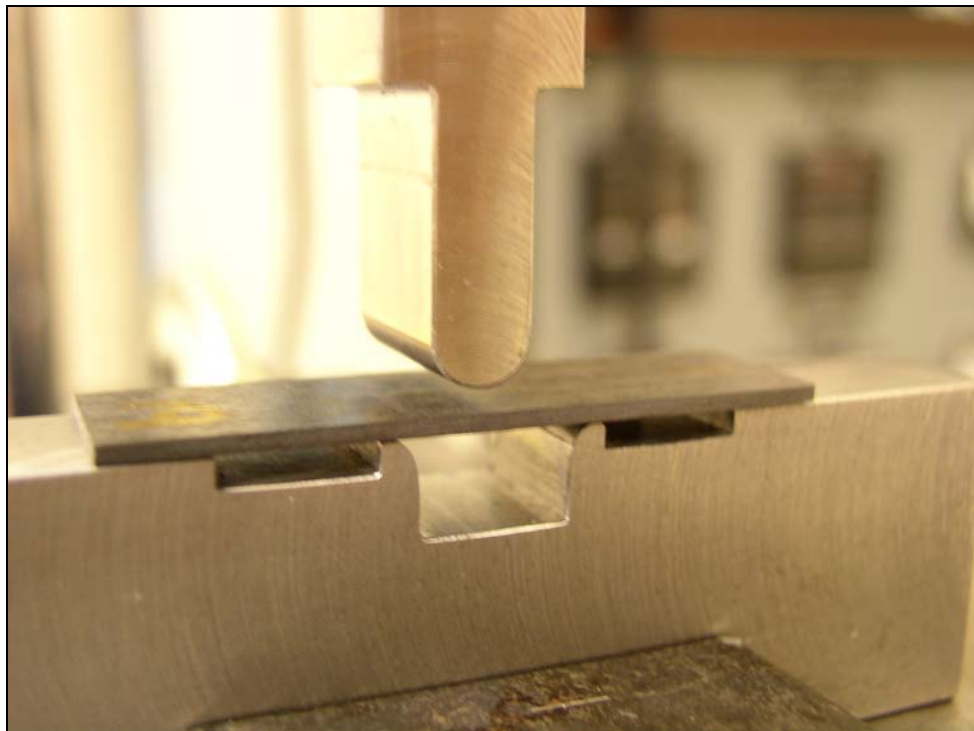
Figure 81: SBS coupon about to undergo loading

Short Beam Shear (SBS) Tests - Single rod and flat coupons were tested in a custom short beam shear apparatus. The rod coupons were 33.02 mm in length. The flat coupons were 12.7 mm by 25.4 mm. The support apparatus for the flat coupons was steel with a support span of 9.61 mm. The support apparatus for the rod coupons was steel with a support span of 19.10 mm. The rod short beam shear support had a 5 mm long by 0.42 mm deep rounded groove in the center that limited the rod movement before loading. Two loading noses were also used. Both were made from steel stock; one contacted coupons of both type on the exterior of a 6.45 mm diameter, 12.65 mm wide half cylinder, the other contacted rod coupons on the inside of a 6.65 mm diameter notch drilled out of a steel flat 3 mm thick by 31 mm wide. This notch was filed into a saddle shape. This loading nose was used for the rod coupons because the other nose was too large for the diameter of the coupon and caused splitting in the rod coupons that traversed the length of the coupon. These fixtures and setups can be seen in Figures 80-82.

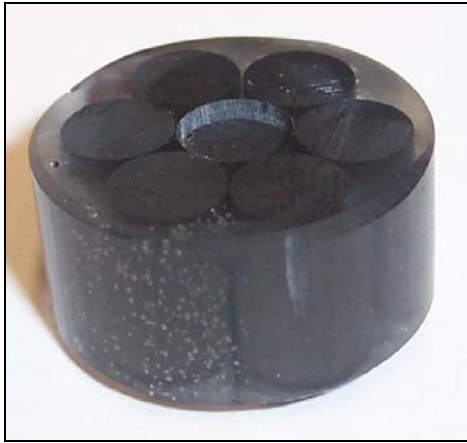
This test is similar to the pullout test in that failure of the interface is initiated at the interface discontinuity where the pushrod contacts the center rod and the embedding epoxy. Once the interface debonds at this location, the interface crack grows around the pultrusion interface by some energy release rate until the crack grows suddenly to debond the final length of the interface. The average IFSS values calculated is based on the assumption described earlier; that the shear stress is constant along the interface after the debonding is initiated. A visual inspection of the failed pushout coupon is shown below in Figures 120 and 121.

Figure 120: Typical pushout coupon interface failure appearance

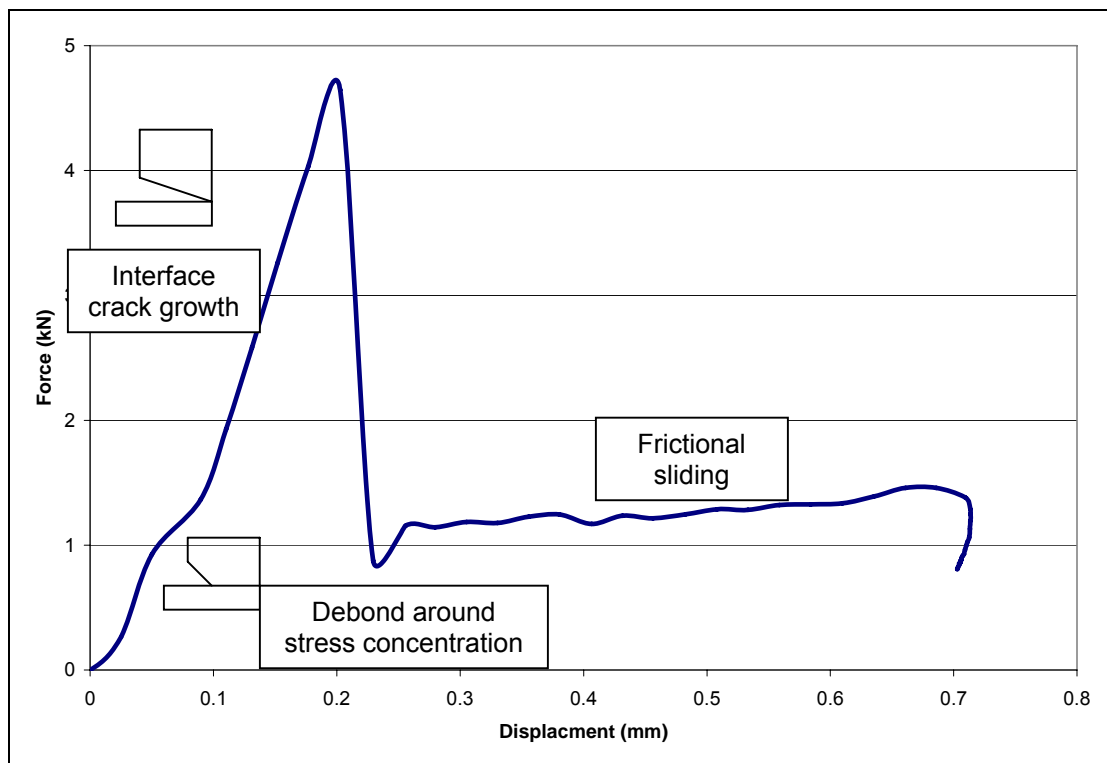
A typical force vs. displacement curve for a pushout coupon is seen below in Figure 122. Not shown at the beginning of the curve is a non-linear region where settling and spreading of contact area between the pushrod and the center rod occur. In most cases, there is a small 'hump' that is seen before the curve becomes very steep. The hump is roughly analogous to the 'jog' described earlier

for the pullout testing; this is where the interface at the stress concentration begins to separate from the embedding epoxy. As the pushout load grows, the interface crack is growing along the interface most likely in a non self-similar growth method. At the maximum load, the crack grows enough to completely separate the pultrusion from the embedding epoxy. After this point, the load drops off considerably and the remainder of the curve is the friction at the new surface between the pultrusion and the epoxy resisting the pushout force. The force versus displacement curves for selected pushout test coupons are located in Appendix C.

Figure 122: Typical pushout coupon force vs. displacement curve
