HIGH CYCLE COMPRESSIVE FATIGUE OF UNIDIRECTIONAL GLASS/POLYESTER PERFORMED AT HIGH FREQUENCY

Andrew Jay Belinky

Chemical Engineering

MONTANA STATE UNIVERSITY Bozeman, Montana

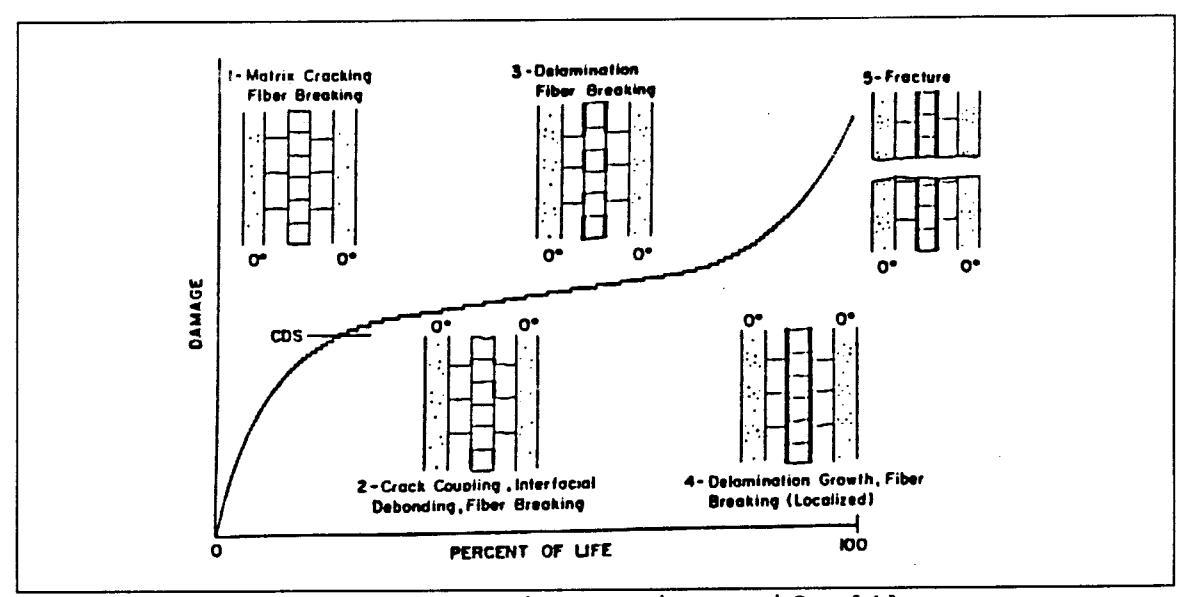
Figure 1. Damage Modes During Fatigue Life [4].

The region where primary and secondary cracks cross each other forms the fourth damage mode, local delamination. Delamination is the separating of adjacent plies and is noticeable macroscopically (usually as discoloration in fiberglass reinforced composites) in the latter stages of life. Figure 1 illustrates the fatigue damage process outlined by Reifsnider.

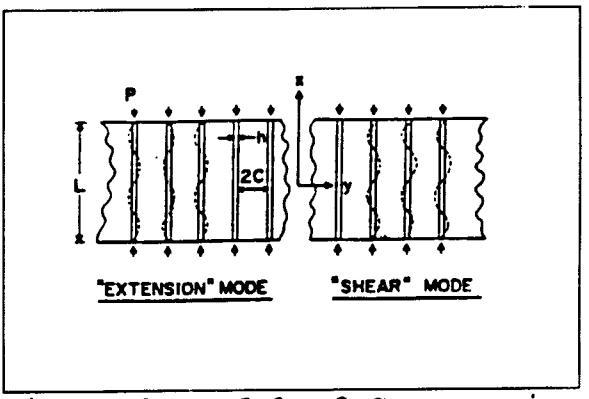
Figure 2. Model of Compressive Failure Modes [15].

Another point of debate with compression is the identification of valid failure modes. In initial work in this area, Rosen [15] modelled a composite as a series of columns (fibers) on an elastic foundation (matrix). As a compressive load was applied to the model, an eventual critical point would be reached when the columns would elastically buckle and the composite fail. This model identified two failure modes,

extension and shear (Figure 2). At low fiber volume fractions (below 30%) the extension mode was found to be dominant, while at higher fiber volume fractions (above 30%) shear dominated. However, the drawback with Rosen's model was its c

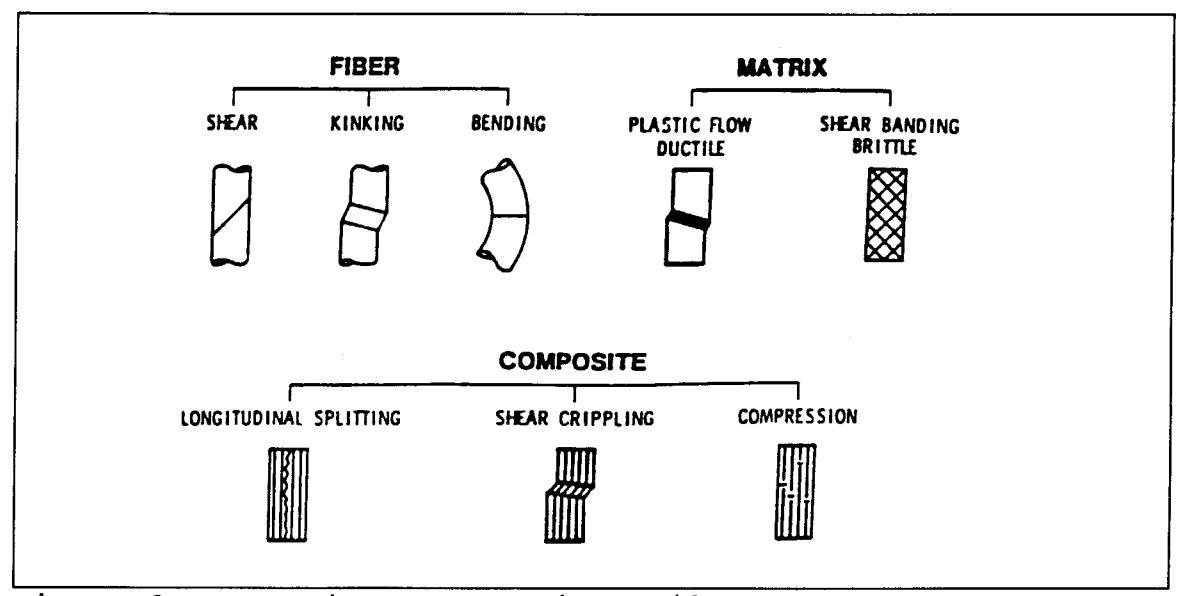
Figure 3. Composite Compression Failure Modes [16].

3). Glass fibers generally fail by bending, and graphite fibers by shear. Greszczuk [14] found that for graphite reinforced composites with low modulus resins, failure was by fiber microbuckling in the shear mode. For intermediate modulus resins, fiber splitting occurred. And for high modulus resins, fiber compression resulted. Thus, matrix modulus plays a critical role.

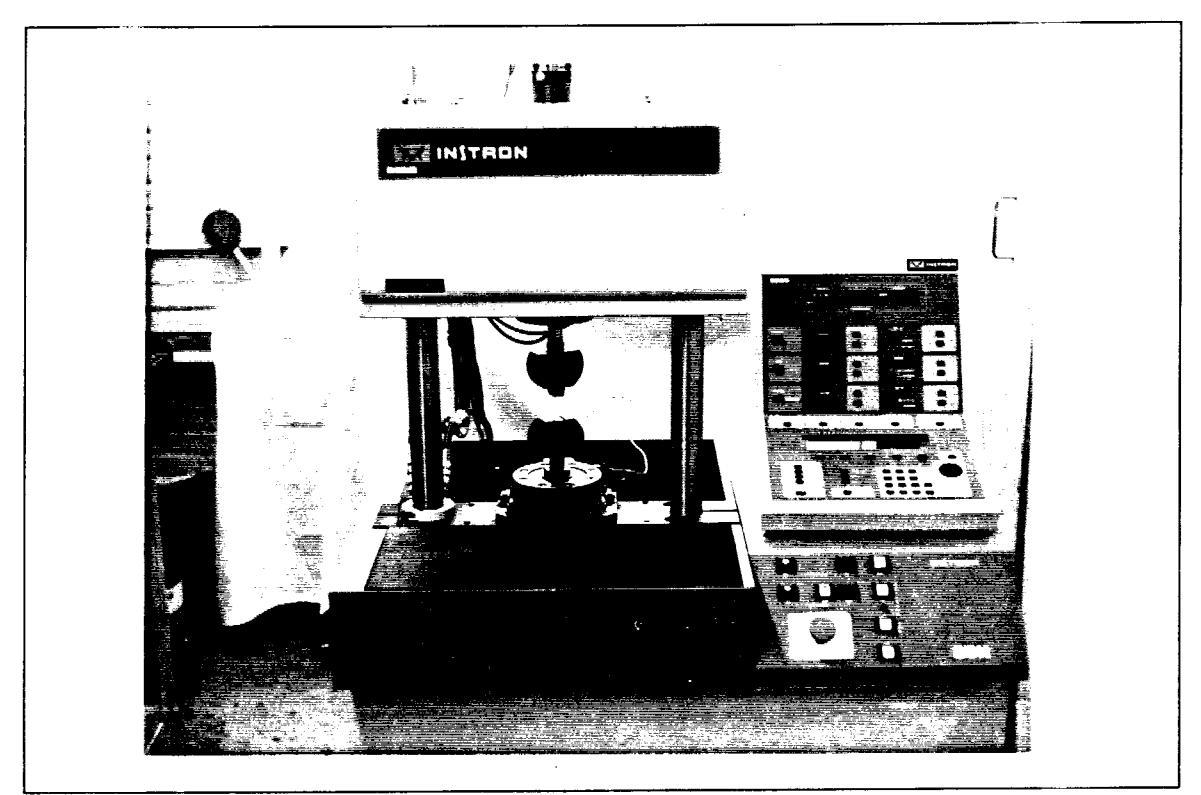
Figure 4. Instron 8511 Servohydraulic Test Machine.

A high response, low force Instron Model 8511 servohydraulic test machine, capable of generating 2000 pounds

of force, was used for static and fatigue testing (Figure 4). A 5000 pound range load cell was employed. Piston displacement was measured with a linear variable differential transducer (LVDT). The 8511 was selected because it is capable of accurately applying low loads (less than 10 pounds) and running at very high frequencies (in excess of 100 Hz) at adequate displacements. It has a 10 gallon per minute (GPM) servo valve and operates at 3000 psi hydraulic pressure supplied by a 20 GPM pump.

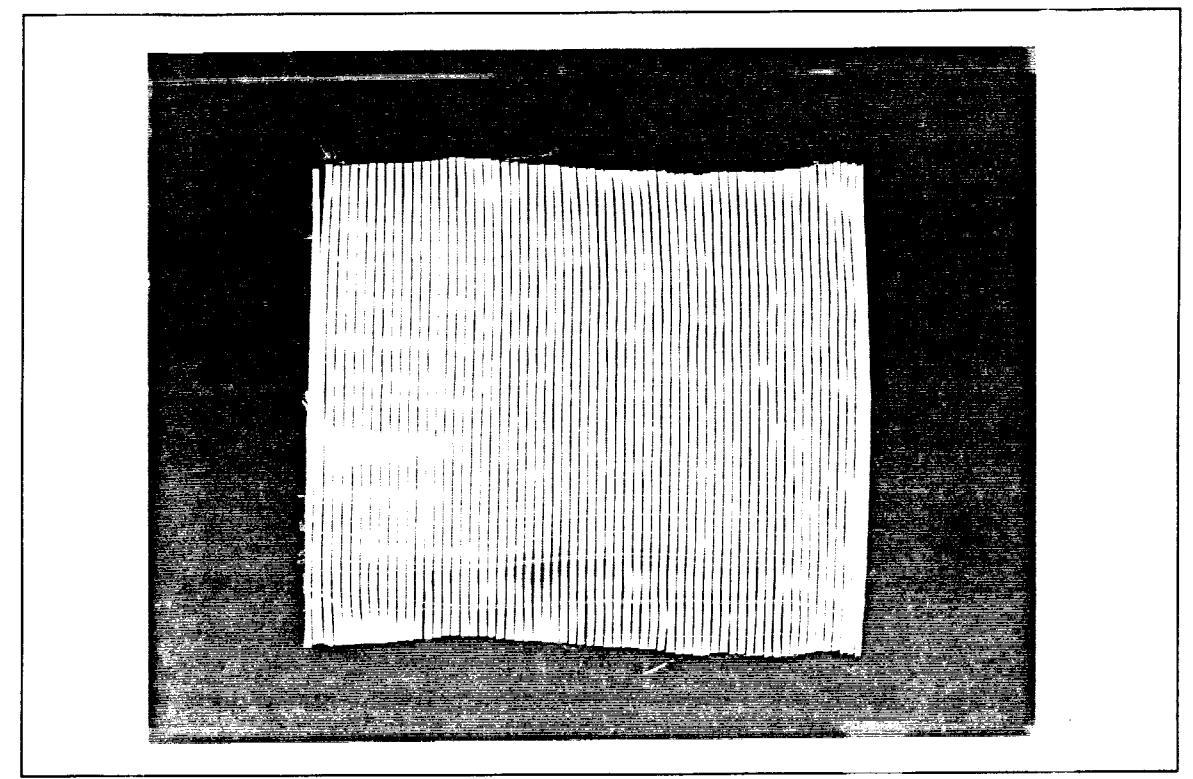
Figure 5. Hexcel Unidirectional E-glass Cloth No. 0155-50.

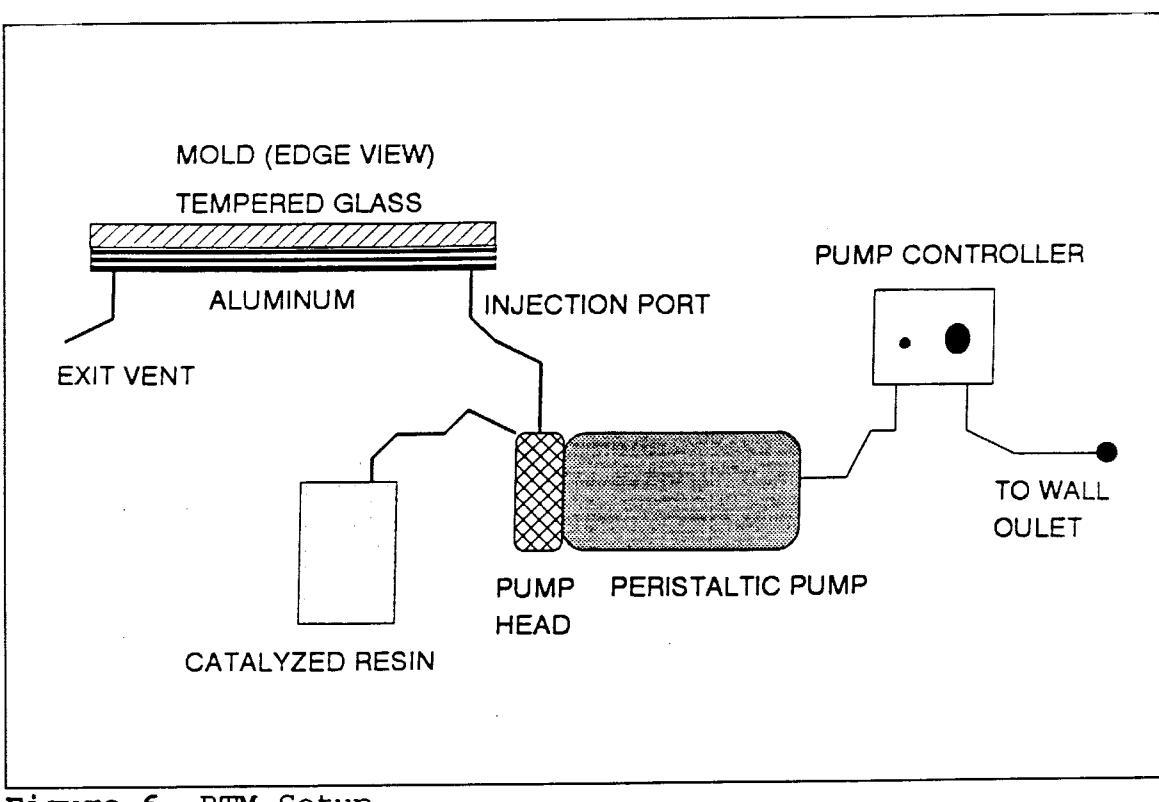
Figure 6. RTM Setup.

research was flat, measuring 18 inches long by seven inches wide. It consisted of a 0.25 inch thick aluminum bottom plate with one injection port and two exit vents. The surface was polished smooth with 2400 grit sandpaper to reduce adhesion of cured material. The other side of the mold was 0.25 inch thick tempered glass. This was used to allow monitoring of the injection process. Tempered glass was chosen because normal glass could not handle the high stresses which resulted from a combination of clamping pressure and internal injection pressure. Around the edges was a rubber gasket seal measuring approximately 0.035 inches thick and 0.5 inches wide. Varying the gasket thickness produced different specimen thicknesses and fiber contents. Fiber Resin Corporation FR-1000 silicone
mold release was applied to both sides of the mold prior to loading the reinforcement.

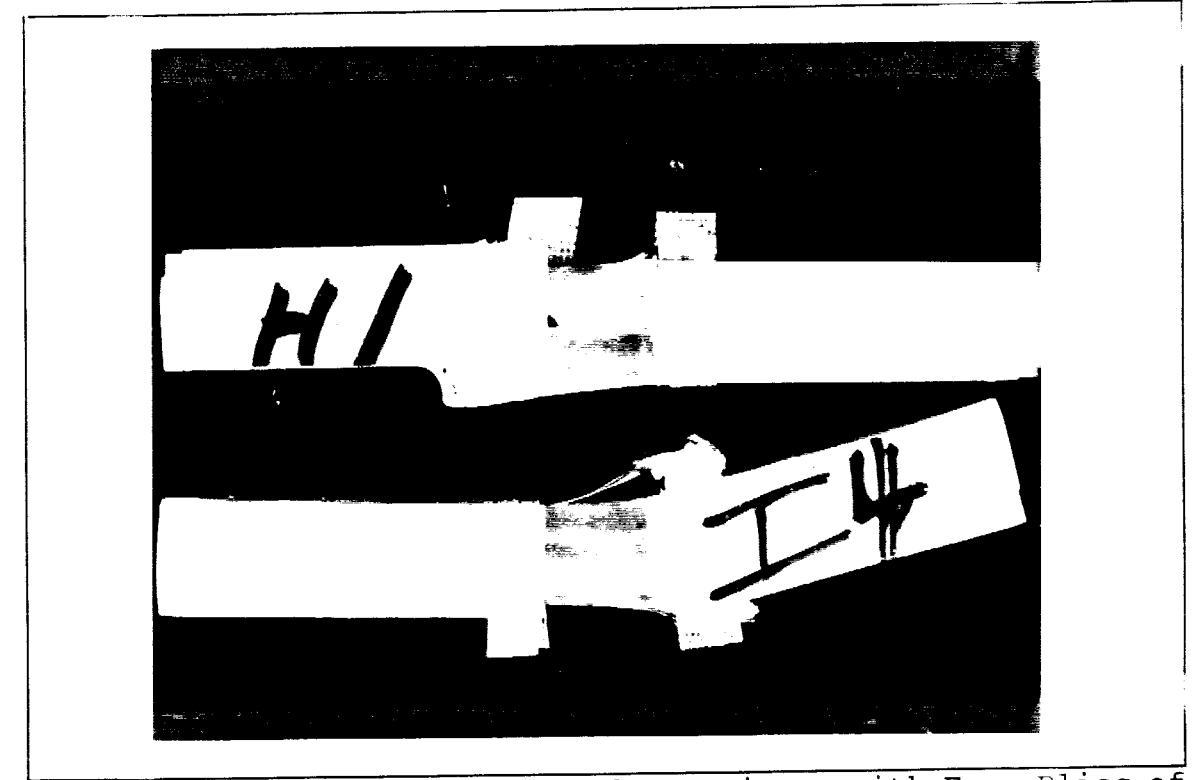
Figure 11. Failure Mode for Early Specimens with Four Plies of Roving.

In an attempt to produce valid compressive failure modes in the gage section, the roving was replaced with three plies of unidirectional cloth. This was done to remove any possible effects of misaligned fibers. It was felt that these potential non-uniform regions could act as initiation sites for specimen failure. The unidirectional cloth specimens with a decreased thickness reduced the amount of force that had to be transferred to the composite through the tabs, thereby reducing the possibility of tab debonding. Teflon was still used at the edge of the gage section to provide a load

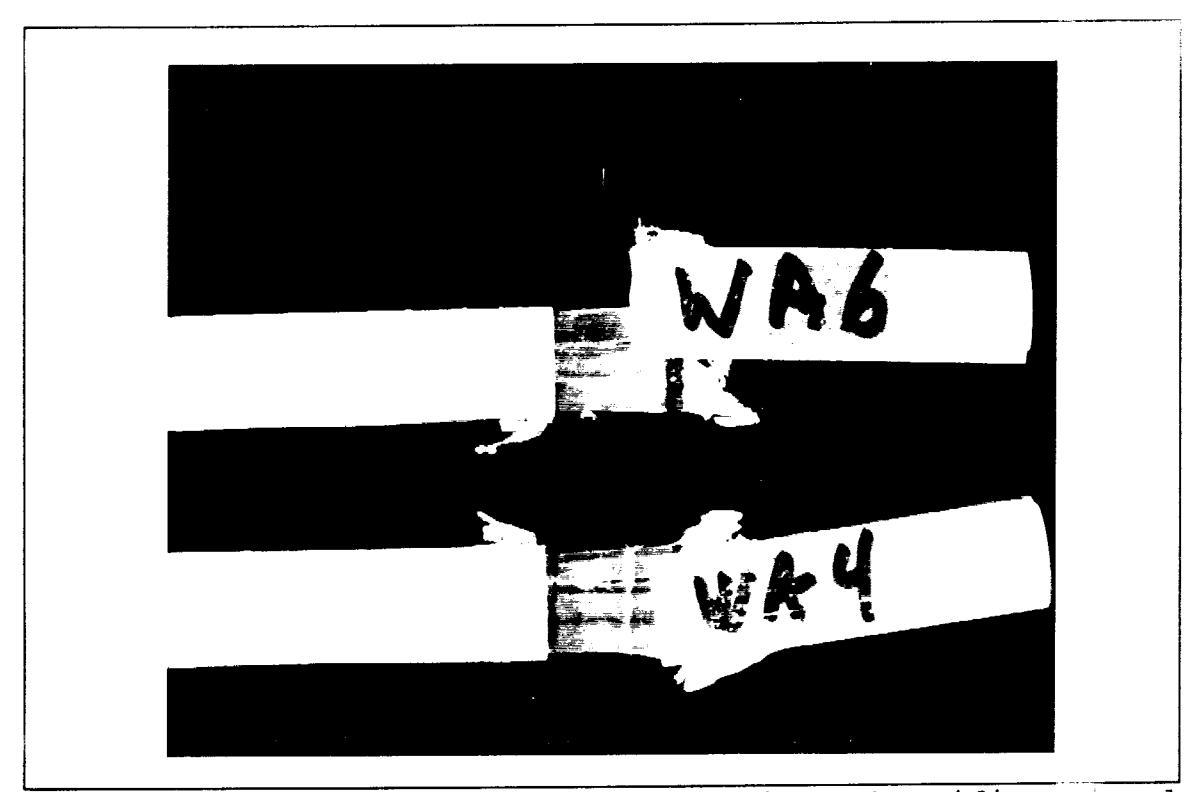
Figure 12. Failure Mode for Three Plies of Unidirectional Cloth.

transition zone. Failure, however, still occurred behind the teflon at the glue/ composite boundary. Figure 12 illustrates the failure mode observed.

was not successful and failure still occurred at the epoxy/ composite boundary. Another method involved tapering the tabs and bonding them onto the composite without using a second material to act as a load transition zone. This method failed because the specimen could not be gripped to the edge of the gage section. The result was an unsupported area that was twice as long as the gage section causing buckling to occur. Finally, square tabs with no teflon were employed, and as discussed later, specimens usually failed in the gage section, supporting the use of this design. The use of square tabs is questionable in terms of stress concentrations. However, finite element analysis by Creed [3] showed that the stress concentration which exists around a square ended tab in a geometry and thickness similar to the one used here extends only several fiber diameters into the composite. Therefore, the effect on overall specimen behavior was not expected to be great.

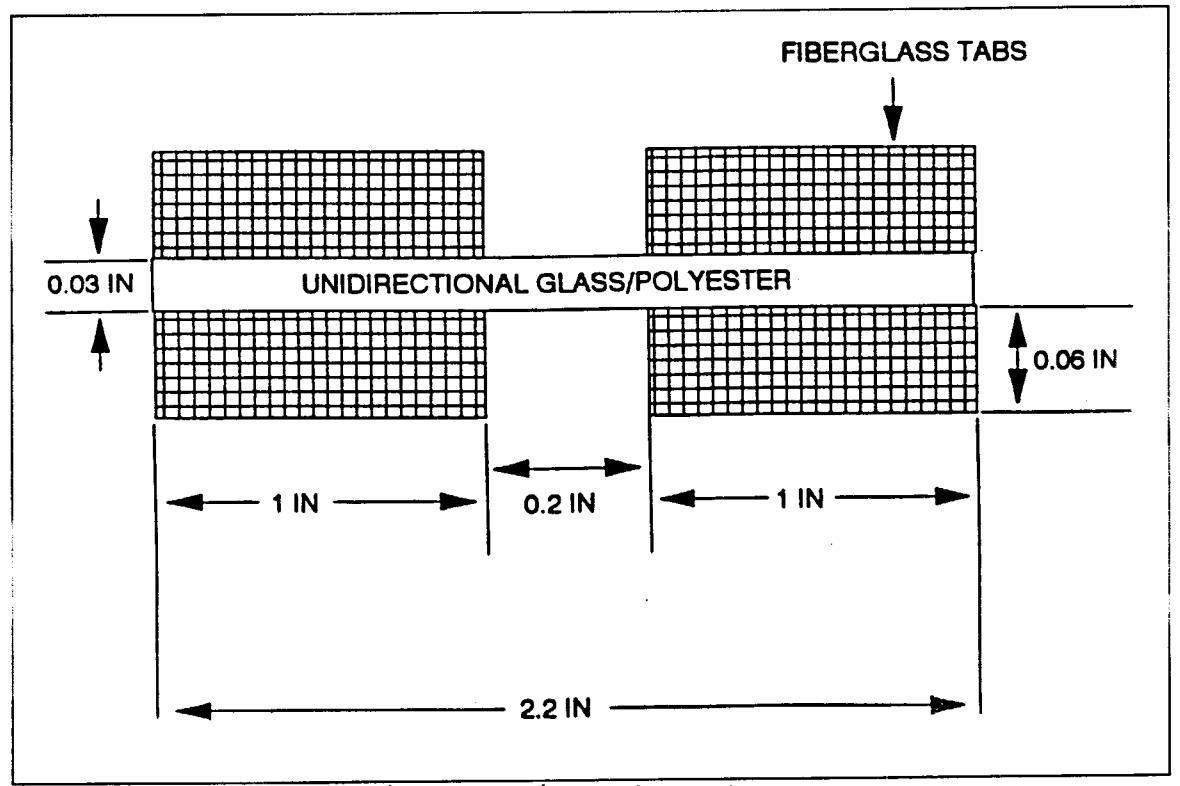
Figure 13. Compression Specimen Geometry.

Specimen geometry was 0.25 inches wide by 2.2 inches long by approximately 0.035 inches thick (see Figure 13). The thin specimens required a short gage length of 0.2 inches (roughly five times the specimen thickness of 0.035 inches) to avoid elastic buckling. Tabs measured 0.25 inches wide by one inch long by 0.06 inches thick. The tab length of one inch was

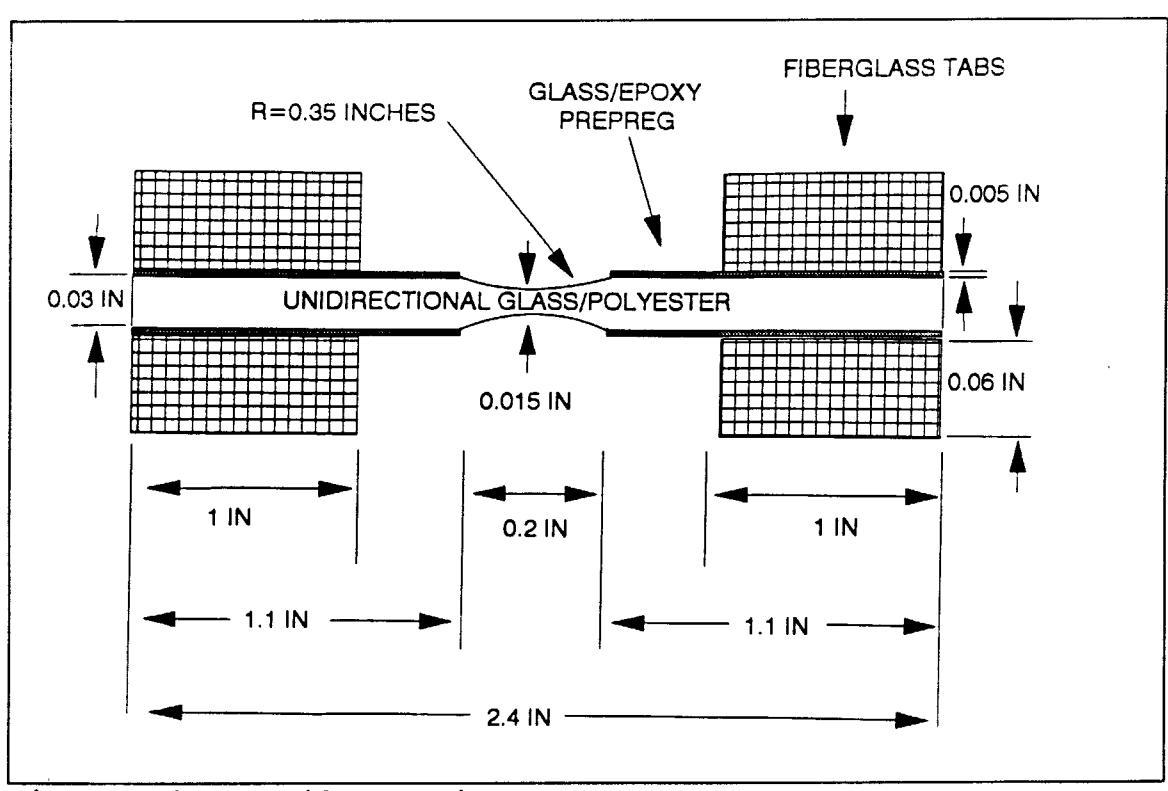
Figure 16. Tensile Specimen Geometry.

with failure location). The same two-ply well-aligned glass/ polyester material was used for the tensile specimens as was used for the compression specimens. Initially the same specimen geometry was used in tension as was used in However, it was observed that when tabs were compression. bonded directly to the composite, debonding occurred after the first few fatigue cycles. This was due to the higher ultimate strength of the well-aligned material compared to the roving used by Creed. To deal with this difference, two alterations were made to the tensile specimens. First, one ply of cured 3M SP-250E unidirectional E-glass/ epoxy prepreg (0.005 inches thick) was bonded to the composite in the tab regions. The gage section (0.2 inches in length) was not covered. Then the tabs (same dimensions as in compression) were bonded onto the prepreg. The prepreg extended beyond the tabs 0.1 inches and was tapered to zero thickness at the edge of the gage section. The distance between tabs was 0.4 inches. Second, the gage section thickness was tapered down from 0.035 to 0.015 inches (approximately one ply thickness) in the center. Tapering was accomplished using a Dremel Moto-Tool Model number 395 with a 0.7 inch diameter grinding bit, yielding a radius of curvature of the tapered region of 0.35 inches, and a uniform thickness across the width of the gage section. The tab stepping arrangement introduced load gradually into the gage section and reduced the stress concentrations which caused tab debonding in the earlier test geometry. Figure 16 illustrates

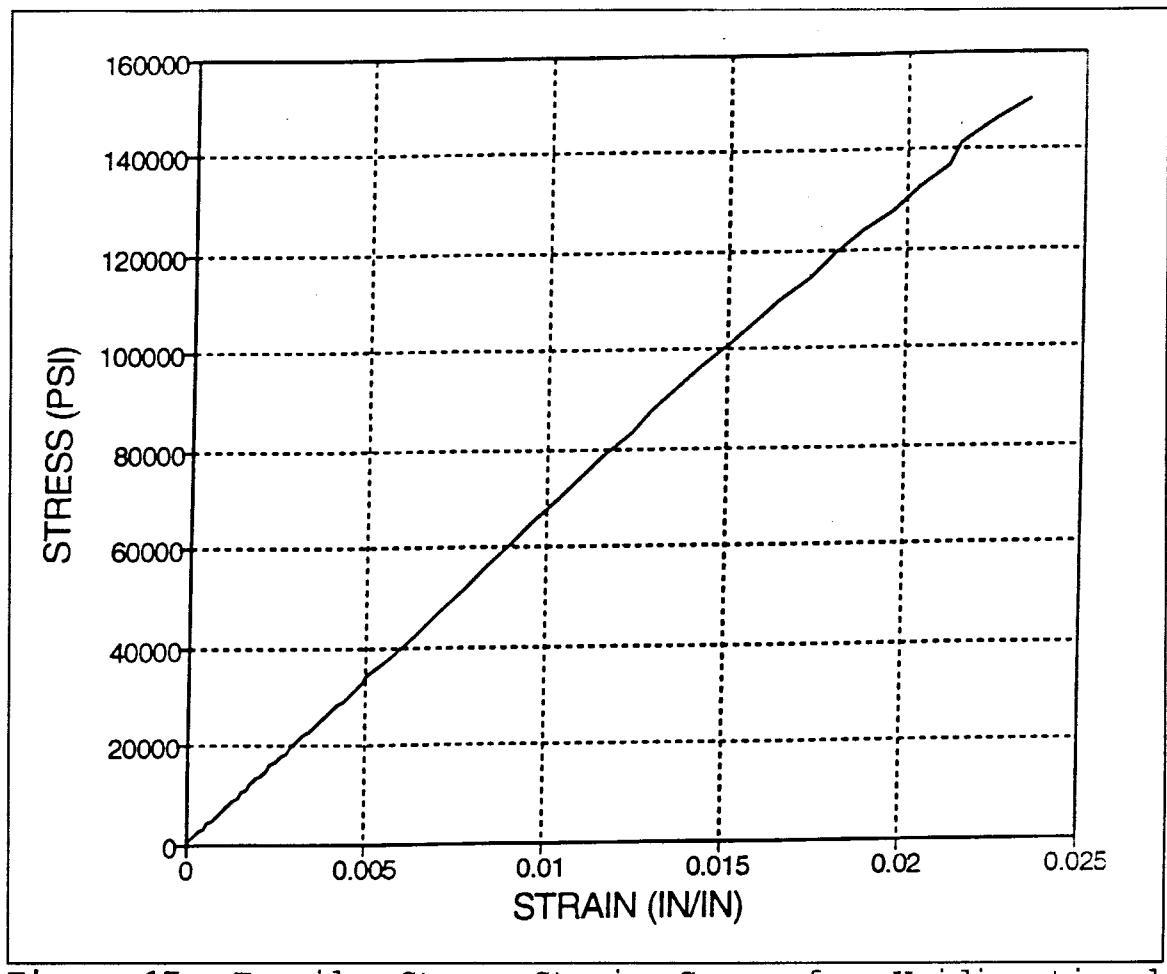
Figure 17. Tensile Stress-Strain Curve for Unidirectional Glass/ Polyester.

tensile specimen geometry used. The material was the characterized using a tensile stress-strain test performed at a loading rate of 25 pounds per second (see Figure 17). An untapered specimen was used because it was impossible to strain gage the small, non-flat tapered section of the tensile fatigue specimens. The modulus of the material was 6.7 msi and this value was used to calculate the initial peak strain levels for the tensile fatigue tests. This modulus is most likely low because the tapered specimens are believed to have a higher fiber content due to the tapering process. The ultimate tensile strength was 153,017 psi and the strain to failure was 2.3%. The fiber volume fraction of the untapered stress-strain specimen was 67%.

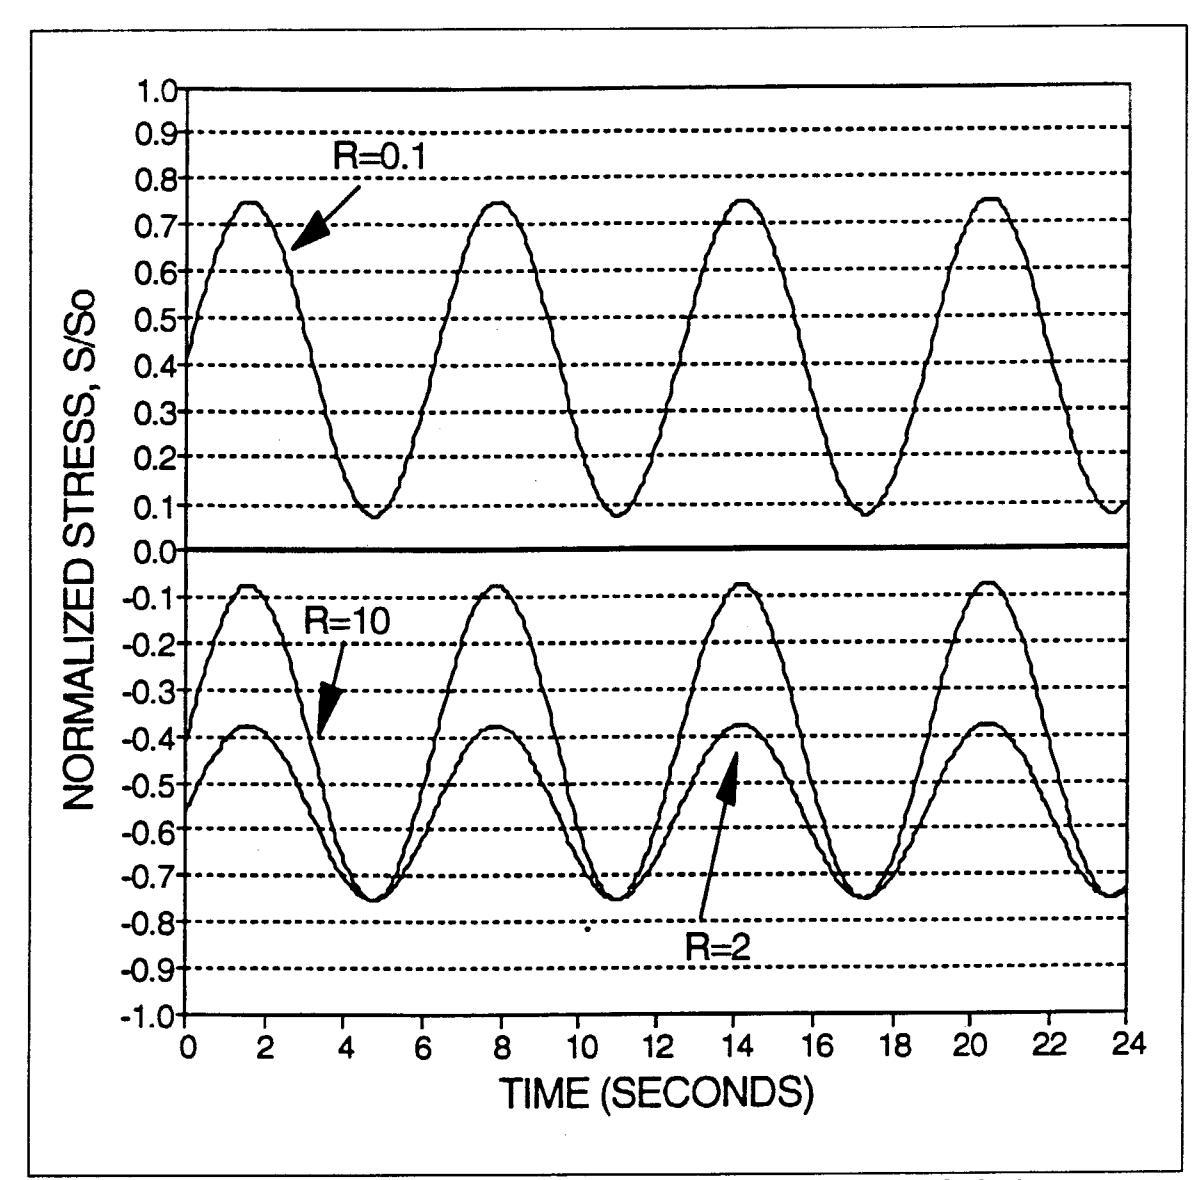
Figure 18. Sine waves for R Values of 10, 2, and 0.1.

Three different R values (minimum testing stress/ maximum testing stress) were tested in this research, R=10, R=2, and R=0.1. Figure 18 illustrates the relationships of the testing sine waves for the three R values on a plot of stress versus time. (Note that the minimum stress is taken as the greatest compressive stress in compression fatigue, since compression is taken as a negative stress.)

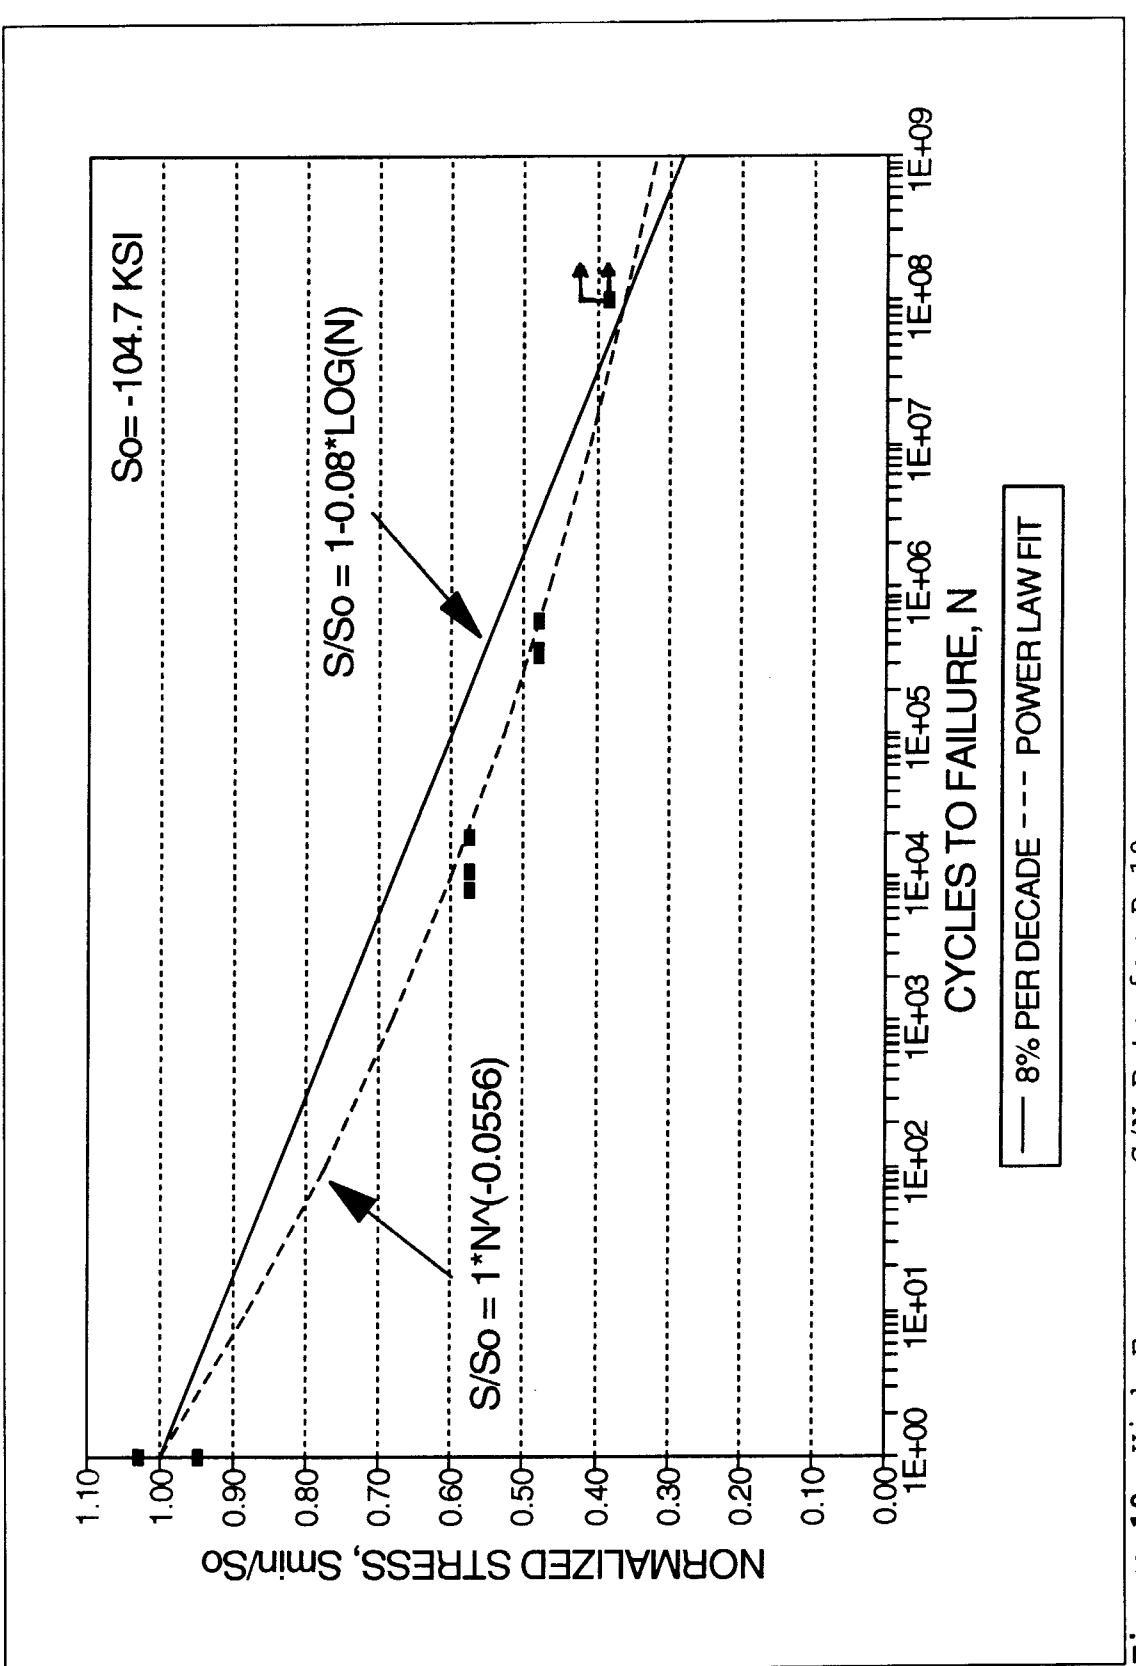
Figure 19. High Frequency S/N Data for R=10.

A least squares power law fit (including runout points) was found to provide the best fit to the data in Figure 19 $(R^2=0.9938)$. The reasons for the differences in trend lines between the small high frequency specimens and the standard

Examination of Figure 19 also indicates that above 10^5 cycles the S/N curve is flattening out. If the power law fit for the entire data set is used to predict fatigue lifetimes past 10^8 cycles, the values would be skewed low. This is because this curve fit is influenced more strongly by low cycle data points which occur at higher stresses. If a least squares power law curve fit is done for points above 10^5 cycles (including runouts), the goodness of fit increases from $R^2=0.9938$ to 0.9976 (Figure 21). Furthermore, at 10^9 cycles the extrapolated failure stress rises from 31.6% of the UCS to 34.9% of the UCS, and the corresponding strain increases from 0.64% to 0.71%. This fact is very important when considering

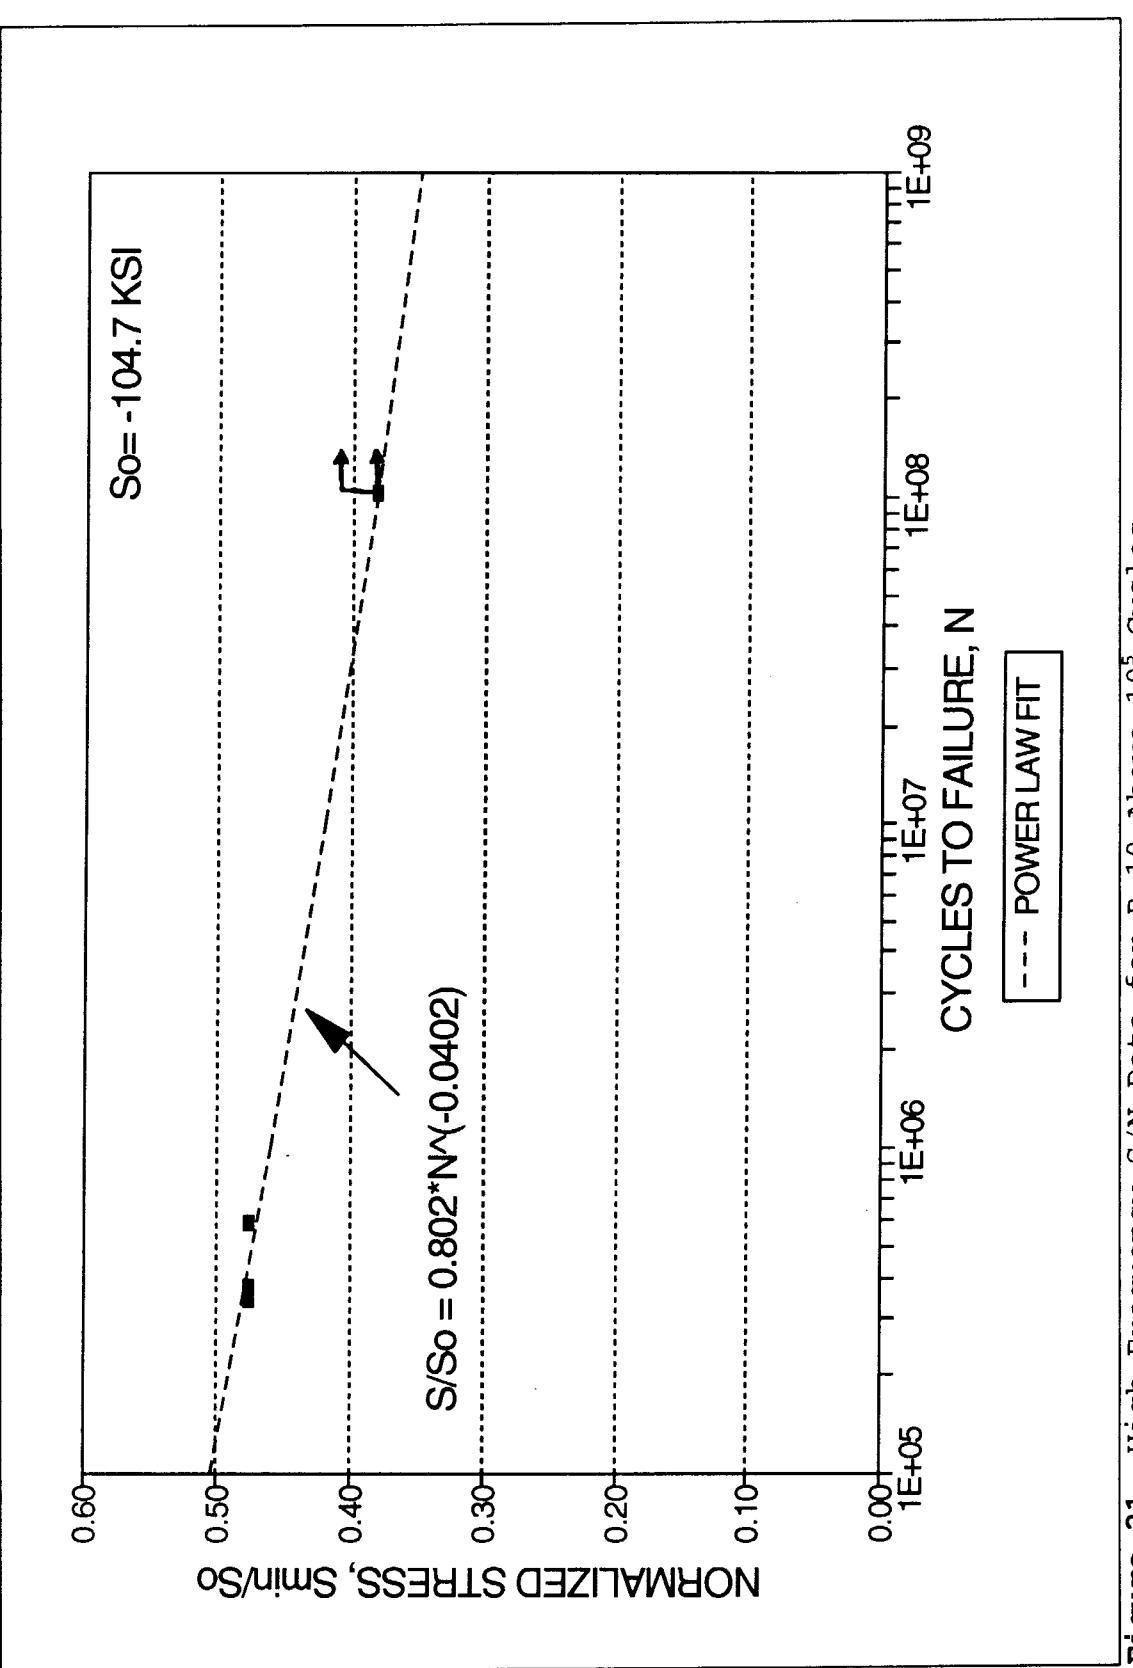
Figure 21. High Frequency S/N Data for R=10 Above 10⁵ Cycles.

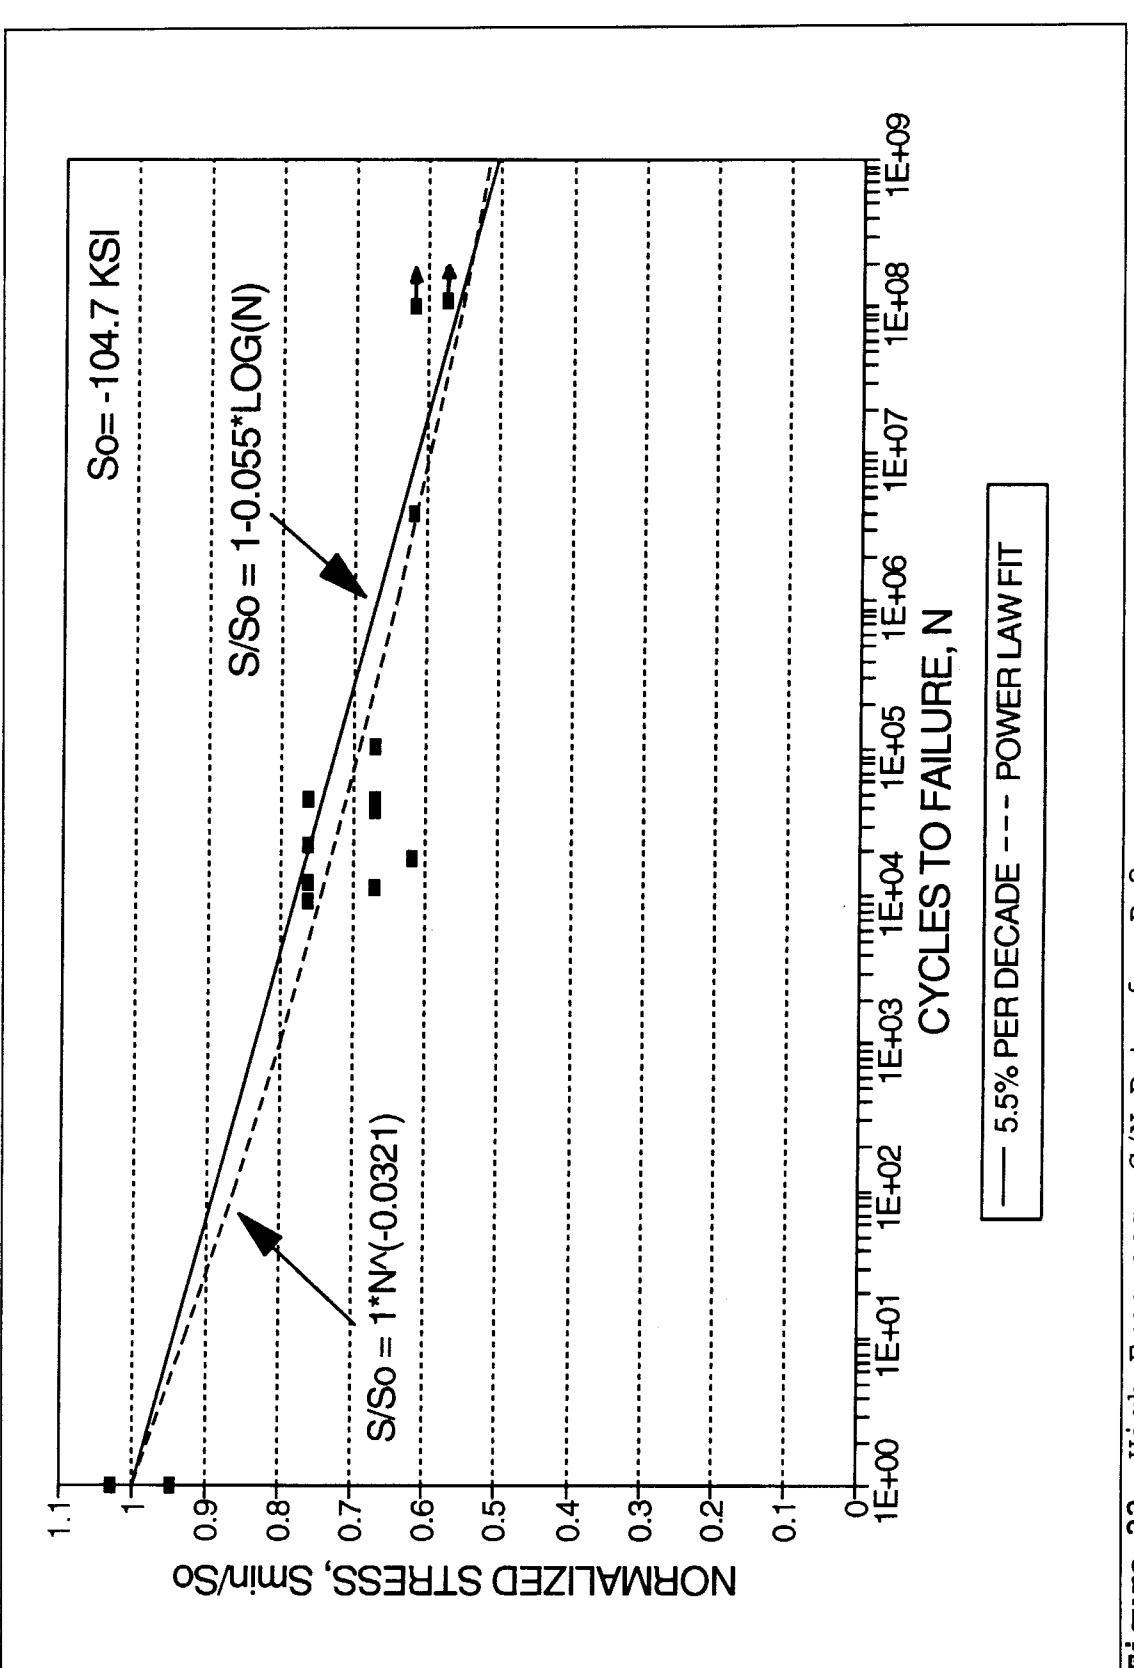
Figure 22. High Frequency S/N Data for R=2.

The region between 60 and 70% of UCS at R=2 shows some interesting behavior. The points at 66% of UCS are almost

directly below those at 76% UCS. This could simply be the result of a larger vertical scatterband than is present in the R=10 curve. It is also possible that this clustering, combined with the large horizontal scatter of points at 66% UCS, indicates that the slope of the S/N curve is flattening out and reaching some form of fatigue limit similar to what exists in steel. This is purely conjecture, however, and more extensive testing would be required before the presence of a fatigue limit could be confirmed. If the high cycle (above 10°) data are analyzed separately, the goodness of fit for a least squares power law fit actually goes down from 0.923 to 0.849 (see Figure 24). This is most likely the result of such a small data set (four points) and the strong influence exerted by the two 10⁸ cycle data points which are separated vertically by only 5% of the UCS. Despite a decreased goodness of fit, the curve can still be used to examine and predict specimen high cycle behavior. The result is once again an increase in the predicted failure stress at 10° cycles from 51.4% of the UCS to 57.3% of the UCS, with the corresponding strain rising from 1.05% to 1.17%.

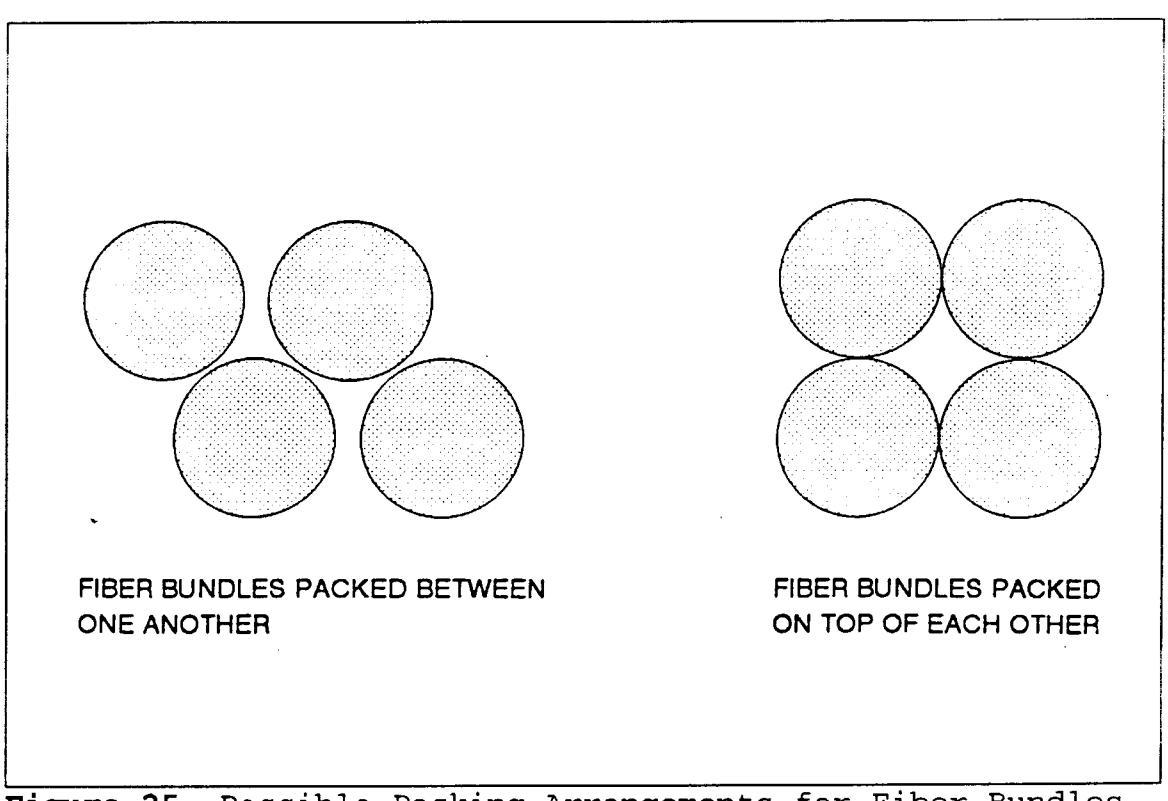
Figure 25. Possible Packing Arrangements for Fiber Bundles.

are illustrated in Figure 25. The inconsistent bundle arrangements made it nearly impossible for specimens to be cut with the same number of bundles across their widths. Furthermore, bundles were often cut into fractional parts. An analysis was undertaken to determine if the varying fiber contents affected the fatigue curve results. Tables 3 and 4 contain the fiber volume fractions for each specimen in the R=10 and R=2 data sets. In both cases it can be seen that the fiber volume fractions hover close to 50%. The R=10 curve has three specimens that are closer to 60%, but otherwise there are no significant variations in the fiber contents. The minimum testing stress of each specimen is normalized by fiber

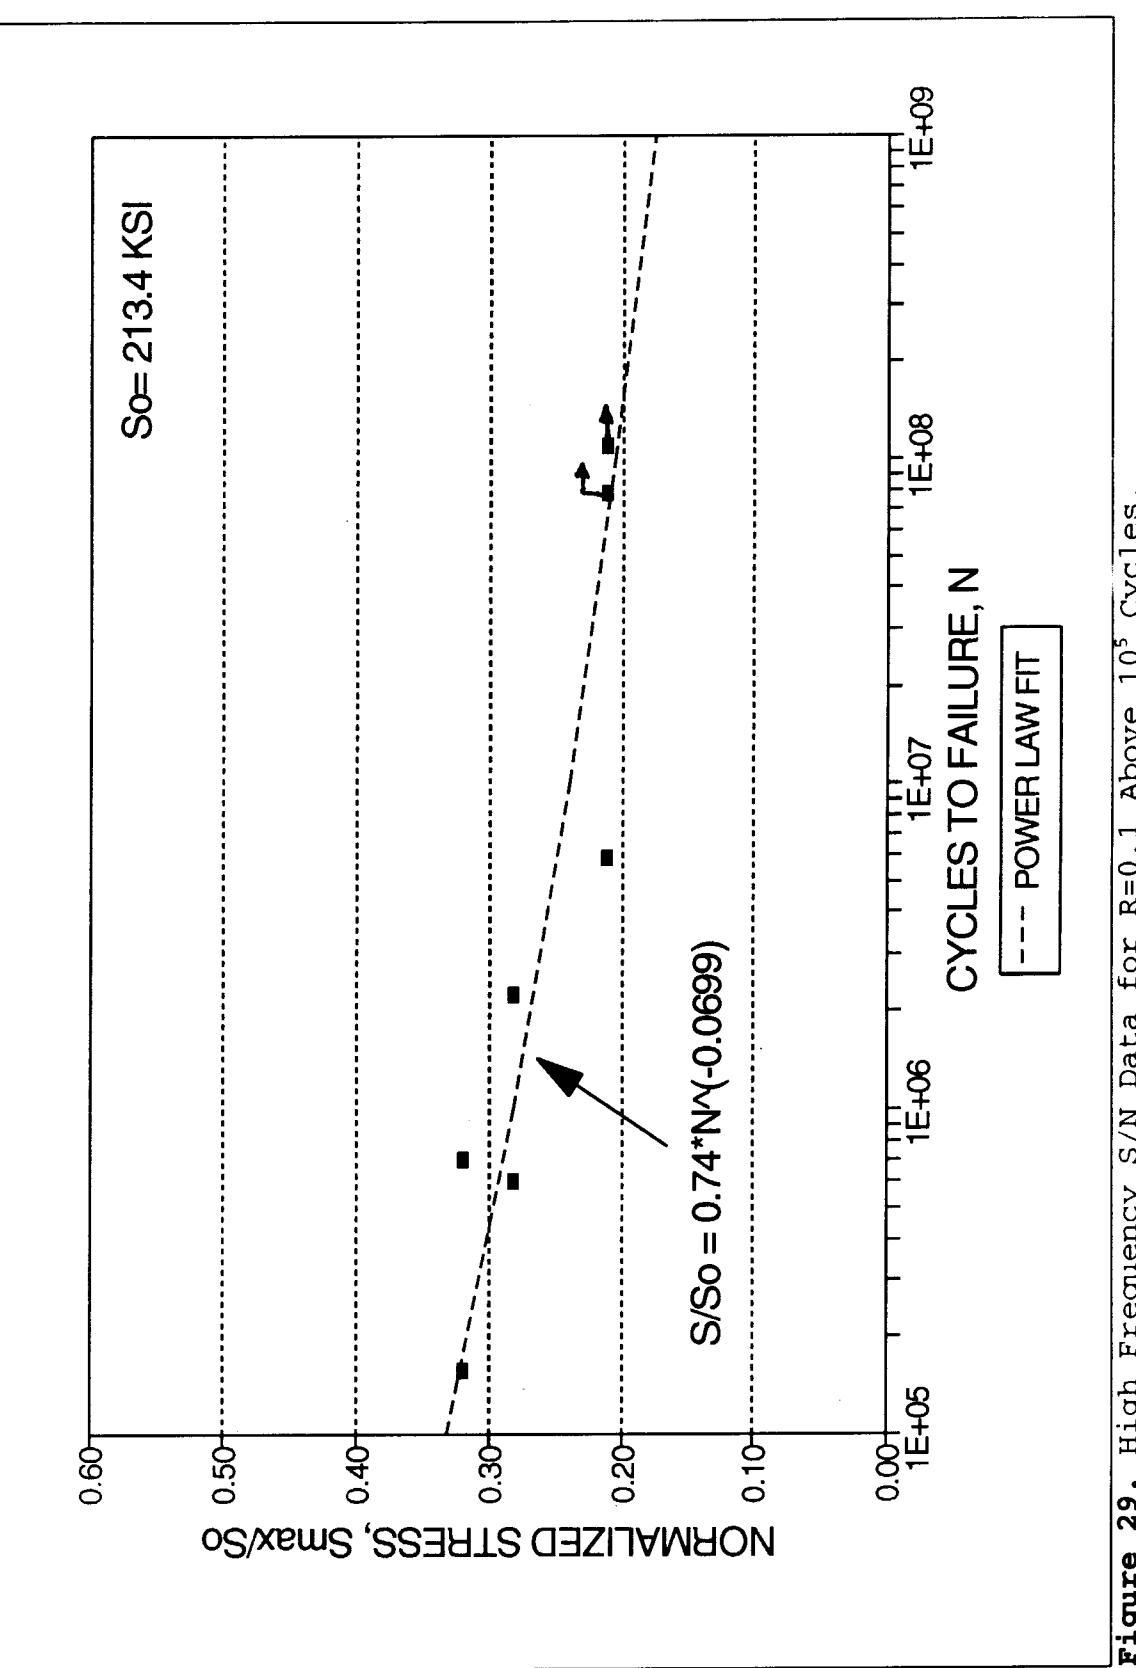
Figure 29. High Frequency S/N Data for R=0.1 Above 10⁵ Cycles.
