HIGH CYCLE COMPRESSIVE FATIGUE OF UNIDIRECTIONAL GLASS/POLYESTER PERFORMED AT HIGH FREQUENCY

Andrew Jay Belinky

Chemical Engineering

MONTANA STATE UNIVERSITY Bozeman, Montana

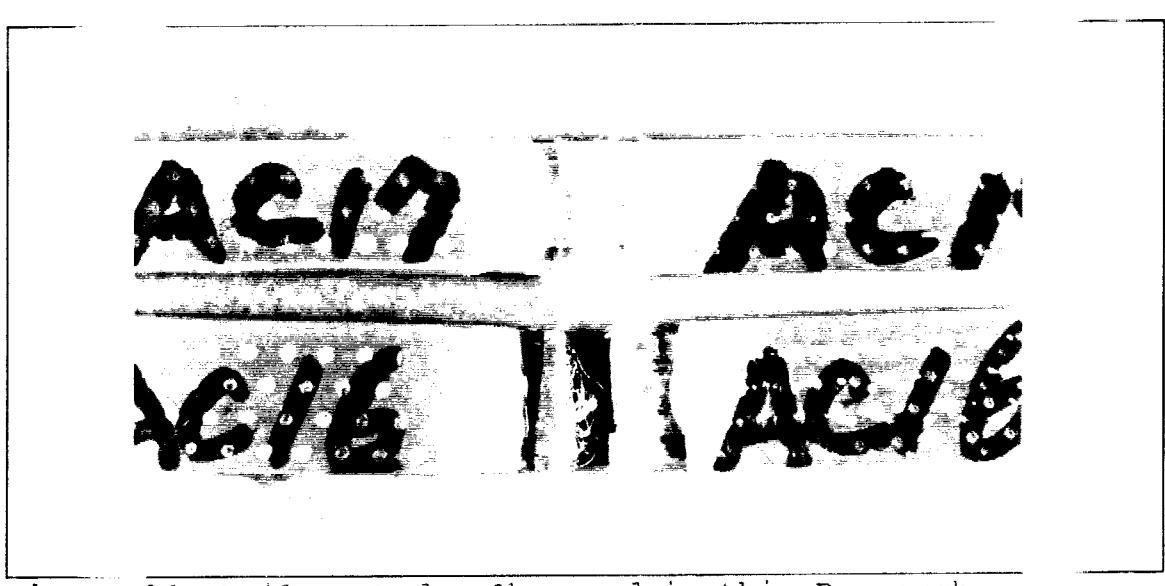
Figure 34. Failure Modes Observed in this Research.

Specimen failures occurred catastrophically in the gage section, without any noticeable warning such as preliminary cracking or delamination. The predominant failure mode was shear crippling. Specimen failure modes are somewhat different than those observed by Combs [39] (Figure 31) for larger coupons and those in the literature [35] (Figure 32). The larger coupons in these studies tended to experience more delamination/ buckling of the outside plies, while some inner plies experienced shear crippling. The greater degree of delamination/ buckling observed in the larger coupons may be

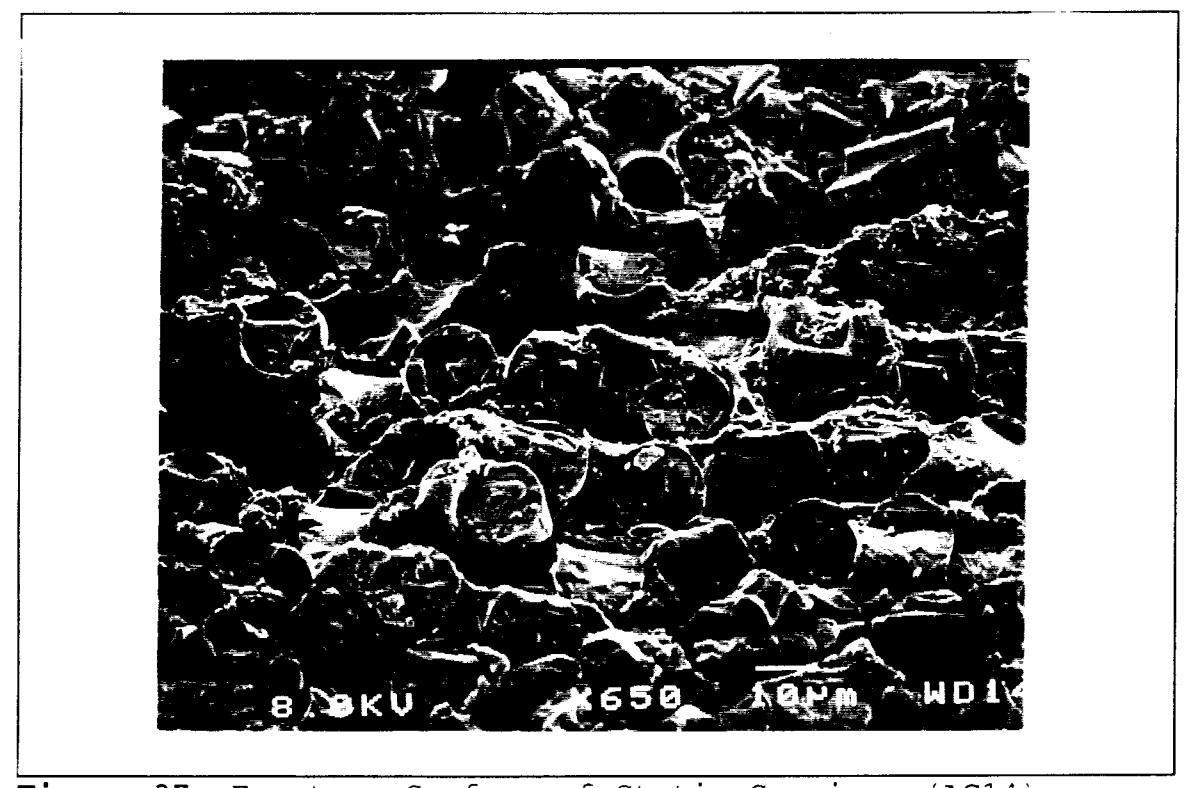
Figure 37. Fracture Surface of Static Specimen (AC14)

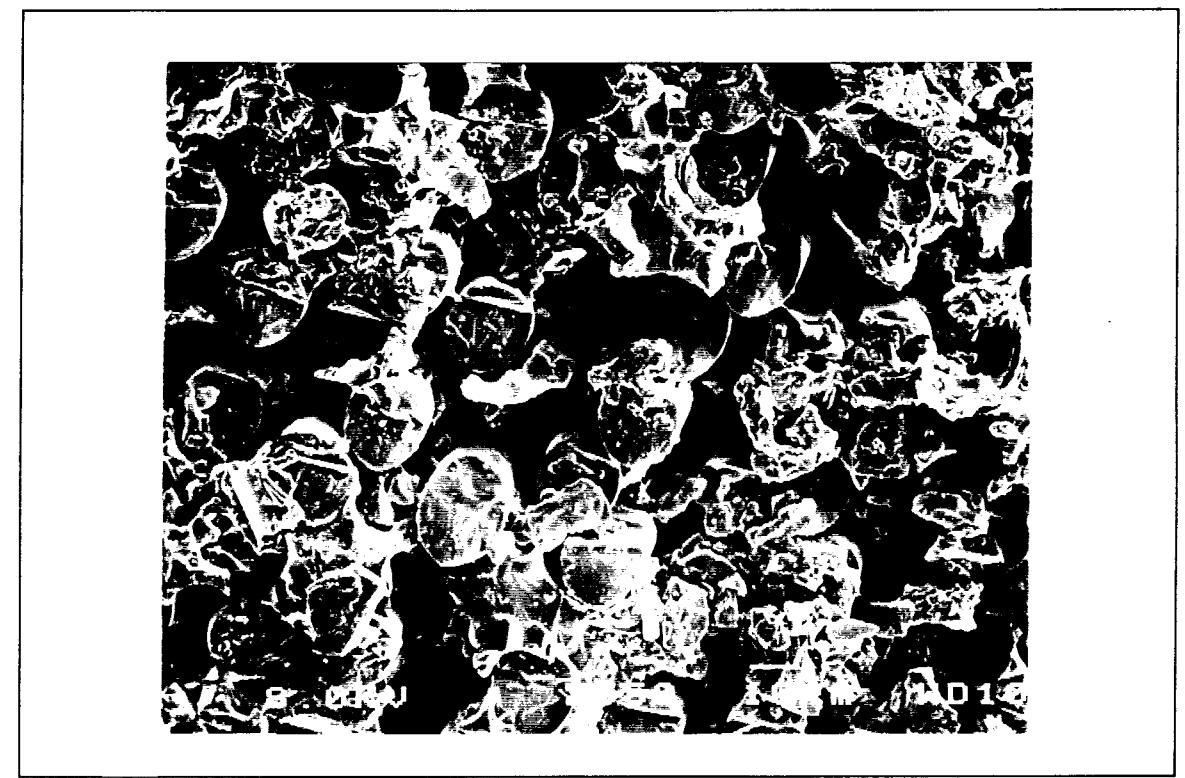
Figure 38. Low Stress Fatigue Fracture Surface (AC15).

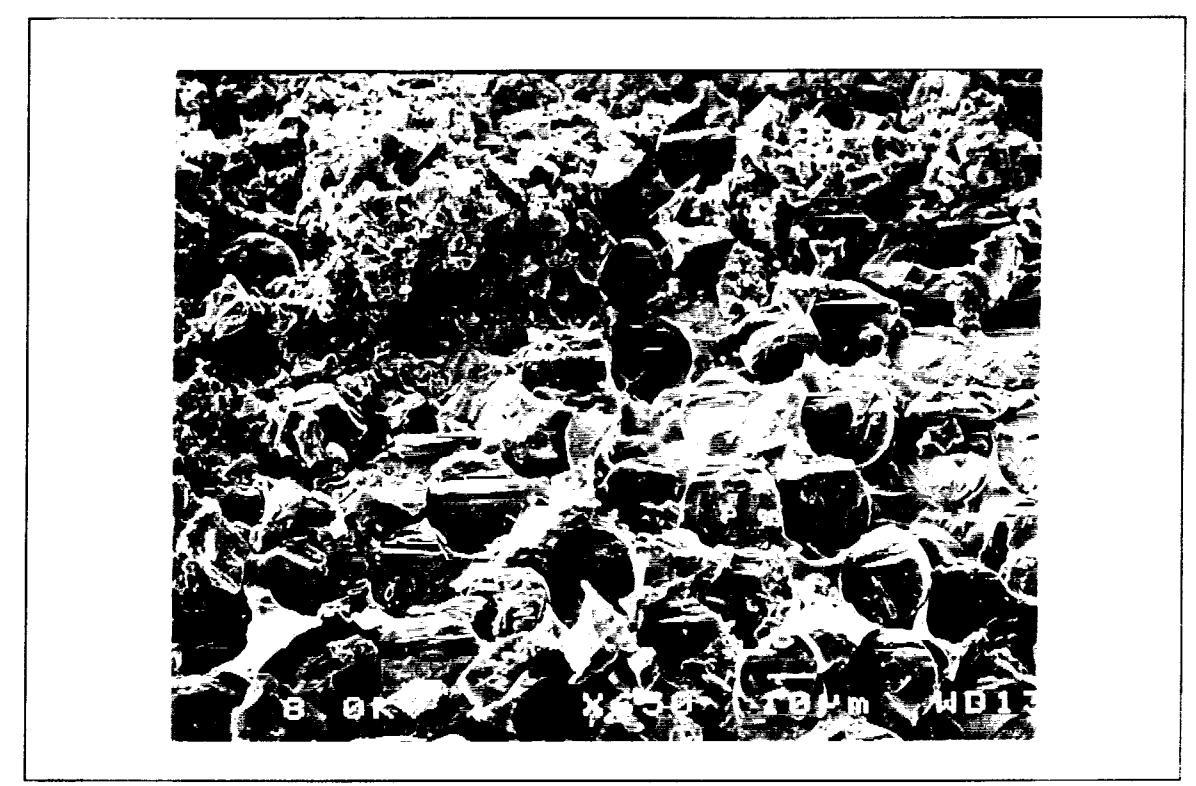
Figure 39. High Stress Fatigue Fracture Surface (AC8).

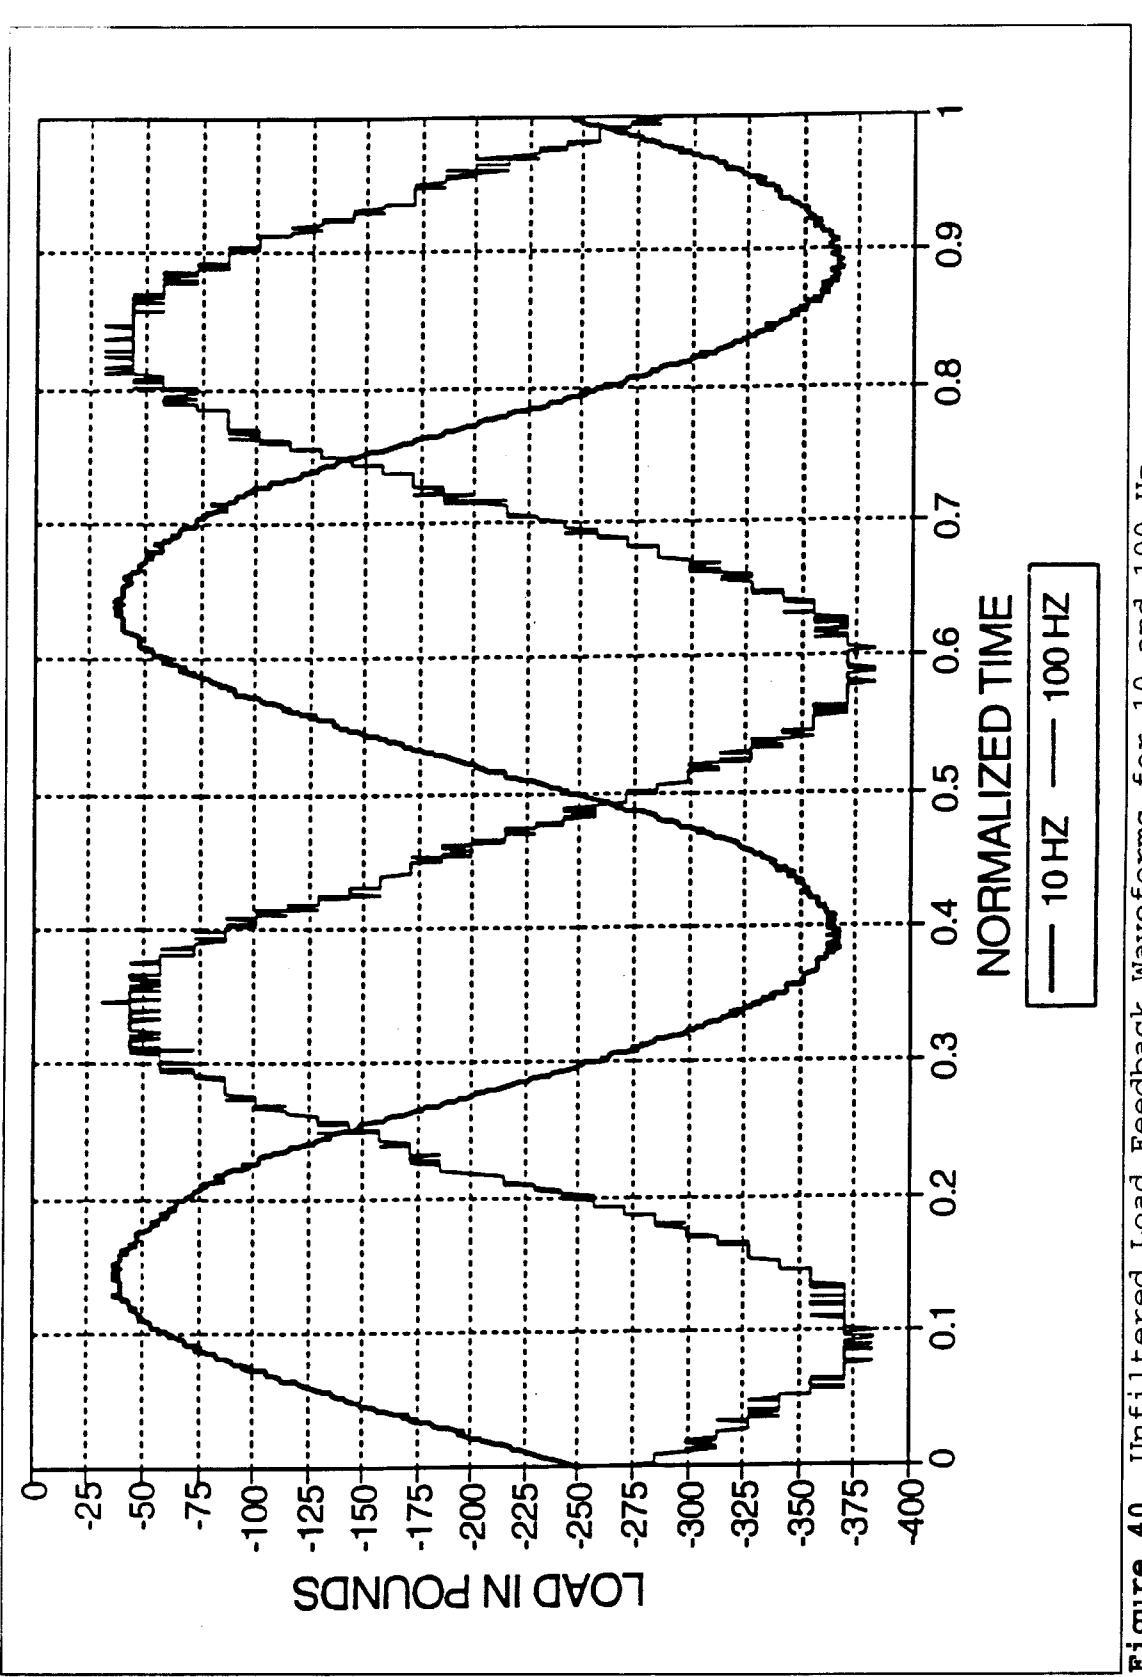
Figure 40. Unfiltered Load Feedback Waveforms for 10 and 100 Hz.

A possible cause of shorter lifetimes at high frequency lies in differences in the load waveforms. Figure 40 shows the unfiltered waveforms obtained for 10 and 100 Hz. Time has been normalized (t/t,, where t, is the time for each waveform

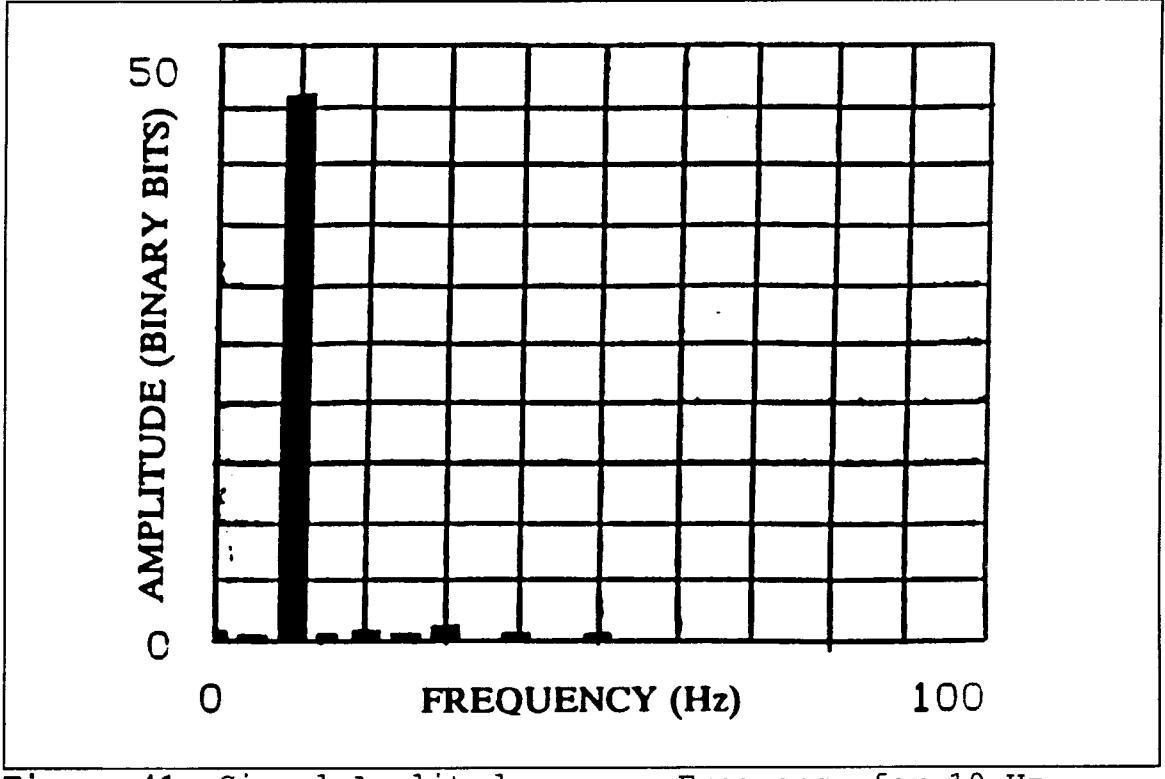
Figure 41. Signal Amplitude versus Frequency for 10 Hz.

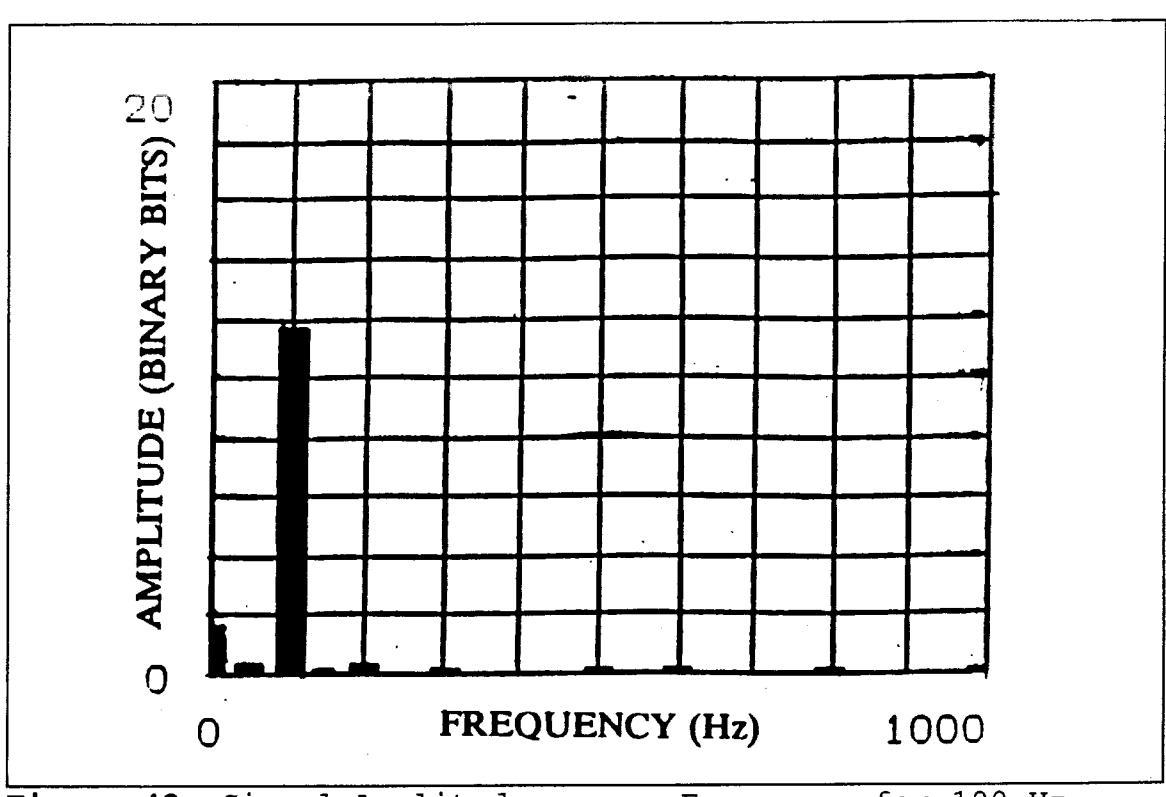
Figure 42. Signal Amplitude versus Frequency for 100 Hz.

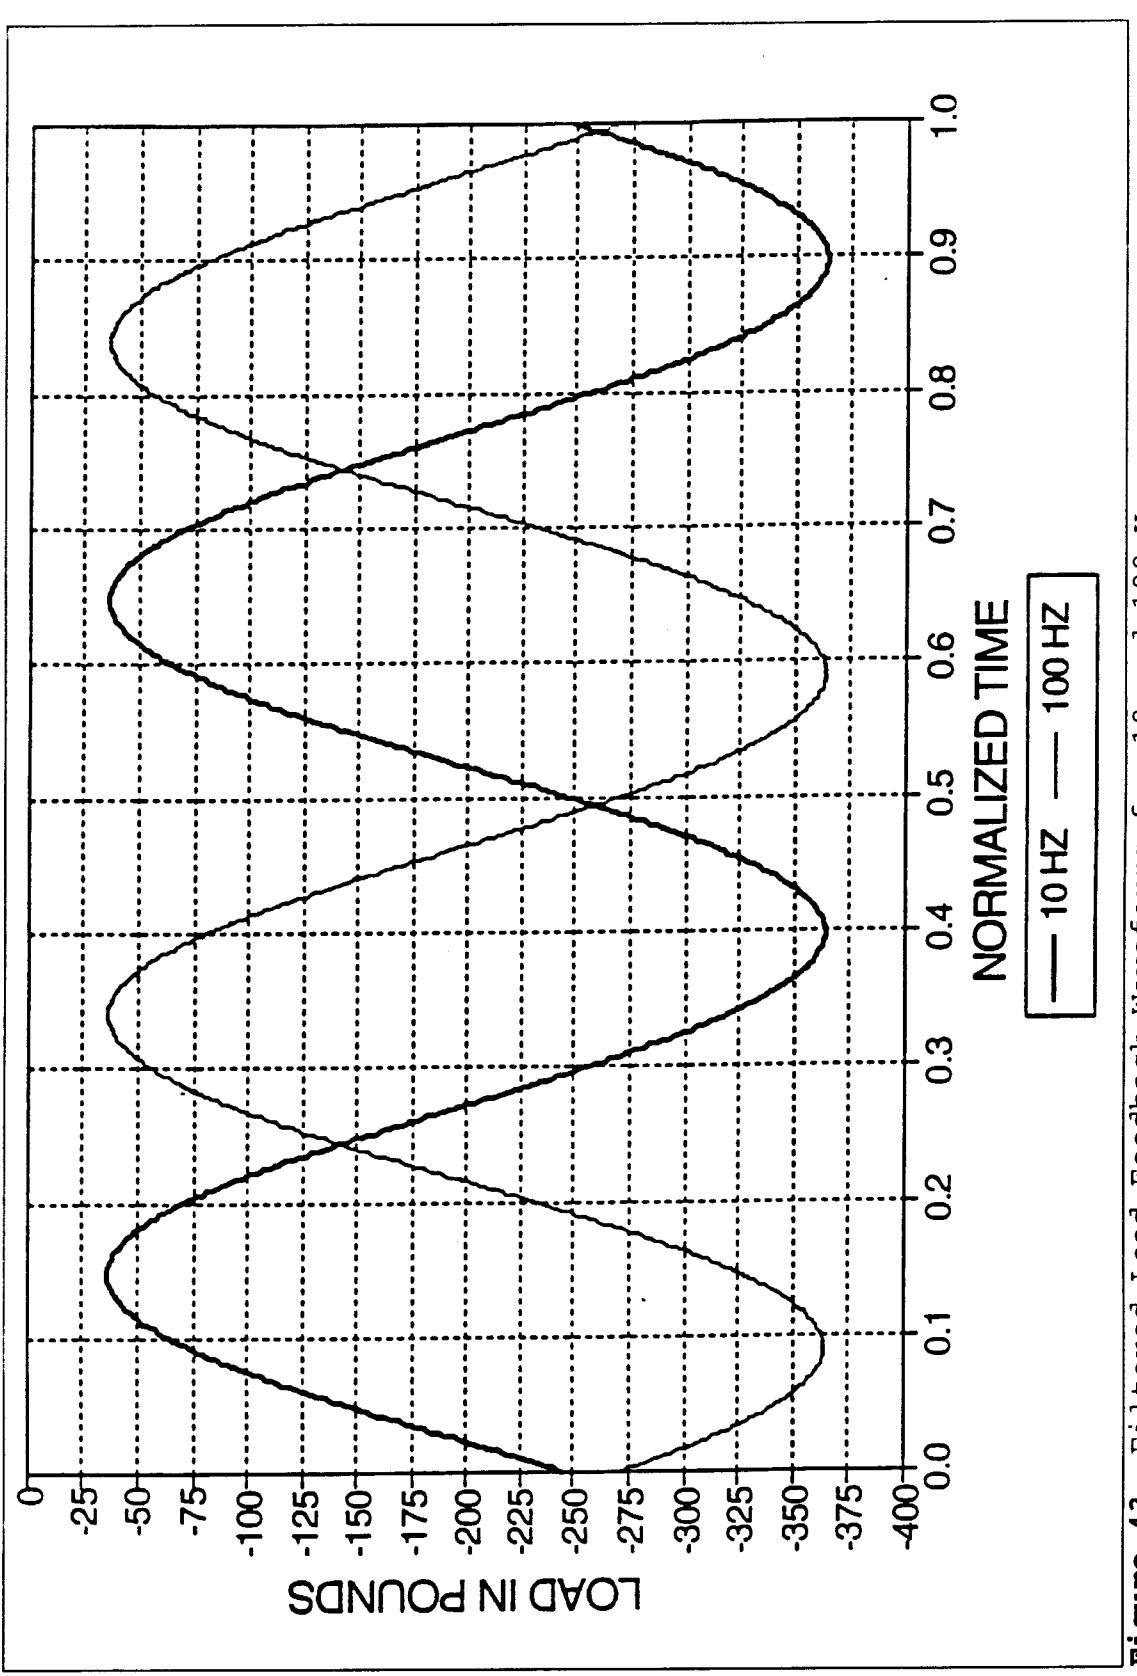
Filtered Load Feedback Waveforms for 10 and 100 Hz. Figure 43.

The filtered waveforms in Figure 43 show the load patterns that the specimen experienced during testing.

Identical waveforms would indicate that the specimen was being tested the same at 100 Hz as at 10 Hz; the only difference being a higher loading rate at 100 Hz. As can be seen in Figure 43, both feedback curves are similar sine waves (the command signal is a sine wave). The fact that both the high and low frequency filtered waveforms are pure, undeformed sine waves is very important because it means that there were no distortions in the loading pattern caused by an increase in test frequency, assuming that the machine does not respond to the high frequency spikes noted earlier. Deformations in the 100 Hz feedback waveform would have indicated that the testing machine was unable to operate properly at such a high frequency. It would also mean that at 100 Hz the specimen is

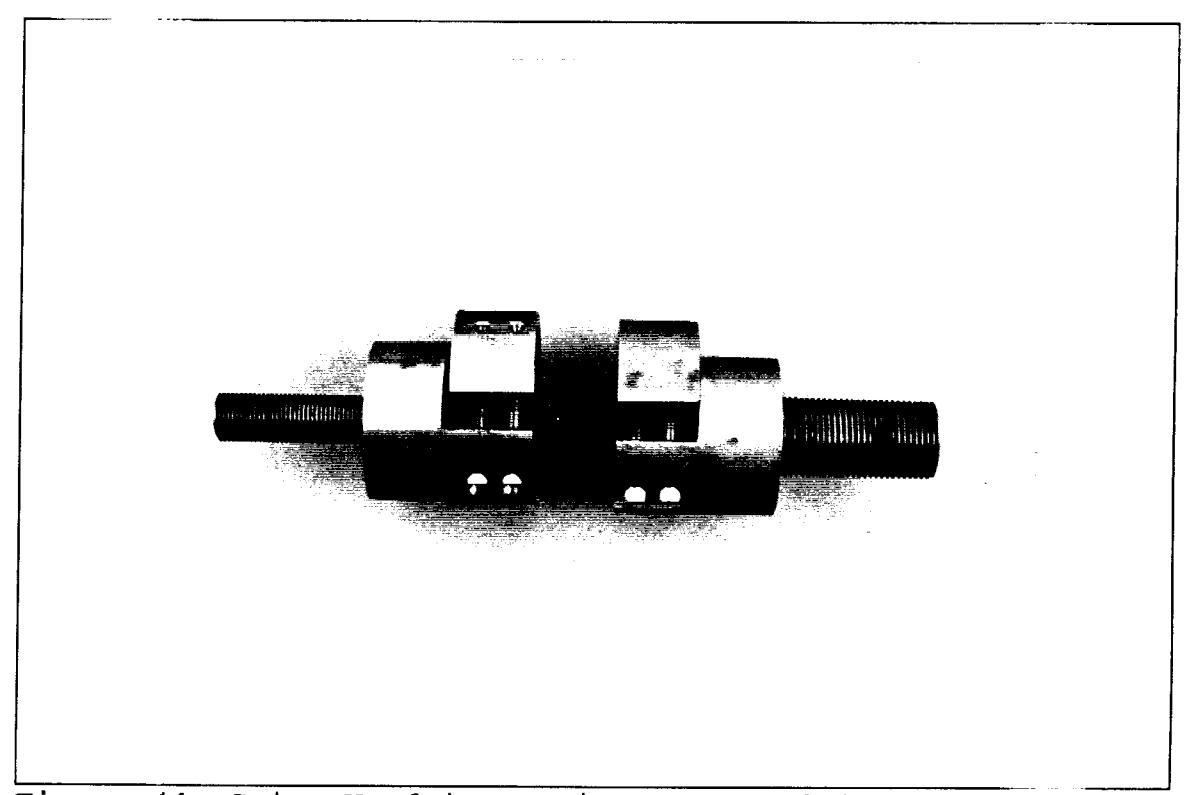
Figure 44. Grips Used in Previous Research by Creed.

In order for valid, reproducible compression testing to be accomplished in this project, it was necessary to utilize different grips from the ones employed earlier in high frequency tensile testing (Figure 44). The design finally

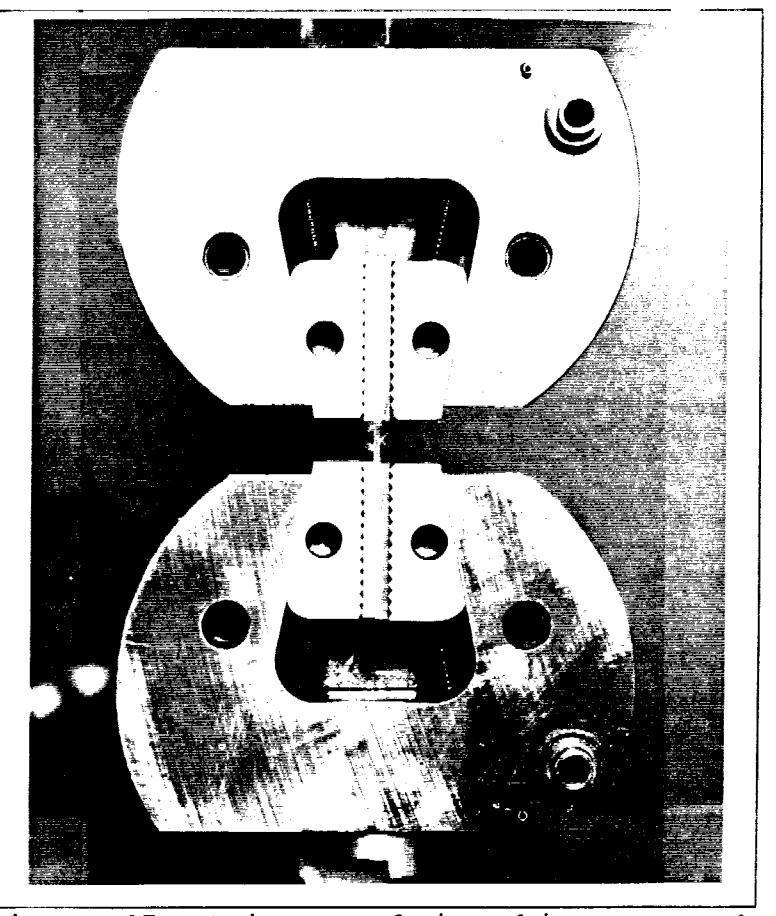
Figure 45. Grips Used in This Research with Specimen Running.

ensuring that the specimen was centered underneath t h e load applicator. These were testing that requirements the previous grips could not accomplish. Modifications were made to allow the arips to be used for compression testing. Four screws were

incorporated into the outer shell to force the jaws together when tightened. This was necessary because compressive loads would act to force the jaws apart since the grips were originally designed to work only in tension. The screws were tightened to approximately 30 inch-pounds of torque during tests. The outer shell was composed of steel hardened to Rockwell C40, while the jaws were steel hardened to Rockwell C60. The jaws were also knurled, creating jaw faces that were able to solidly grip specimens by digging into the tabs.

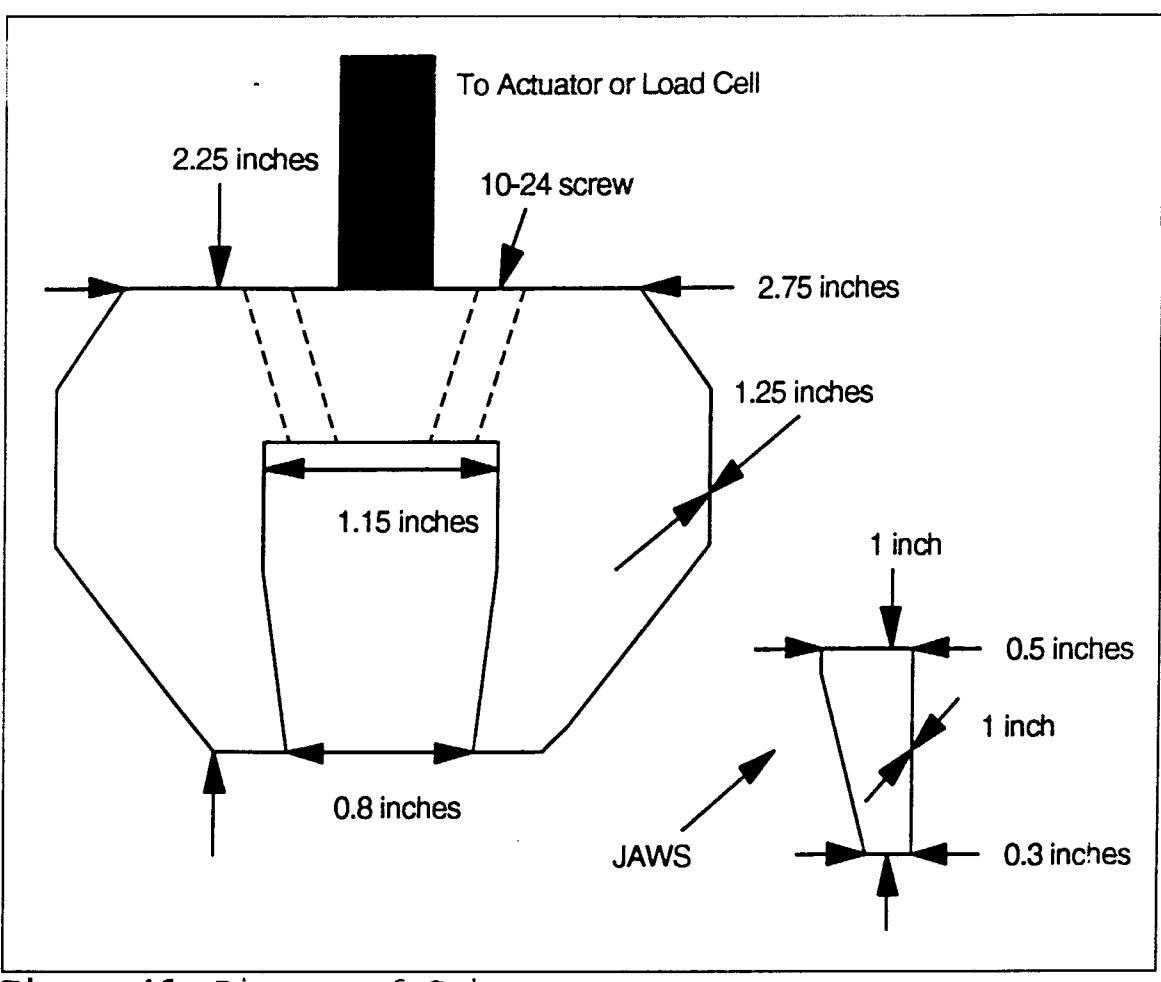
Figure 46. Diagram of Grips.
