Montana State University
**Johnstone Center Exterior Painting
Construction Drawings**

PPA #19-0025
February 2021

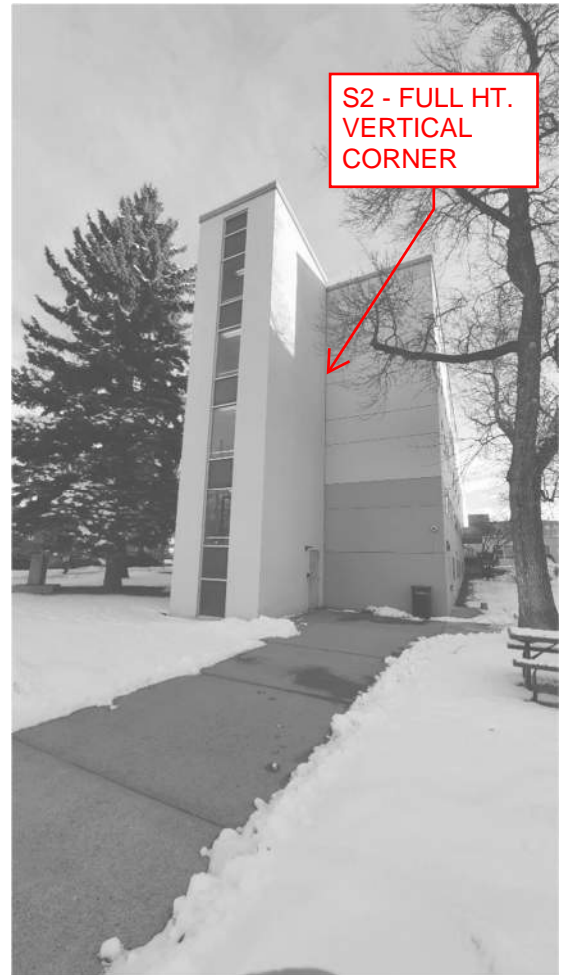
PRYOR - NORTH

W1 - ALL PRYOR
WINDOWS, UNLESS
OTHERWISE NOTED

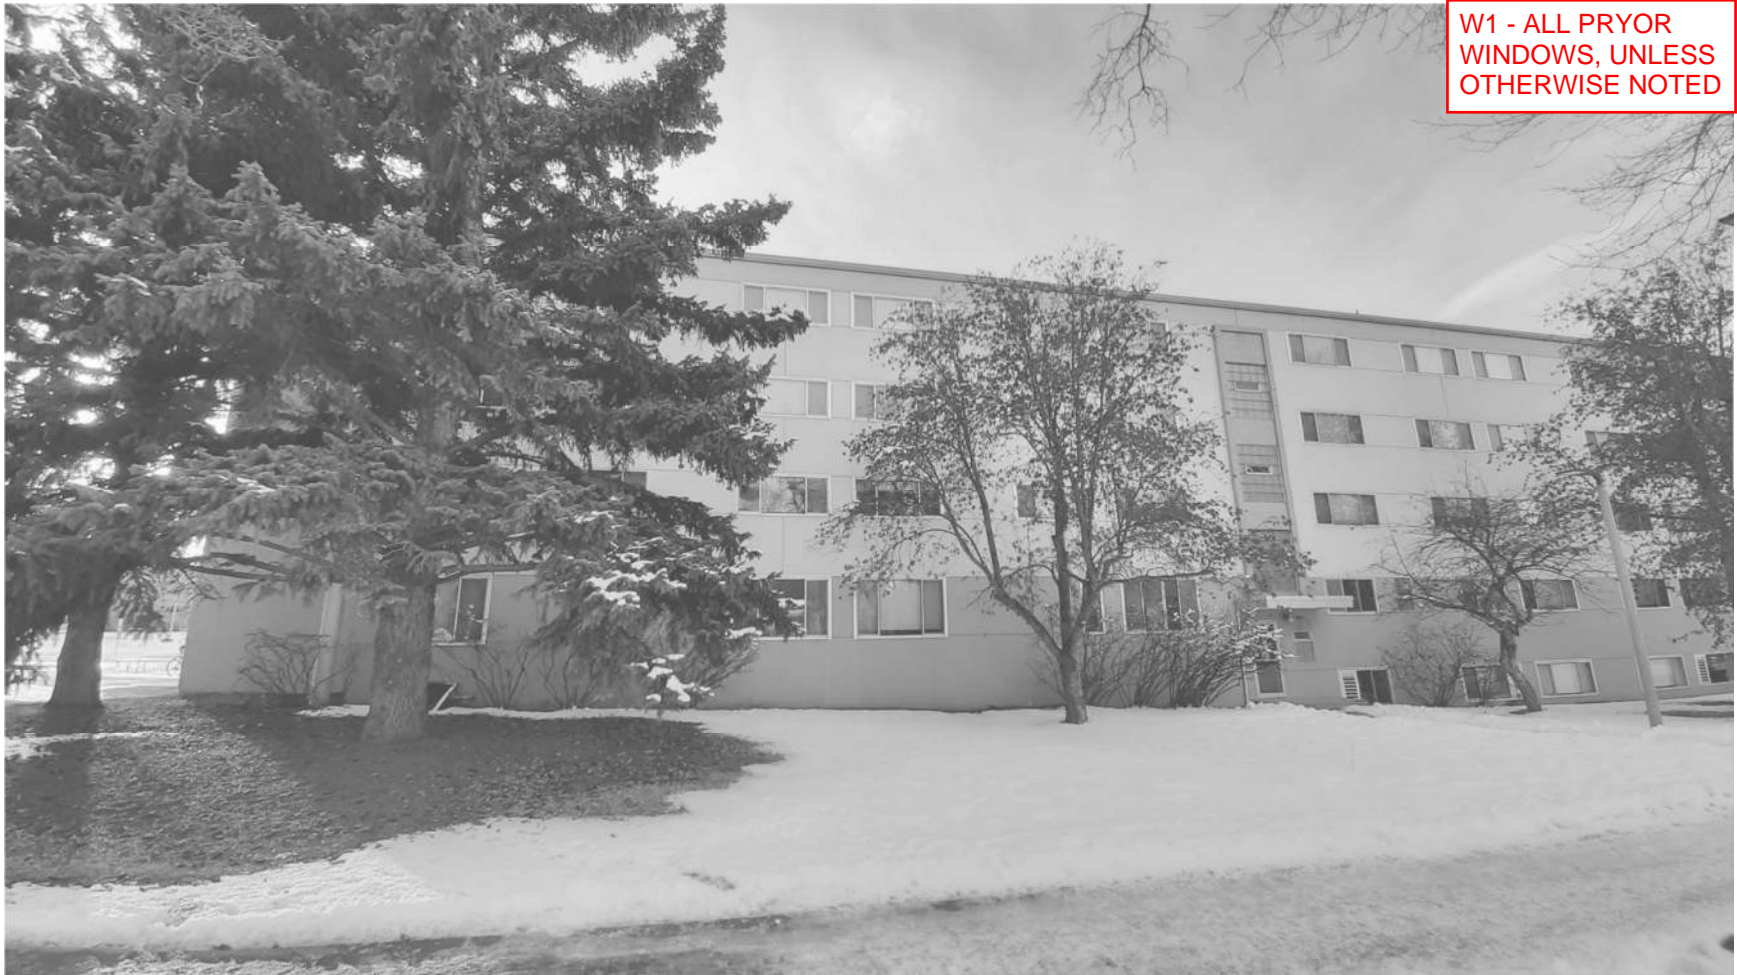
PRYOR - SOUTH

W1 - ALL PRYOR
WINDOWS, UNLESS
OTHERWISE NOTED

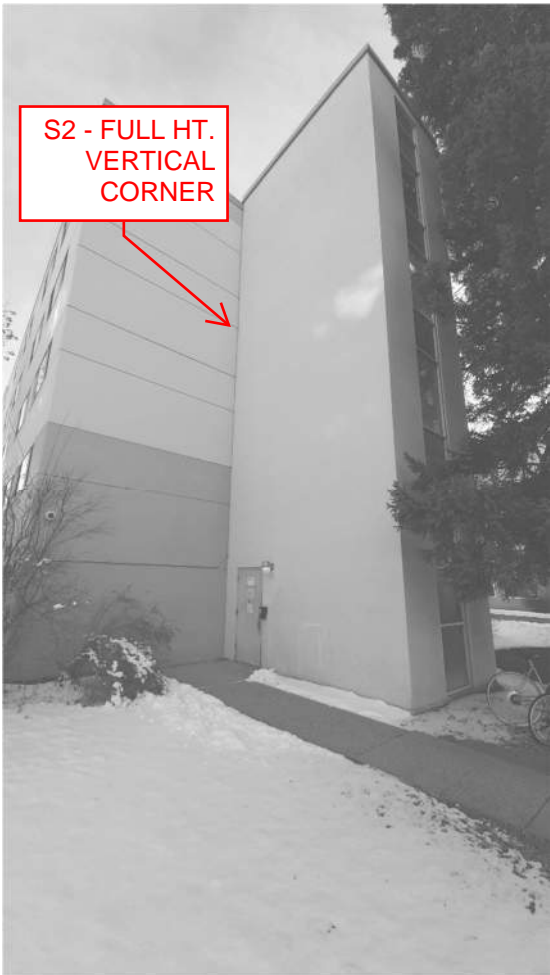
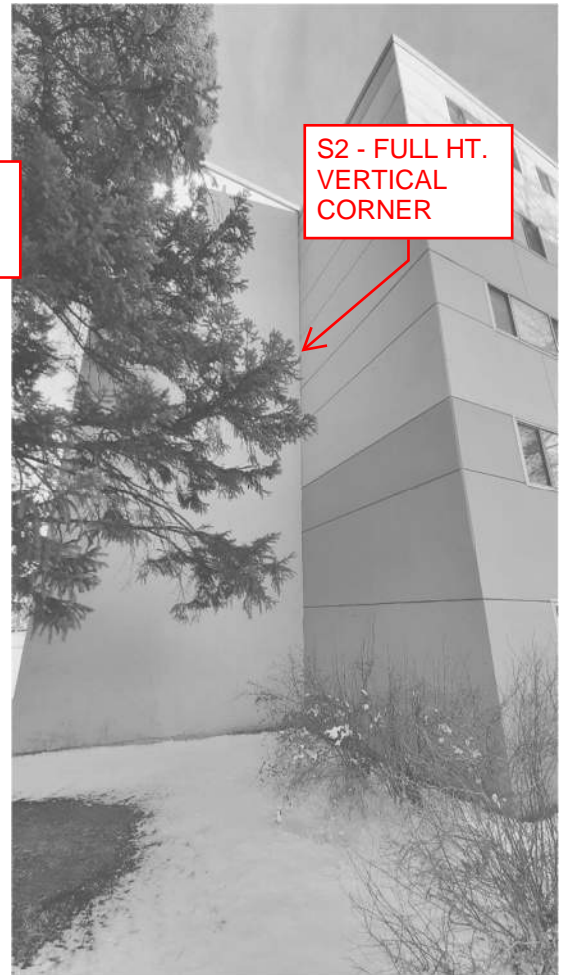
PRYOR - EAST

W1 - ALL PRYOR
WINDOWS, UNLESS
OTHERWISE NOTED

W3

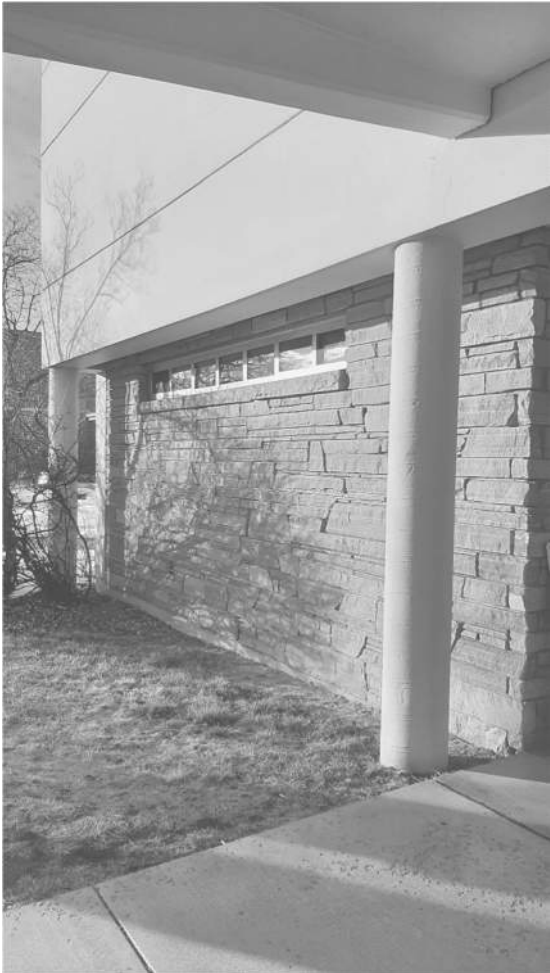
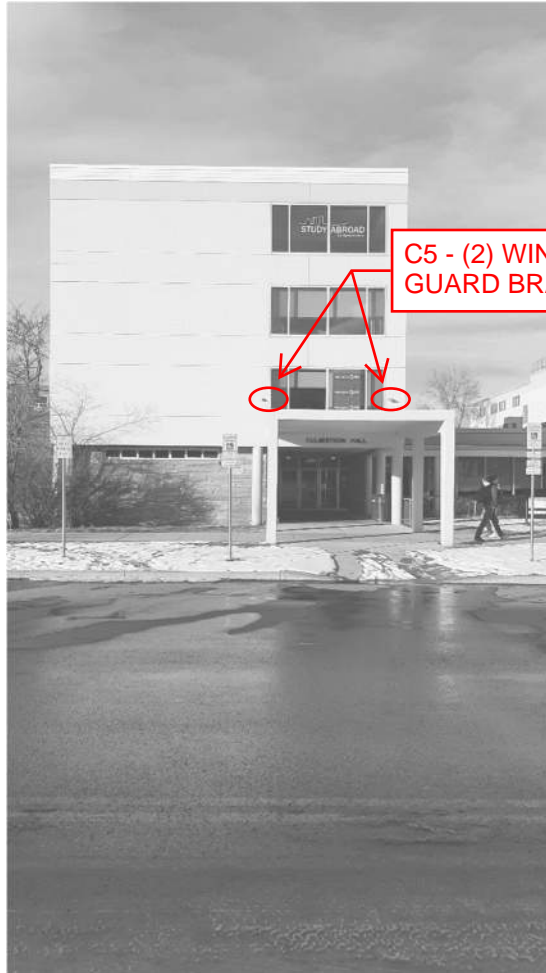
CULBERTSON - WEST

C1

C5 - (2) WINDOW
GUARD
BRACKETS

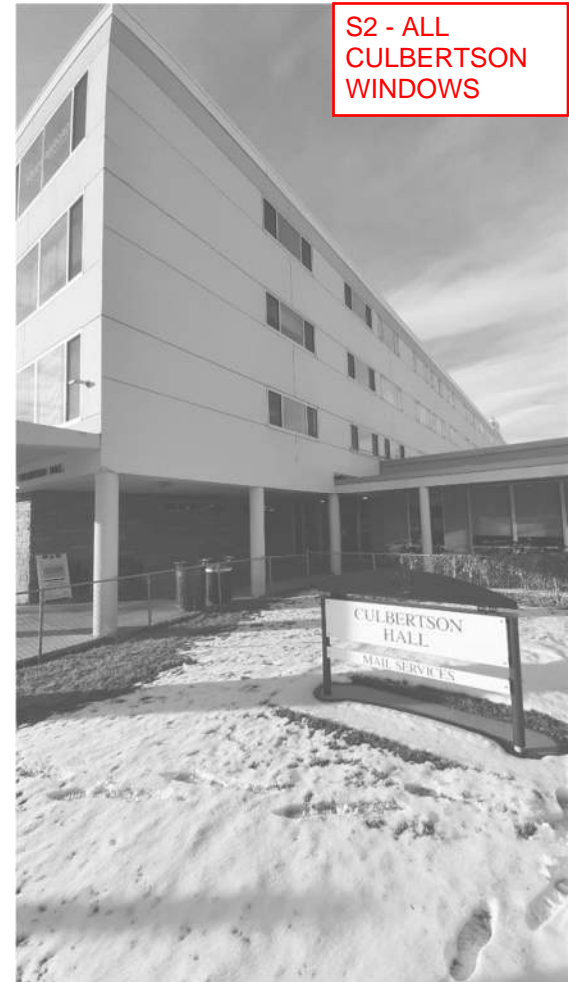
CULBERTSON - EAST

S2 - ALL
CULBERTSON
WINDOWS
